# AIRCRAFT SERIOUS INCIDENT INVESTIGATION REPORT

ALL NIPPON AIRWAYS  
AIRBUS A320-200, JA8947  
(DECOMPRESSION IN AN AIRCRAFT CABIN)

September 27, 2002

Aircraft and Railway Accidents Investigation Commission  
Ministry of Land, Infrastructure and Transport

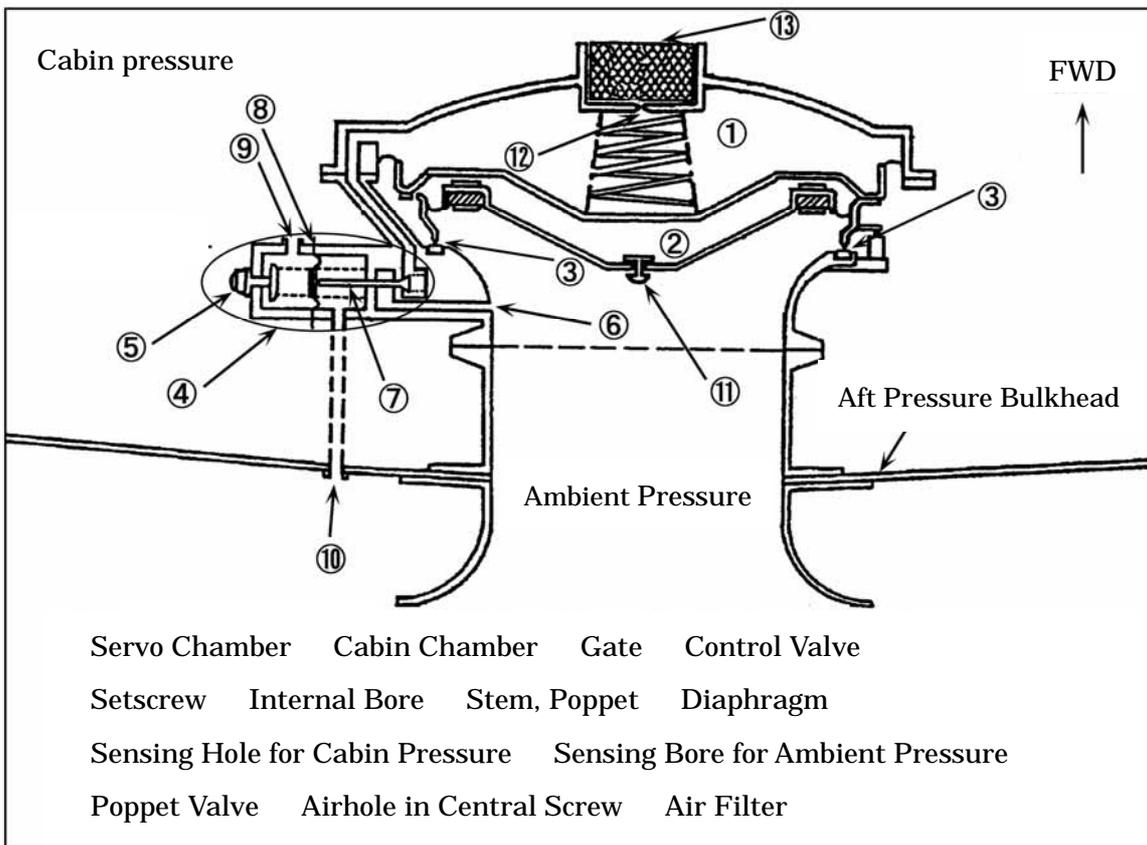
Figure 4 Cross-Sectional View of Safety Valve

As shown in Figure 4, if the cabin pressure rises such that the differential between the cabin pressure and the ambient pressure exceeds a specified limit (positive pressure), the diaphragm ( in Figure 4) in the control valve moves to the right, the gate of the safety valve opens and the cabin pressure is relieved. On the other hand, if the cabin pressure becomes less than the ambient pressure (negative pressure), the gate of the safety valve opens by the opening of a poppet valve in the cabin chamber, and the differential pressure between the inside and outside of the cabin is regulated within the specified limits.

The adjusting screw, which sets the valve's positive differential pressure cracking point (indicated as "set screw" in Figures 4 and 5), was driven in to an abnormal depth on S/N129. The length from the control cover to the tip of adjusting screw head was measured as 1.63mm, but is nominally around 5.6mm.

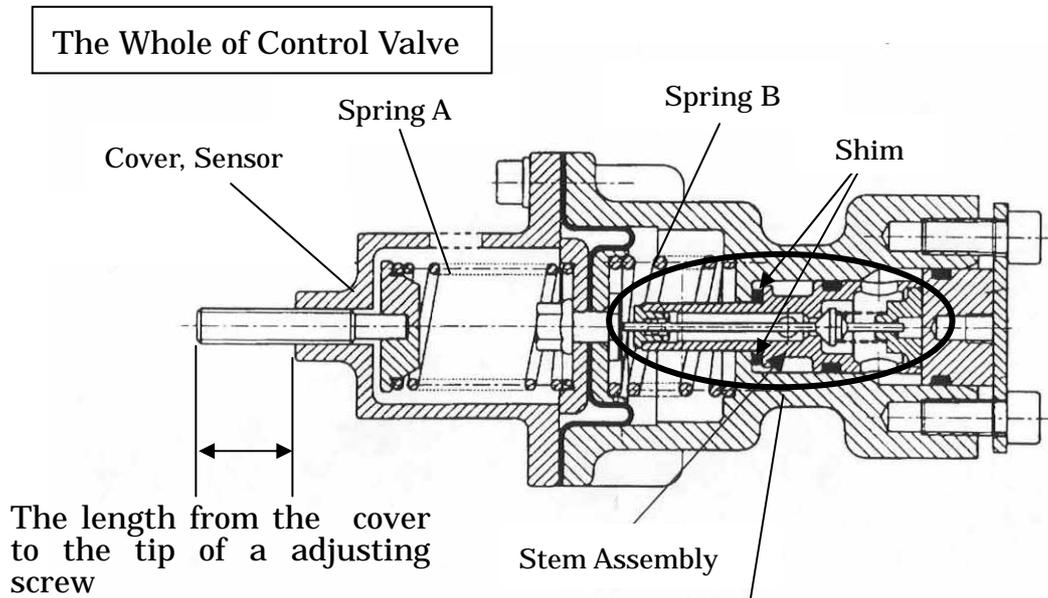
Figure 6 Cross-Sectional View of Control Valve

According to the maintenance records of the ARS, the adjustment was performed appropriately according to the updated CMM issued by the safety valve manufacturer. The adjustment screw of the control valve was driven inwards, and the setting brought to within specified limits by increasing the preload on spring-"A" shown in Figure 6.

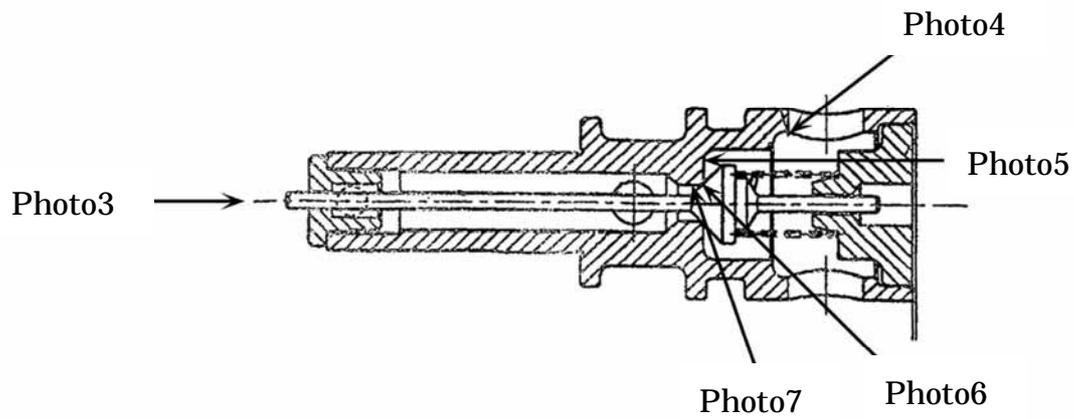
## Figure 7 Description of photographed points

An arrow shows below the direction with fault observed under the microscope inspection about each part.
