**AIRCRAFT SERIOUS INCIDENT
INVESTIGATION REPORT**

**JAPAN AIRLINES CO., LTD.
J A 8 9 8 0**

BOEING 767-300, JA8980

AT AROUND 15:55 JST, MAY 24, 2018

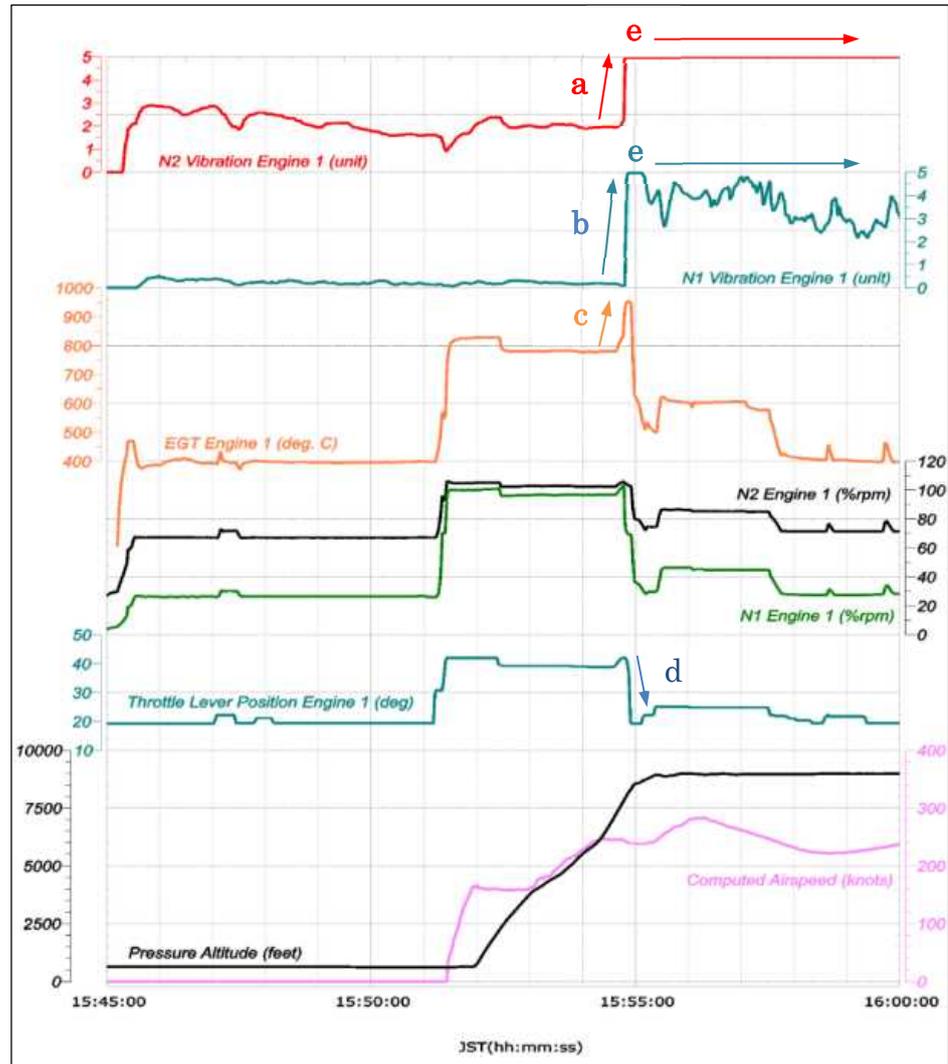
Figure 5: QAR record

2.6 Additional Information	<p>(1) Damage to the Ground</p> <p>Windows and roofs of buildings and windshield of vehicles on the ground near the serious incident site were damaged from fragments of inner parts exhausted from No. 1 engine. About 400 exhausted fragments were gathered, and the heaviest one among them weighed about 70 gram.</p> <p>Besides, LPT of same type of engine weighs about 726 kg and the pertinent LPT after the damage weighed about 653 kgs. When comparing the weights, the weight reduced by exhausted fragments was calculated equivalent to about 73 kgs.</p> <p>(2) Engine Data Recorded in FDR and QAR</p> <p>Analysis of FDR and QAR revealed that abnormality or its indication was not recorded until the occurrence of the serious incident.</p> <p>At 15:55 when the Aircraft was climbing, the vibration level*² on N2*³ side of No. 1 engine abruptly increased reaching the upper limit of measurement (4.99 unit) (see “a” in Figure 5), immediately followed by abrupt increases of the vibration level on N1*⁴ side reaching the upper limit of measurement (see “b” in Figure 5) and EGT*⁵ up to about 950° C (see “c” in Figure 5).</p> <p>Then, rpm on N1 side was abruptly decreased, and the same on N2 side was almost simultaneously reduced as well. Thrust lever was reduced to idle five seconds thereafter (see “d” in Figure 5). Engine rpm (N1 and N2) was still maintained near idle position until landing, and vibration level on N1 and N2 sides remained high (see “e” in Figure 5). Besides, figures of EGT record after EGT sensor was damaged associated with the damage to HPT may not be accurate.</p>
