**AIRCRAFT SERIOUS INCIDENT
INVESTIGATION REPORT**

**JAPAN AIRLINES INTERNATIONAL CO., LTD.
J A 8 9 8 6**

BOEING 767-300, JA8986

ON RUNWAY 34L OF TOKYO INTERNATIONAL AIRPORT

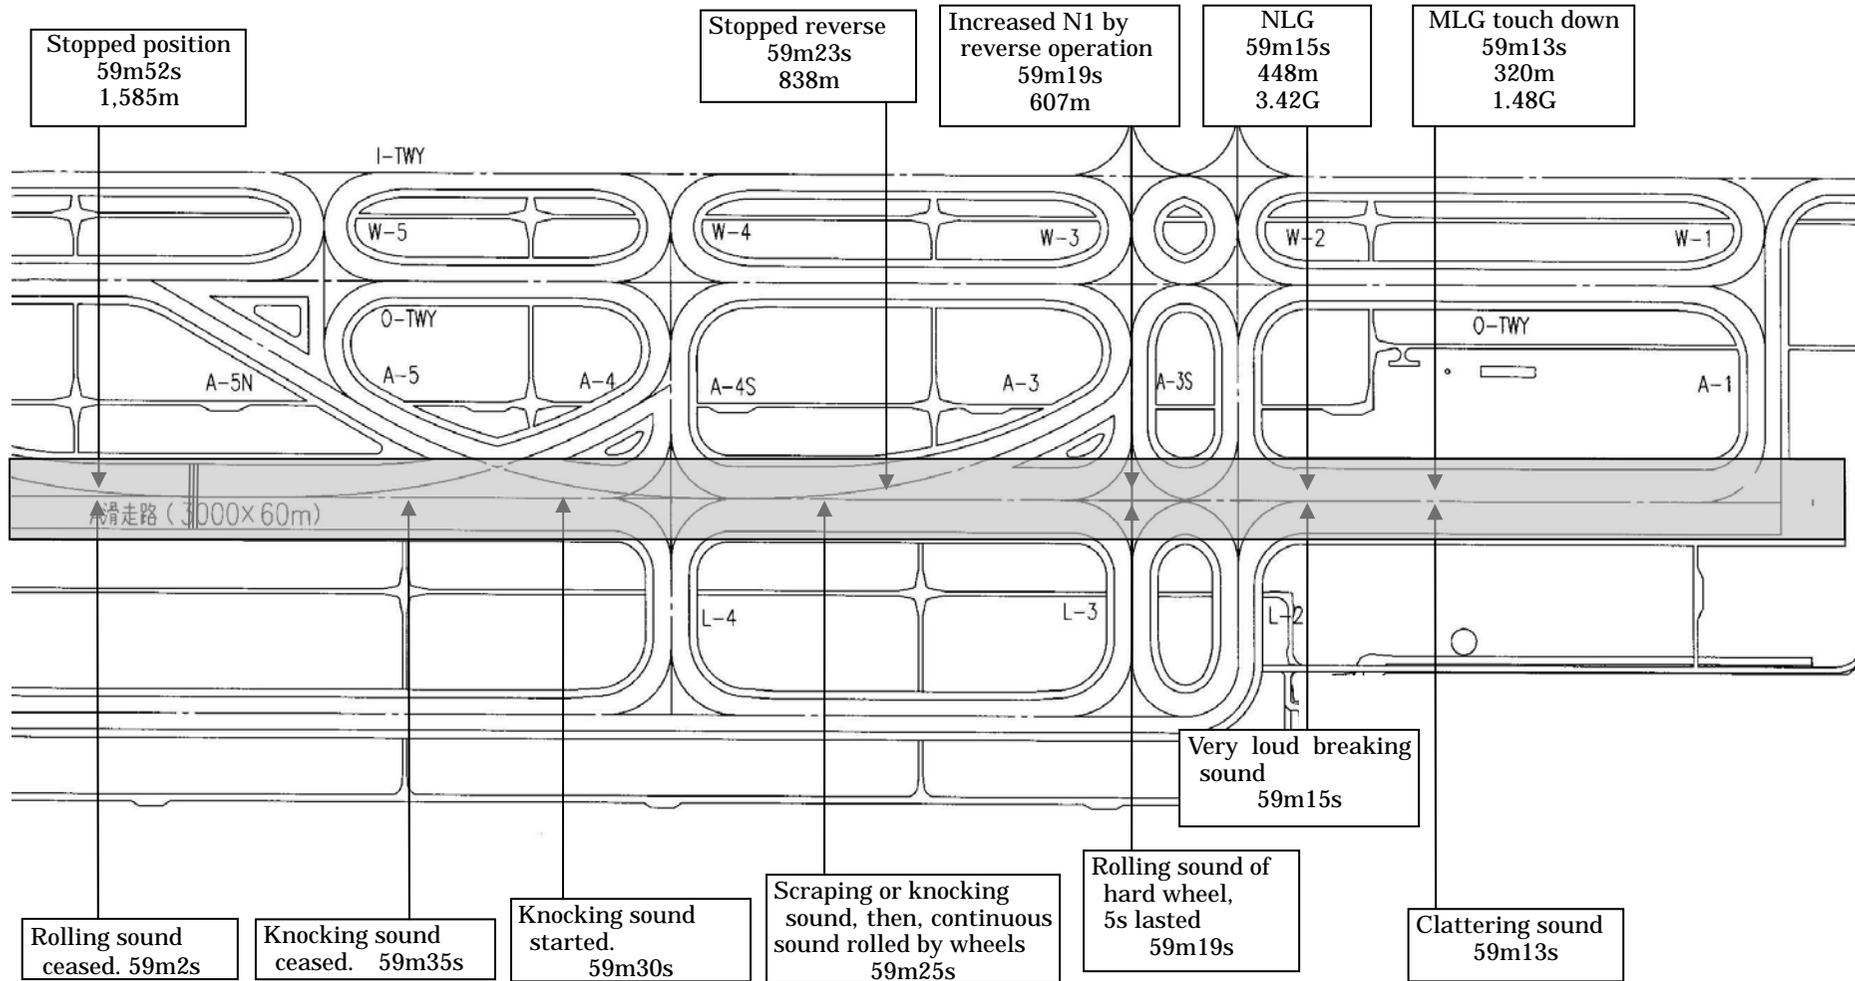
Figure 4 Situation of the Aircraft Stop

This serious incident occurred as the Aircraft landed on Runway 34L of Tokyo International Airport, it is estimated that it bounded on its first touchdown and then the nose gear touched down before the Aircraft weight was completely placed on the main landing gears again, and that an excessive load was placed on the nose gear, and consequently, the nose gear damaged, and the Aircraft went into the condition unable to taxi by itself.

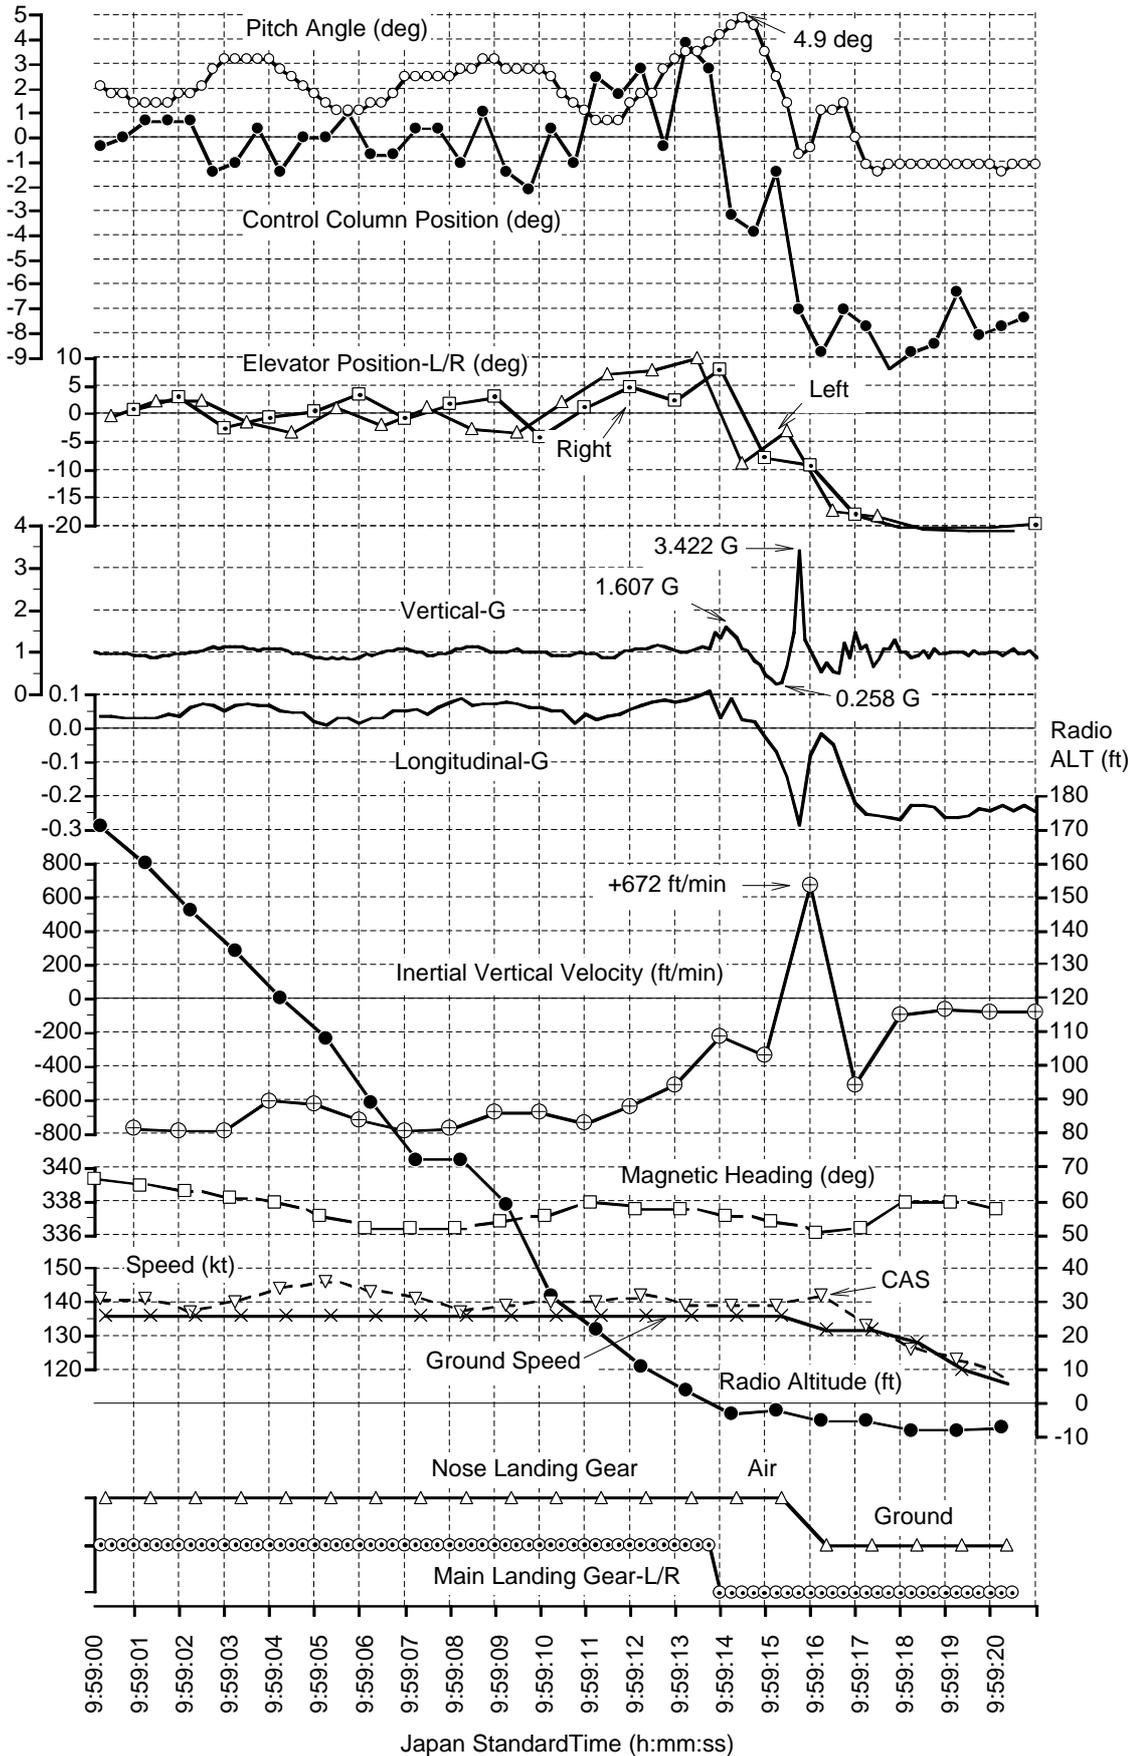
Figure 5-3 DFDR Records 3 (Just touch down)

to increase (3.9° to 4.2°) when the CCP was at 2.81° and was still increasing (from 4.6° to 4.9°) when the CCP was at -3.16° at the first half of 59m:14s. Therefore it is considered likely that the PF continued to operate the control column forward to respond above situation. Moreover, it is considered possible that the PF operated unintentionally the control column forward by responding against the condition that the main landing gear touched down firmly at that time.

- (3) Approximately one second after the touchdown, the control column was operated forward (the CCP was -3.87°), and the pitch angle was 4.6°. It is estimated that the Aircraft bounded (0.258G), because even after it touched down with rather a large load, the pitch angle increased up to 4.9° and the CAS was also slightly fast at 139kt. As the DFDR record remained in the ground condition at that time, it is estimated that the height was not high enough to make the tilt angle of the main landing gear reach 17° and be recorded as AIR on the DFDR, namely the tires were not completely lifted up from the surface of the runway.

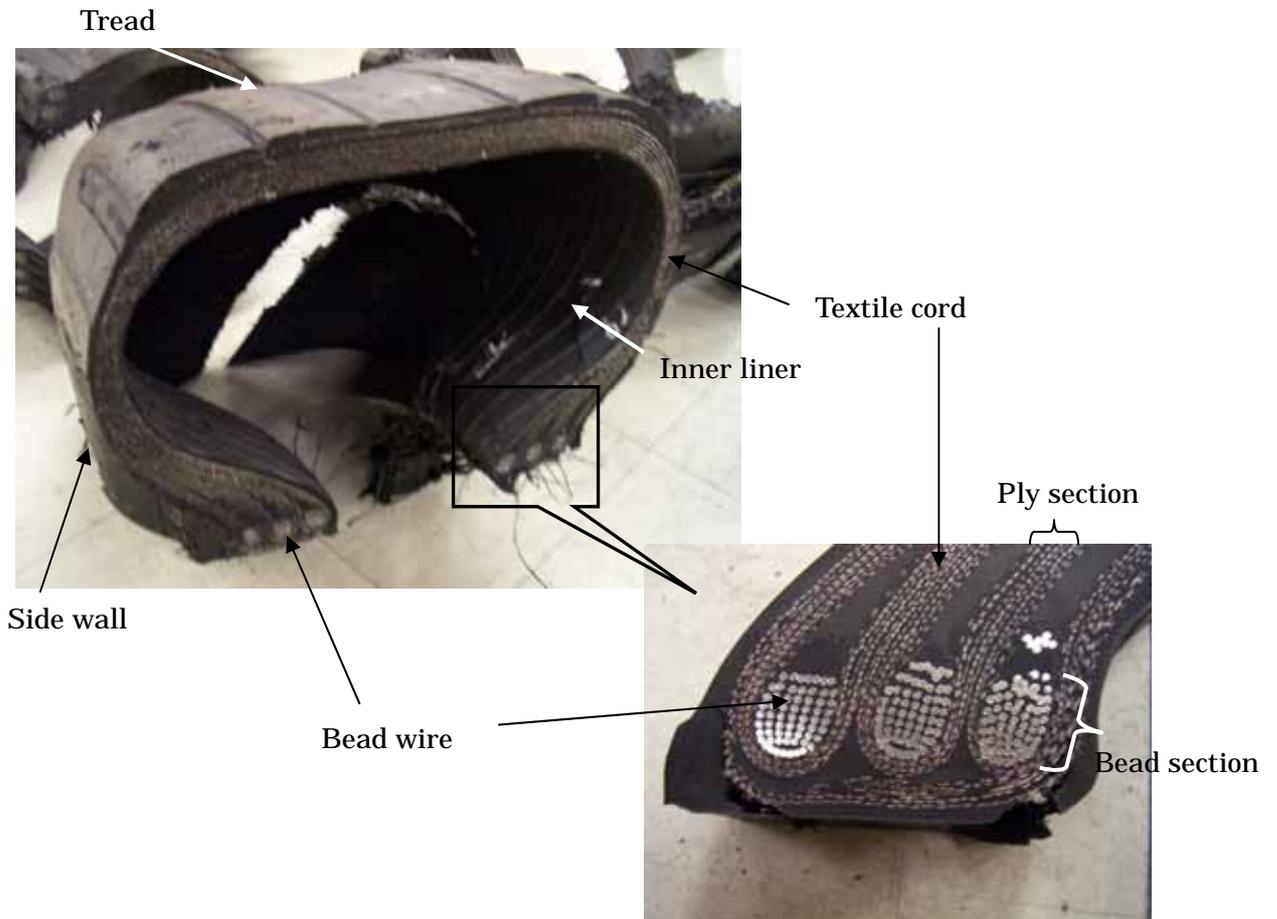
Photograph 4 Cross Section and Names

It is estimated that the bottoming of the tires occurred first and then the wheels were destroyed, because marks of bottoming were found inside the right tire by the appearance inspection on tires, and also because, based on the result of the actual load strength test described in 2.12.4, it is considered likely that the wheels would not be destroyed unless the bottoming of tires occurs.

It is estimated that both of inboard and outboard rims of the right wheel and the inboard rim of the left wheel were destroyed almost simultaneously the instant the nose gear touched down on the ground, and rolled for a while in a condition in which the outboard rim of the left wheel remained, and then the outboard rim of the left wheel was eventually destroyed, because there was a mark of damage only on the outboard rim of the left wheel, which indicates that the left wheel rolled on the runway surface.
