**AIRCRAFT ACCIDENT  
INVESTIGATION REPORT**

**S·G·C SAGA AVIATION CO., LTD.  
J A 9 2 5 2**

CRASH AFTER CONTACT WITH A POWER LINE  
S·G·C SAGA AVIATION CO., LTD.  
AEROSPATIALE AS350B, JA9252  
CHIKUSEI CITY, IBARAKI PREFECTURE, JAPAN  
AT ABOUT 08:18 JST, JULY 29, 2019

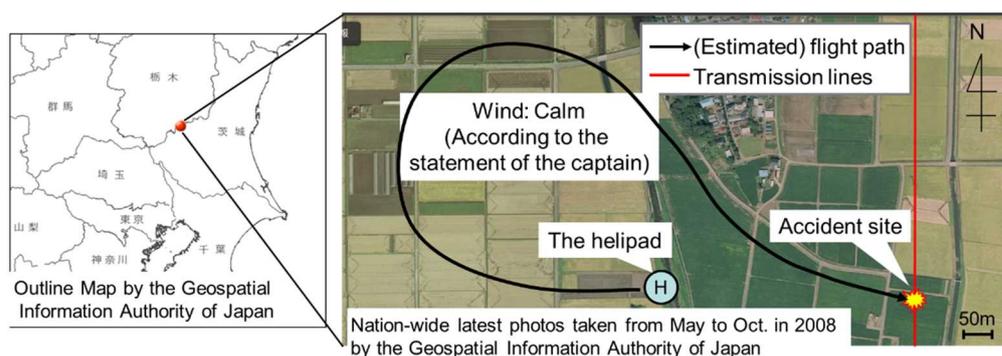
Figure 1: Accident site

This accident occurred at around 08:18 on July 29, 2019, in a paddy field in Kuchido, Chikusei City, Ibaraki Prefecture (Latitude 36°20'56" N, Longitude 139°57' 47" E).
