AA2020-2

**AIRCRAFT ACCIDENT
INVESTIGATION REPORT**

**TOHO AIR SERVICE CO., LTD.
J A 9 6 7 2**

**UNCONTROLLED CRASH
TOHO AIR SERVICE CO., LTD.
AEROSPATIALE AS332L (ROTORCRAFT),
REGISTERED JA9672,
IN UENO-MURA, TANO COUNTY,
GUNMA PREFECTURE, JAPAN
AROUND 14:29 JST, NOVEMBER 8, 2017**

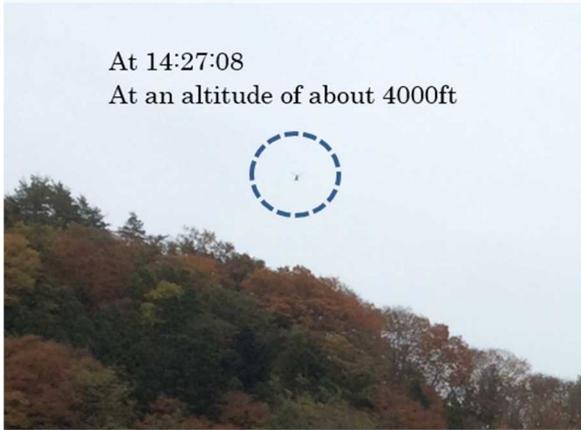
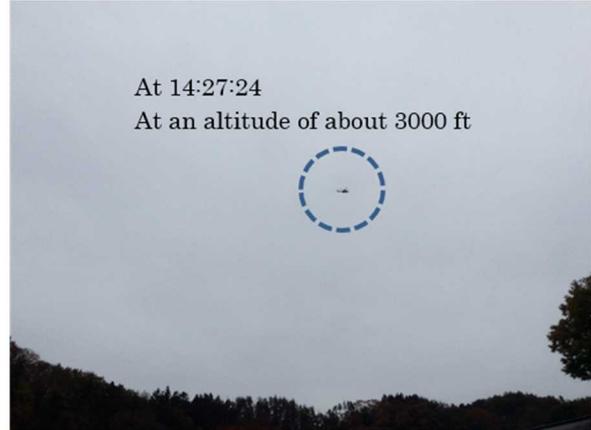
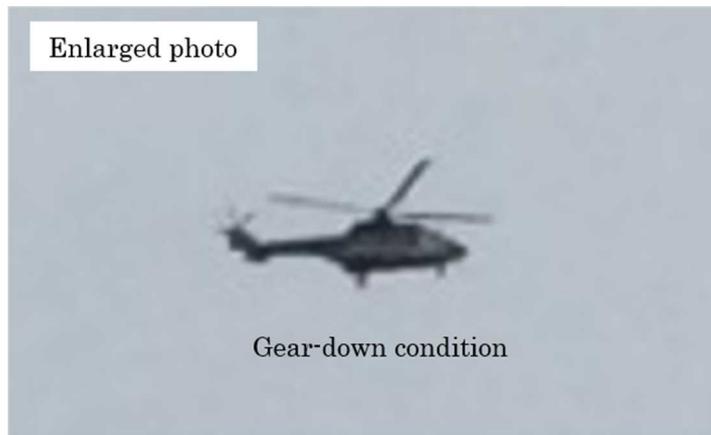
Figure 3: Approaching aircraft while going around

A witness B heard an unfamiliar and abnormal noise of “clapping” from the Helicopter that was coming close while going round the riverside and took two photos (Figure 3) of the Helicopter wondering what was happening.

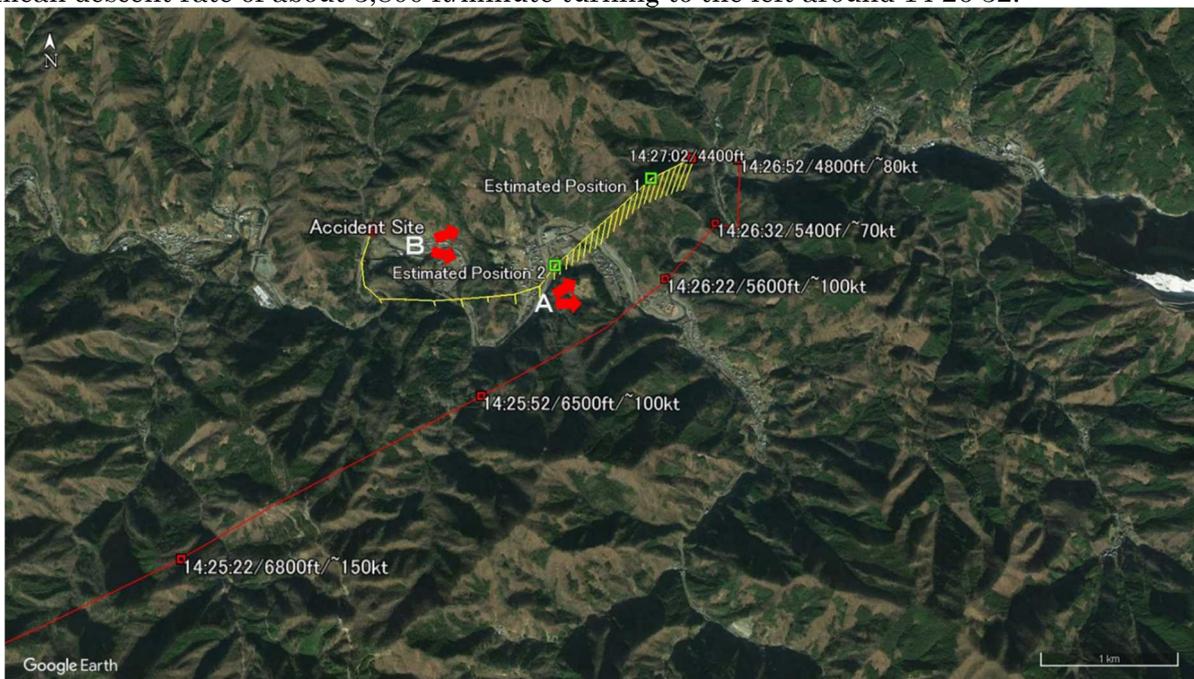
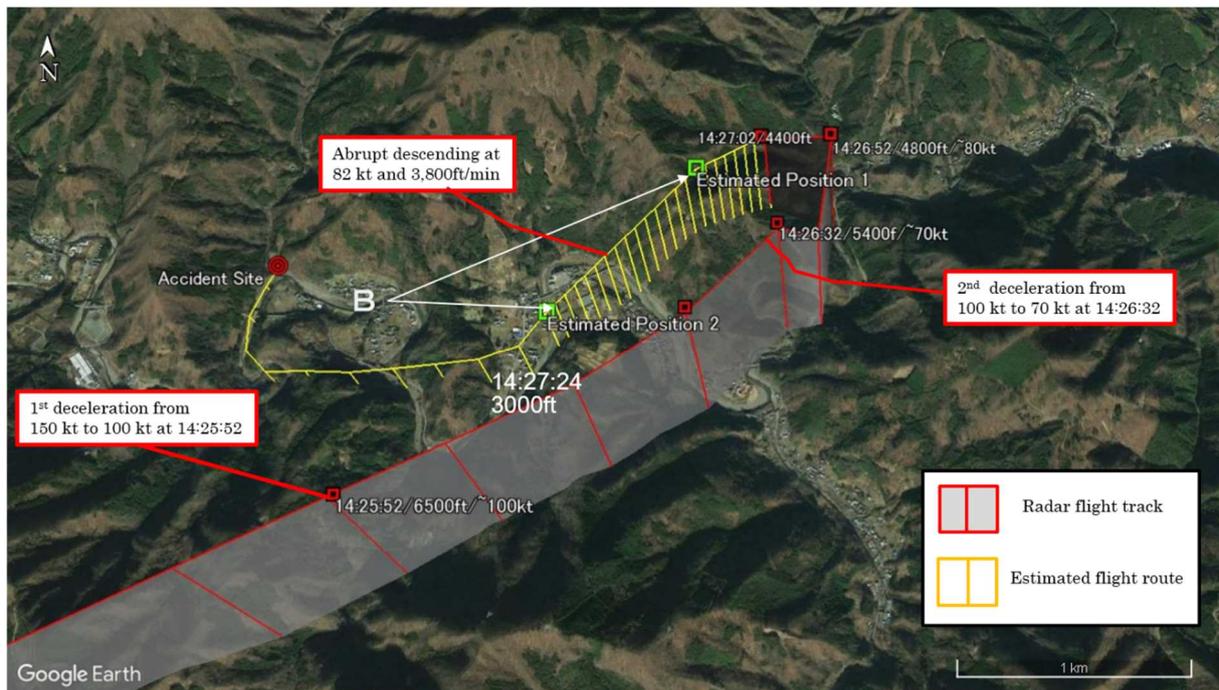
Figure 5: Estimated flight route from witnesses' information and radar track records

It is probable that the Helicopter commenced approaching the riverside along the Kanna River selected as the emergency landing site along the flight route in Figure 5 and 6 as described in the preceding subsection. It is highly probable from the statements of the witnesses C and D described in 2.1.4 (3) and (4) that the tail rotor separated from the airframe after the Helicopter made a noise of explosion while turning to the right about 200 m short of the riverside, thereafter the Helicopter became uncontrollable, and there occurred left whirling and a significant nose down as shown in Appended Figure 6 and Figure 26. It is probable that

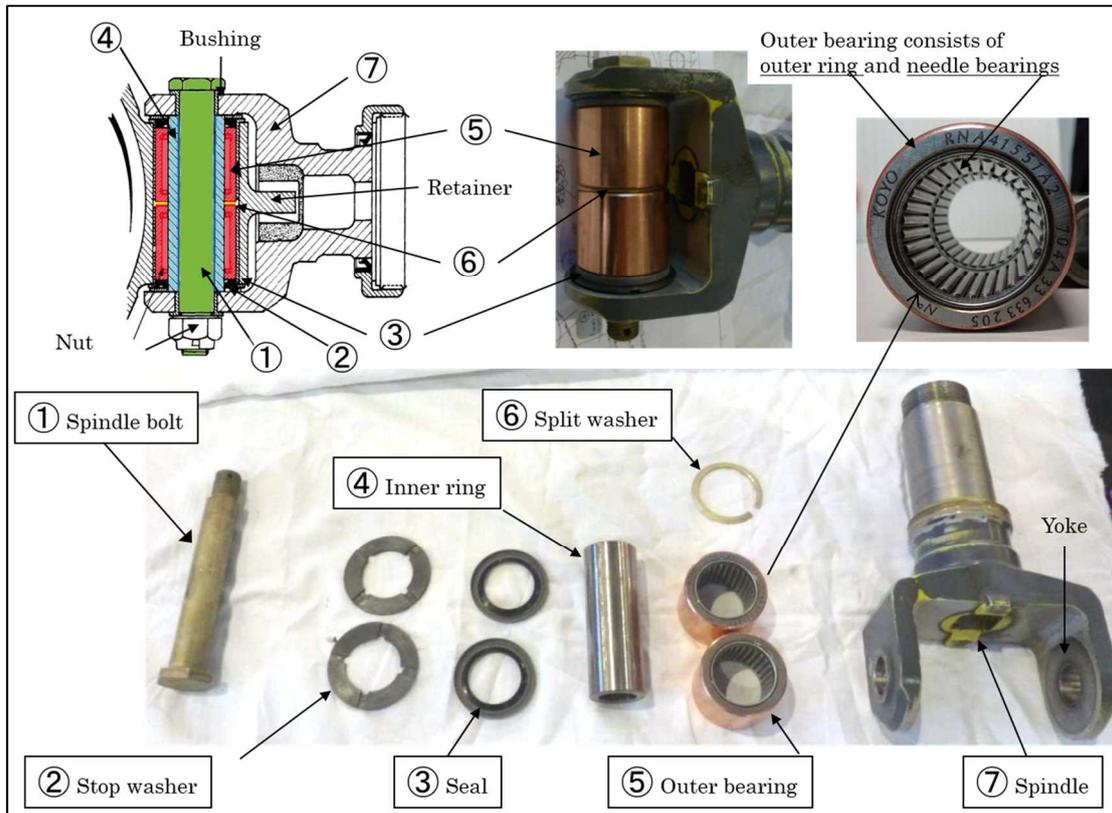
Figure 15: Flapping hinge parts

According to a mechanic (hereinafter referred to as “Mechanic A”) who assisted the maintenance work at that time, all five spindle bolts were smoothly pulled out (see Figure 15 for the flapping hinge parts) and all stop washers were replaced due to cracks. He remembered that the inner ring and the outer bearings were not removed in this maintenance work. Some of five spindle bolts had corrosion and were polished for removal of the corrosion with a brass brush. The final inspection and re-assembly of the spindle bolts were performed by CMA. The maintenance record at this time did not contain any other description than malfunction of the stop washer and its replacement. The seal was not replaced against the spindle bolt removal-installation procedures, which require the replacement.

remained same, i.e. 0.4 mm; however, because the motion of the blade was not smooth, the CM A decided to remove the spindle bolt of the flapping hinge of the White Blade to see its condition in the 250-hour inspection scheduled from September 20 until September 23 at Tochigi heliport. Because the spindle bolt was not smoothly pulled out on September 20, Mechanic B sprayed lubricant on it and pulled it out tapping with a brass rod. The CM A decided to replace the inner ring and the washer because he confirmed cracks in the inner ring without having the inner ring removed. The removed stop washer was not so much scraped off; however, the contact face of the yoke (See Figure 15), to which the stop washer was attached, was scraped off. Replacement work on September 23 after receipt of replacement parts was performed in a way to insert a new inner ring from the top to push out the one to be removed (hereinafter referred to as “the Old Inner Ring”) in order to prevent dust from getting into the outer bearings (See Figure 18). Because the Old Inner Ring was broken into fragments, it was replaced by receiving the fragments in a vinyl bag, which were discarded as kept in the bag. This way of replacement work hindered the condition of the outer bearings inside the spindle and the existence of residue associated with the fracture of the inner ring from being confirmed when the inner ring was replaced. Besides, the stop washer was replaced when the inner ring was replaced, but the seal was not replaced.

Because checking the removed spindle bolt revealed the existence of red rust and black rust scattering on it, the surface of which was polished by an abrasive sponge. The spindle bolt was pasted by grease without completely removing the rust, and was installed in the flapping hinge.

(1) As shown in Figure 17, 500-hour and 1,000-hour inspections related to the tail rotor flapping hinge were performed from March 21 until May 16, 2017. The spindle bolt was pulled off smoothly; however, all stop washers were replaced with new ones due to deterioration and cracks. Some of the spindle bolts had corrosion and were polished with a brass brush for removal. Attachment and final inspection of the spindle bolts were performed by the CM A. Maintenance record noted nothing but malfunction of the stop washer and its replacement, and the seal was not replaced against the spindle bolt removal and installation procedures, which require the seal replacement.

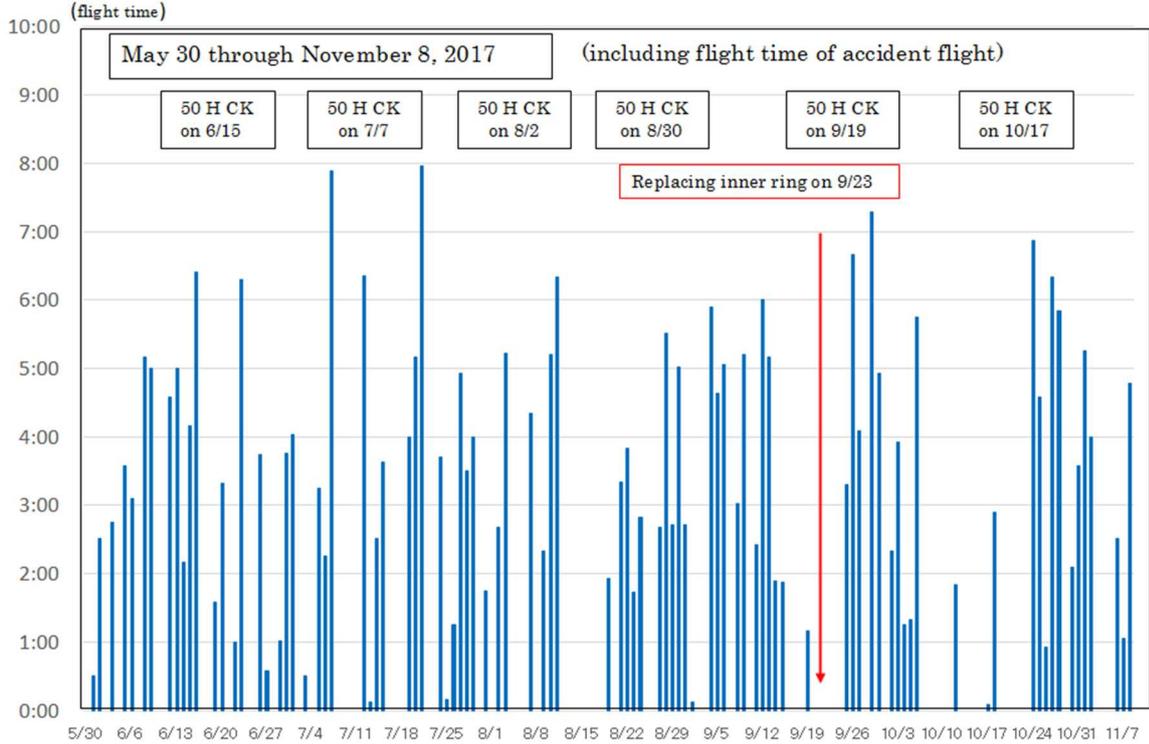
Figure 19: Flight time of the Helicopter since the Previous 1,000-Hour Inspections

Flight time of the Helicopter since the Previous 1,000-Hour Inspections are as shown in Figure 19. In particular, the accumulated flight time until September 23, 2017, when the inner ring of the flapping hinge was replaced, was about 243 hours, and the same from the replacement of the inner ring until the accident was about 94 hours.

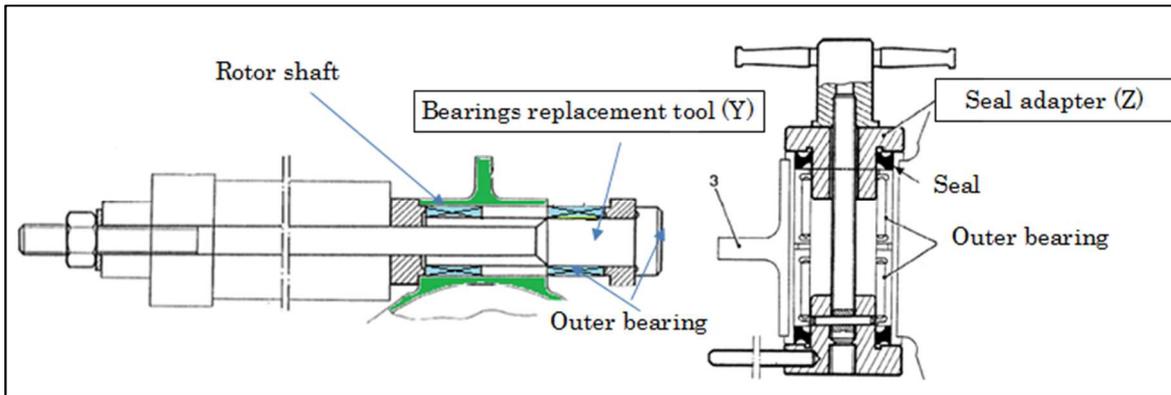
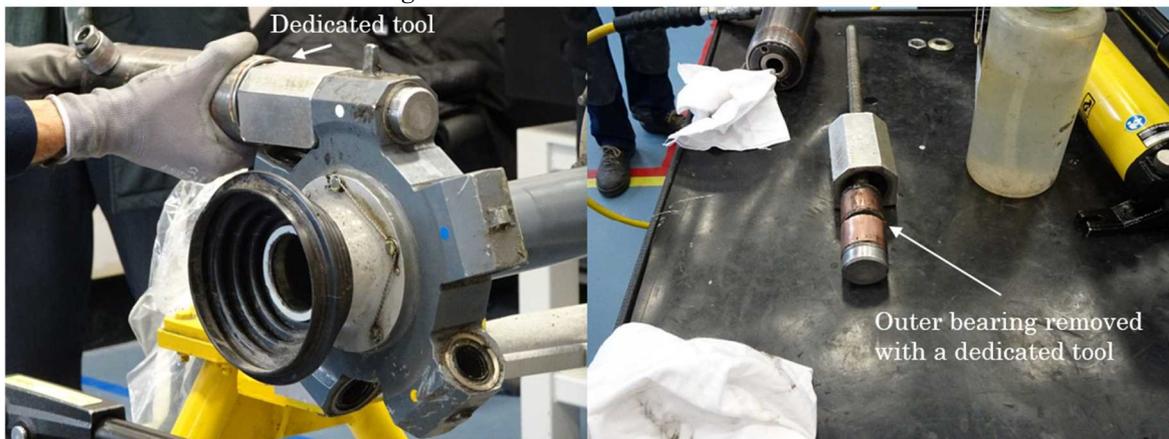
Figure 24: Part of dedicated tool

In the event that there has occurred an excessive binding in the feel check of the flapping hinge performed in 50-hour inspection, the inner ring and the outer bearings must be replaced. Besides, replacement work of the outer bearings requires use of a dedicated tool. Because the Company did not own such a dedicated tool, they needed to borrow it from the manufacturing company or other company.

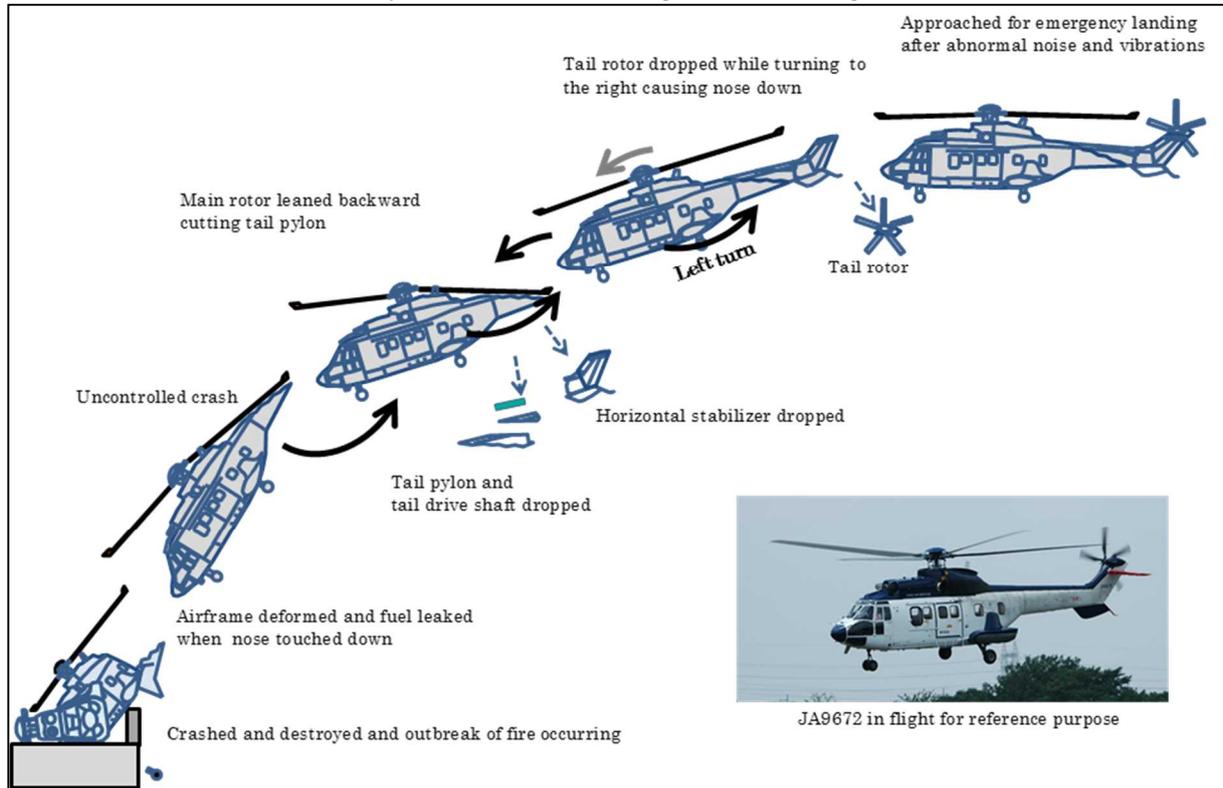
Figure 26: Changing flight attitude before the crash

the Helicopter at that time performed nose up maneuvering in response to the nose down, and it is highly probable that the maneuvering caused the main rotor to lean backward that resulted in cutting the tail boom, and the pylon and the horizontal stabilizer dropped. It is highly probable that the Helicopter immediately, crashed with the nose firstly while cutting electric wires, and was destroyed, and the fuel caught fire causing the outbreak of fire.

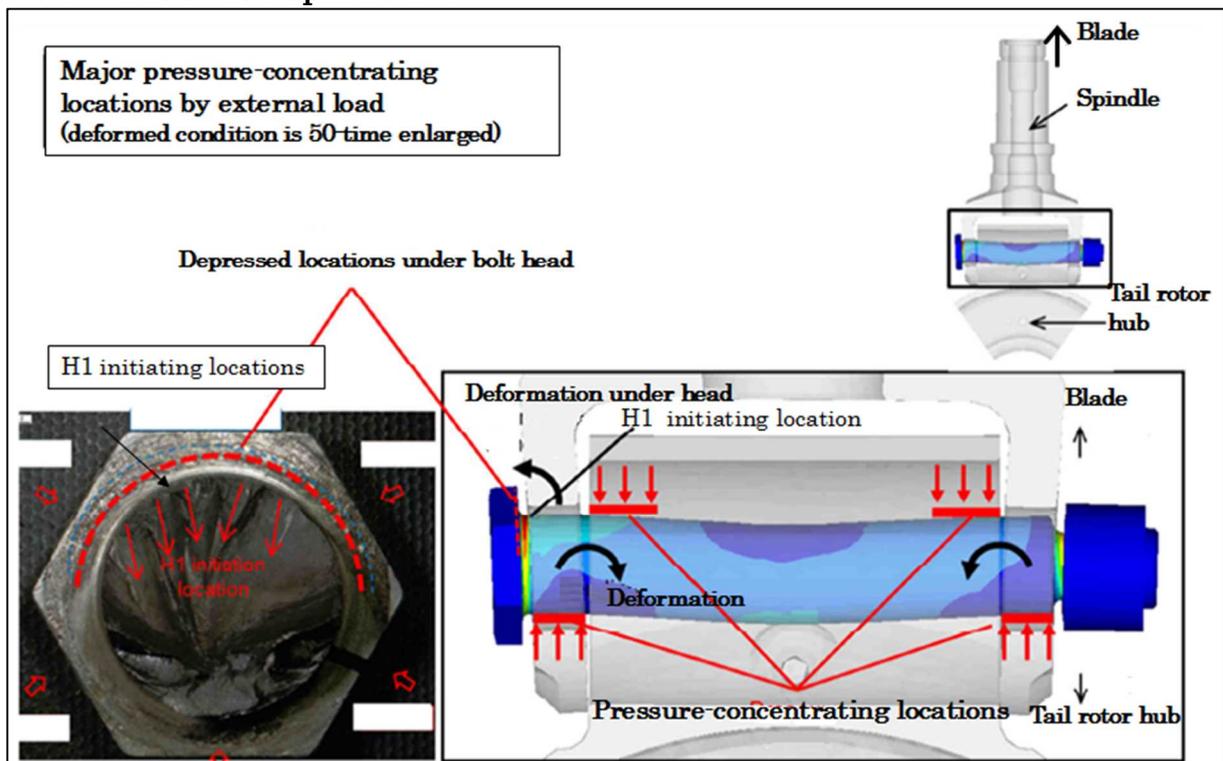
Figure 27: Pressure added to spindle bolt

As described in 2.14.3 (1), cracks were propagating from the bolt head of the spindle bolt of the White Blade of the Helicopter. The spindle bolt under normal condition with normal bearings receives load in axial direction initiating from CF and lead-lag moment and some shearing load as shown in Figure 27; however, flapping moment is as low as negligible and the spindle bolt does not receive the torsional load.

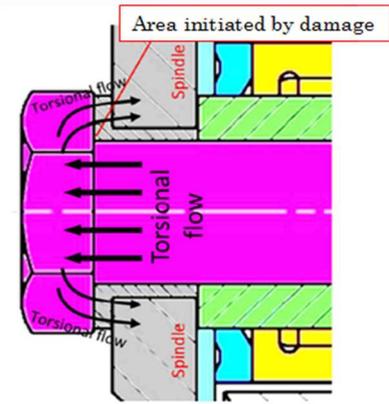
Figure 28: Torsional load flow of bolt

Propagation of the cracks of the spindle bolt of the Helicopter shows torsional condition, which indicates that it received unexpected fatigue load. In the event that torsional load occurs on the bolt head, flow of the torsional load propagates in the spindle, and load is generated by occurs on the boundary between the spindle bolt head and the spindle as shown in Figure 28. It is highly probable that the cracks were generated on the contact face between the spindle bush and the bolt head, which was added by the torsional load leading to the fracture of the spindle bolt.

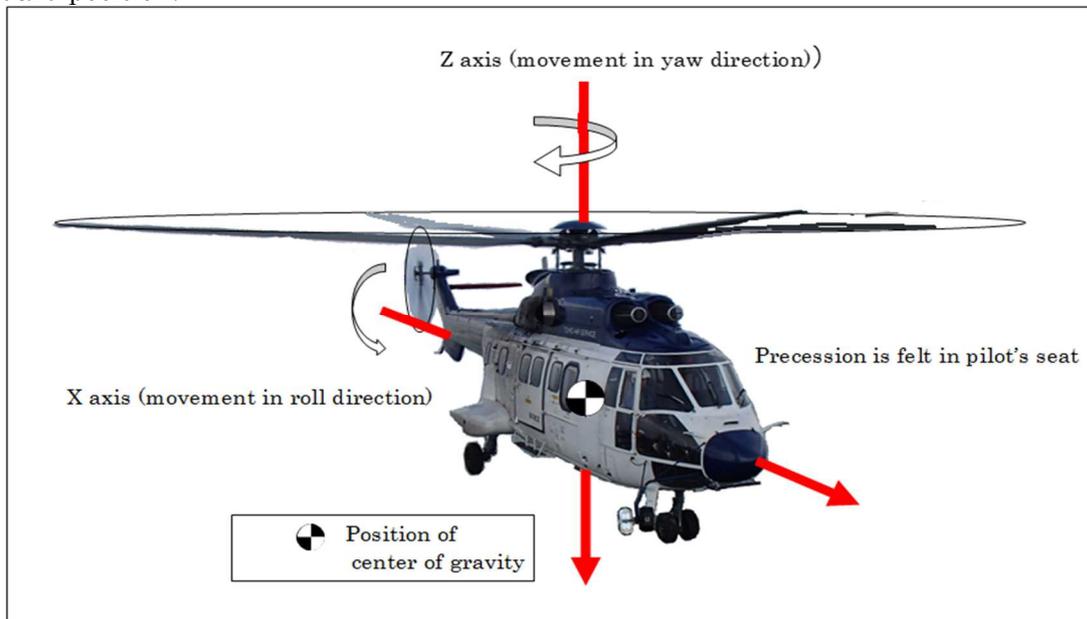
Figure 31: Unstable relation between lateral vibrations and rotating face of tail rotor

As stated in 2.1.3 (1), the Lateral Vibrations that occurred on or around October 31, 2017 was considered to be caused by a small amount of oil leakage from the sleeve of MRB. As described in 2.12.1 (2), it is unlikely that the small amount of oil leakage was a sign of malfunction causing vibrations because a sufficient amount of oil was supplied to the main rotor head from the reservoir tank all the time. The position of the CG of the same type of aircraft is normally located directly under the main rotor mast as seen in Figure 31, and the

motion of the airframe occurs with the position of the CG in the center. Because the tail rotor rotating vertically at the aft airframe is located higher than X axis of the airframe, it causes balancing malfunction of the tail rotor blade, and in the event that thrust of the tail rotor is altered, motion in yaw direction around the vertical Z axis and the same in roll direction around X axis are generated. In the event of ASE mode, it is probable that precession is felt in pilot's seat affected by flight control to make attitude, direction and altitude reverted to the standard position.

It is probable that rotating face of the White Blade and other four blades was largely slid because the Helicopter had the spindle bolt of the White Blade fractured in flight, and further larger vibrations occurred.

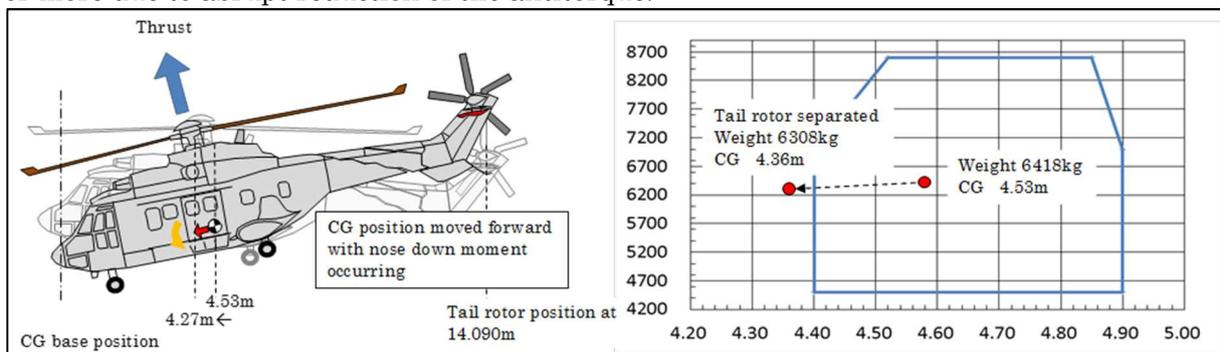
Figure 33: Change in center of gravity immediately before crash of aircraft

In the event that the tail rotor has been separated from the pylon, it is probable that there occurs a remarkable change in the position of the CG and a change in thrust. It is estimated that the weight of the Helicopter was approximately 6,418 kg and the position of the CG was 4.53 m immediately before the accident, and it is probable that the total weight of the separated tail rotor was about 110 kg locating 14.09 m from the CG base line. Because the weight of the Helicopter becomes approximately 6,308 kg and the position of the CG becomes 4.36 m after the separation of the tail rotor, it is probable that the Helicopter was in forward position exceeding allowable longitudinal CG, and there occurred a large nose down moment. Accordingly, it is probable that the CG exceeded the forward limit line, and the pilot maneuvered to pull the cyclic stick backward in an attempt to revert to the previous attitude under the situations of being lack of affordable maneuvering in the directions of back and forward. It is highly probable that this caused the main rotor to lean backward leading to cutting the tail boom. It is probable that this caused the pylon and the horizontal stabilizer attached to it to drop.

Besides, computing whirl rate generated by reduced thrust of the tail rotor by separation of the tail rotor indicates that it is probable that there occurred a left whirling at 120 °/second or more due to abrupt reduction of the antitorque.

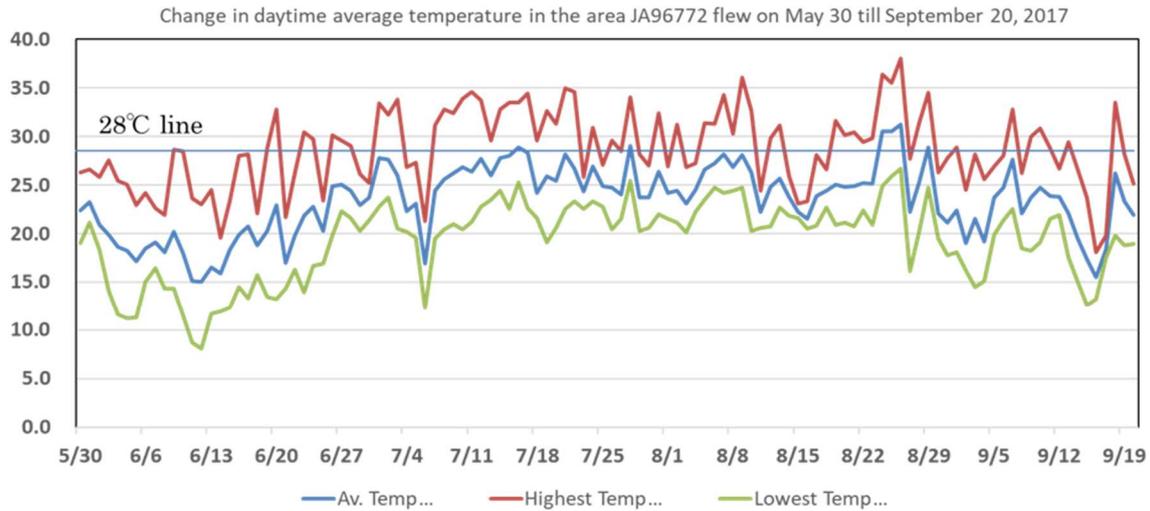
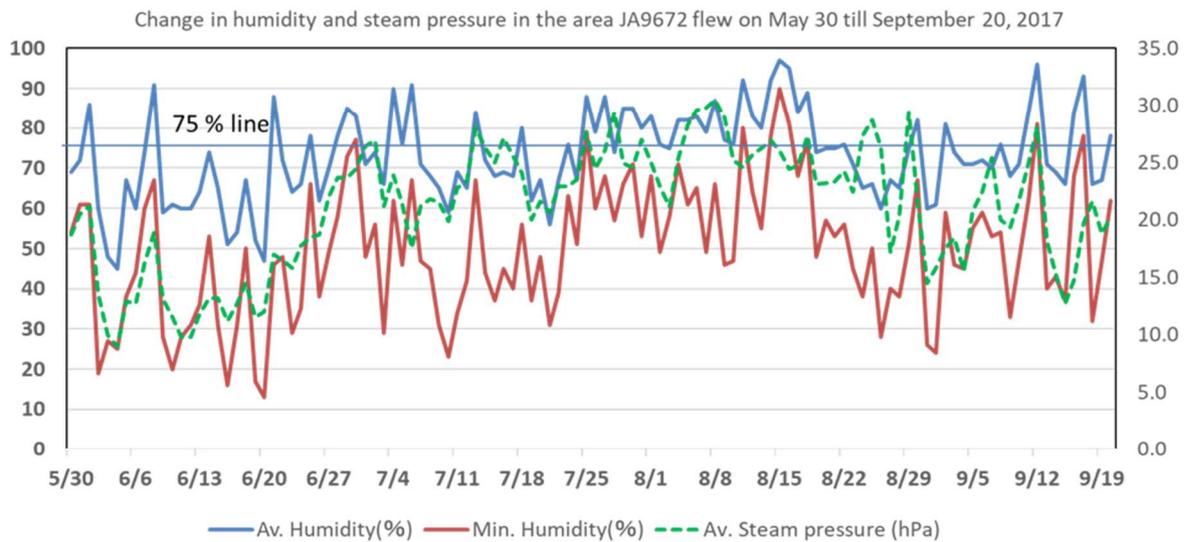
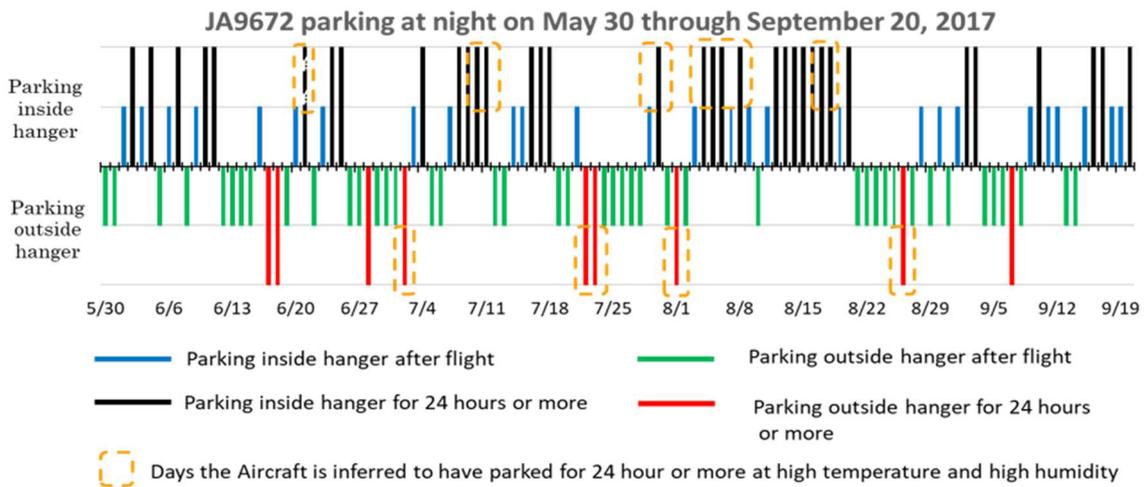
Appended Figure 2: Weather Change in the Area Where the Helicopter Flew

Daily change of weather (temperature, humidity and mean steam pressure) of the area where the Helicopter parked during the period from May 30, 2017 after the completion of 1,000-hour regular inspection until September 20 when 250-hour regular inspection was performed was as shown in Appended Figure 2. There were many days with the average daytime temperature exceeding 25 °C in early July through late August. There were many days with the average humidity exceeding 70% in early July through late August, and particularly days exceeding 80% lasted in the middle of August. Days with high steam pressures lasted in the middle of July through middle of August.

The Helicopter had the drag play from around the middle of July, and as described in 3.5.1.3, the play was found to be at 0.4 mm in 50-hour inspections performed on August 30 and September 19, 2017. Besides, as seen in Appended Figure 2, comparing the parking situations of the Helicopter and the meteorological changes during the period from May 30 until September 19, 2017, when flight was resumed after completion of 1,000-hour inspection revealed that the number of days when the Helicopter parked at high temperature and high humidity for 24 hours or more inside a hanger was 10 days and outside a hanger was 5 days during the period from late June until middle September 2017. Among these days, the number of applicable days when the Helicopter should have been lubricated by grease prior to flight were 10 days. It is somewhat likely that insufficient grease lubrication made the malfunction progress and caused damage to the parts because the applicable days generally coincide with the time when the black grease of the White Blade was generated. Taking into account the play of the White Blade and the generating situations of the black grease, it is probable that failure to maintain lubrication caused damage and sticking of the parts in the Old Inner Ring to occur and generated cracks leading to the fracture. However, it could not be determined why the damage to the White Blade progressed far rapidly compared to the other blades.

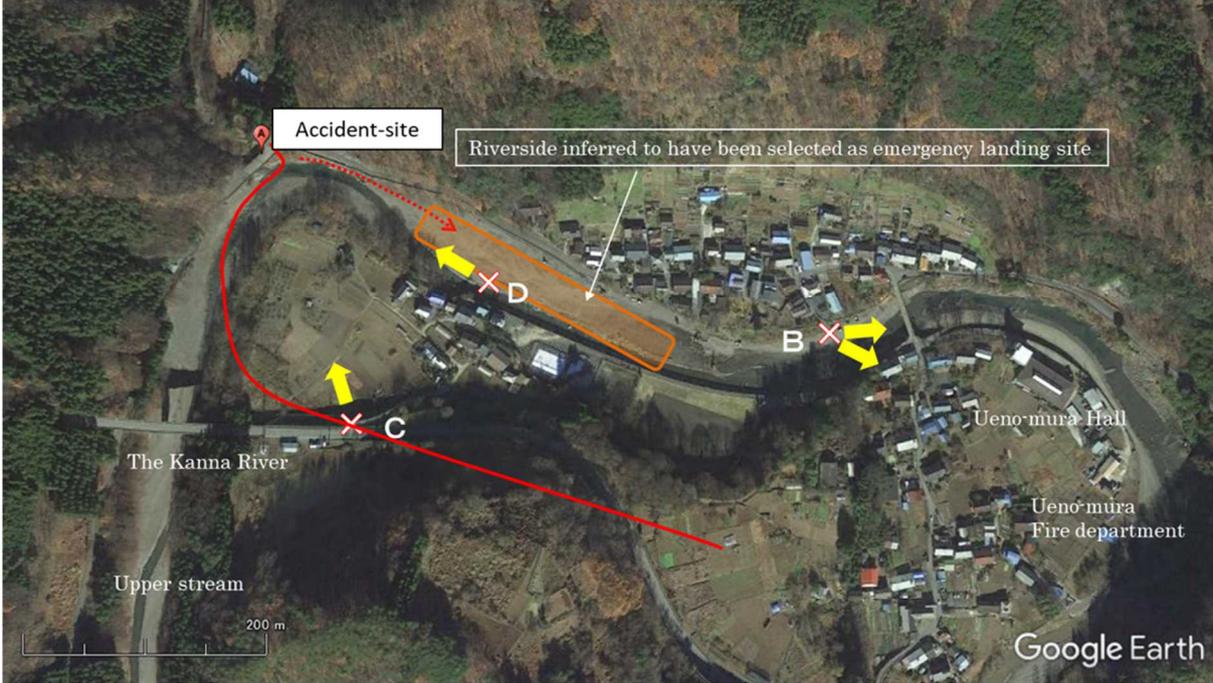
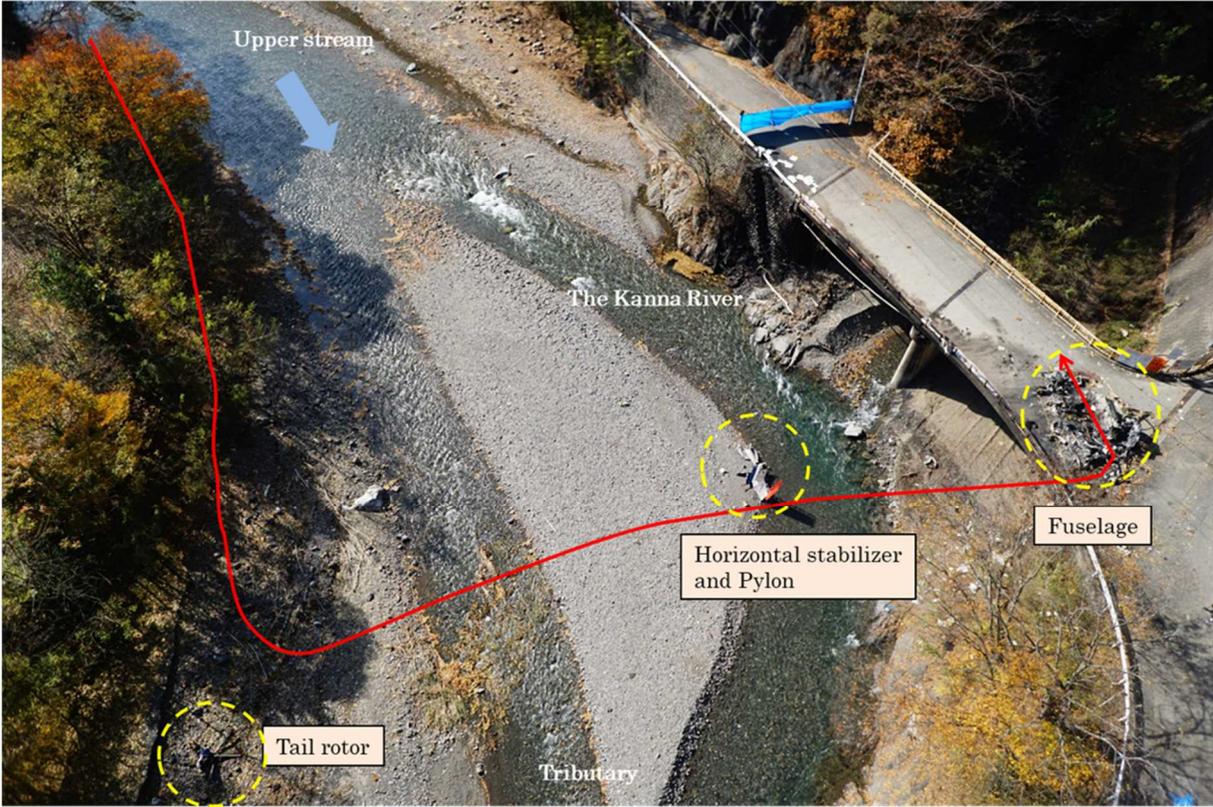
Appended Figure 6: The flight track of the Helicopter before crashed

From the statement of the witness A described in 2.1.4 (1) and the radar track records described in 2.1.5, the Helicopter commenced abrupt descending at a mean ground speed of about 80 kt and a mean descent rate of about 3,800 ft/minute while turning to the left around 14:26:40 after the second abrupt deceleration. Synthesizing the location of the Helicopter computed from the photos taken by the witness B as described in 2.1.4 (2), information from the witnesses as described in 2.1.4 and the radar track records reaches that the estimated flight route immediately before the accident was such as the one shown in Figure 5 and 6 and Appended Figure 6.

Besides, there is a riverside of about 300 m long and about 30 - 50 m wide in the vicinity of about 200 m east side from the accident site as shown in Appended Figure 6, and it is probable that the riverside was selected as an emergency landing site and the Helicopter was in an attempt to approach the selected emergency landing site while going around after descending at a low altitude.

The location where the tail rotor was separated was where the Helicopter commenced a direct approach toward the selected emergency landing site near 200 m short of the landing site according to the flight route in Appended Figure 6. It is highly probable that the captain was unable to maneuver to cope with the left turn exceeding 120 °/second and the abrupt nose down because it is probable that there occurred the alteration of the CG and the abrupt left turn caused by the separation of the tail rotor described in 3.6.9 immediately after the pilot commenced the direct approach for landing maneuvering.
