**AIRCRAFT SERIOUS INCIDENT
INVESTIGATION REPORT**

**AERO ASAHI CORPORATION
JA 9678**

AERO ASAHI CORPORATION
AÉROSPATIALE AS332L1 (ROTORCRAFT)
JA9678

DROPPING OF OBJECT
DURING EXTERNAL CARGO SLING OPERATION
MIHAMA TOWN, MIKATA-GUN,
FUKUI PREFECTURE, JAPAN
AT AROUND 10:08 JST, MARCH 1, 2016

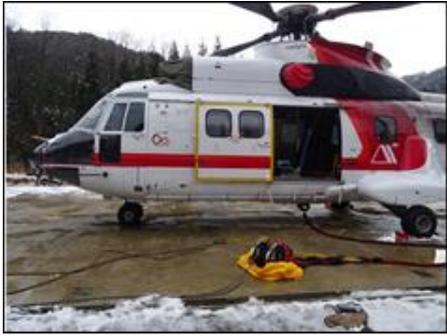
<p>Photo 1; The serious incident rotorcraft</p>

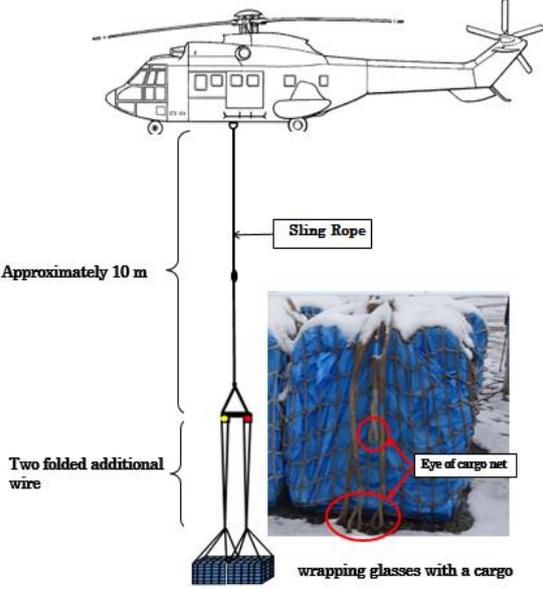
<p>Figure 1 Image of Sling</p>
	<p>The rotorcraft was scheduled to perform twenty cargo transport</p>

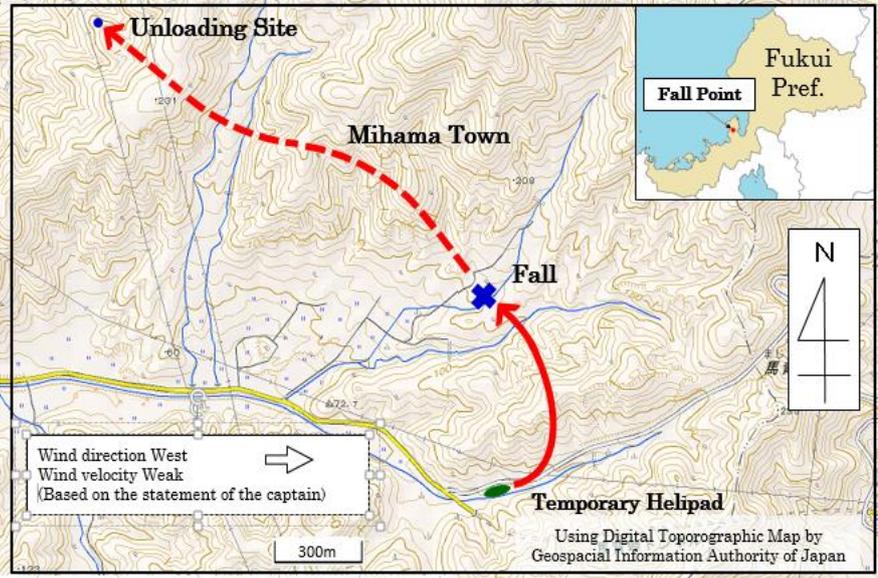
<p style="text-align: center;">Figure 2; Estimated Flight Route</p>
2.2 Injuries to Persons	None
2.3 Damage to the Aircraft	None
2.4 Personnel Information	<p>Captain: Male, Age 35</p> <p>Commercial pilot certificate (Rotorcraft) January 8, 2003</p> <p>Type rating: Aérospatiale SA330 April 9, 2015</p> <p>Class 1 aviation medical certificate Validity: June 4, 2016</p> <p>Pilot Competence assessment</p> <p>Expiration date of piloting capable period: April 30, 2017</p> <p>Total flight time 3,654 hours 23 minutes</p> <p>Total flight time on the type of rotorcraft 200 hours 57 minutes</p>

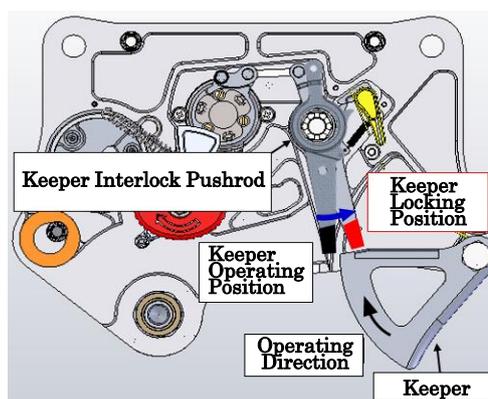
Figure 3 ; Keeper Locking Mechanism

Regarding a keeper, applying a specific load (34 kg or more) or an instantaneous downward load on a load beam, an edge of a “Keeper interlock pushrod”(hereinafter, referred to as “the pushrod”) moved onto the keeper and locked. (Figure 3)

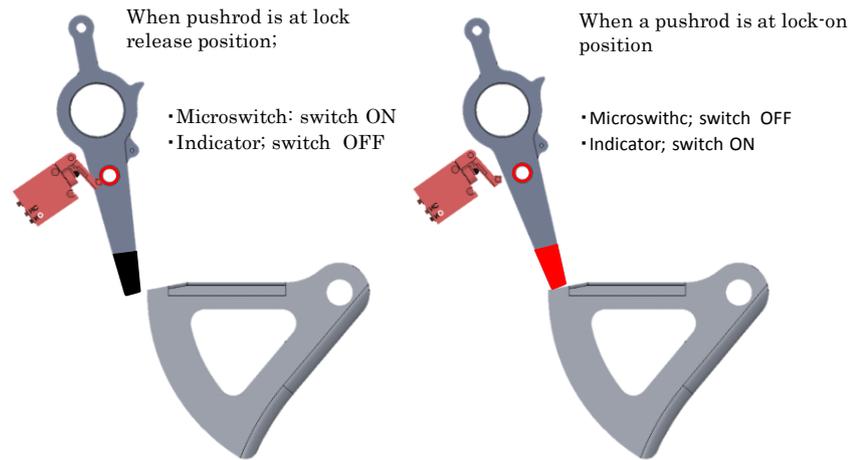
The indicator of the keeper will be lighted on the light, when the micro-switch in contact with the pushrod is off. As shown in the right drawing of Figure 4, when the pushrod moves onto the top of the keeper, the micro-switch turns off, then the indicator turns the light on.

Figure 4: Operation of Indicator (Keeper)
