AIRCRAFT ACCIDENT INVESTIGATION REPORT

**Aero Asahi Corporation Aerospatiale AS332L, JA9690
UNAZUKI, SHINKAWA COUNTY, TOYAMA
(Merged into KUROBE City on March 31, 2006)
October 18, 2005**

July 28, 2006

**Aircraft and Railway Accidents Investigation Commission
Ministry of Land, Infrastructure and Transport**

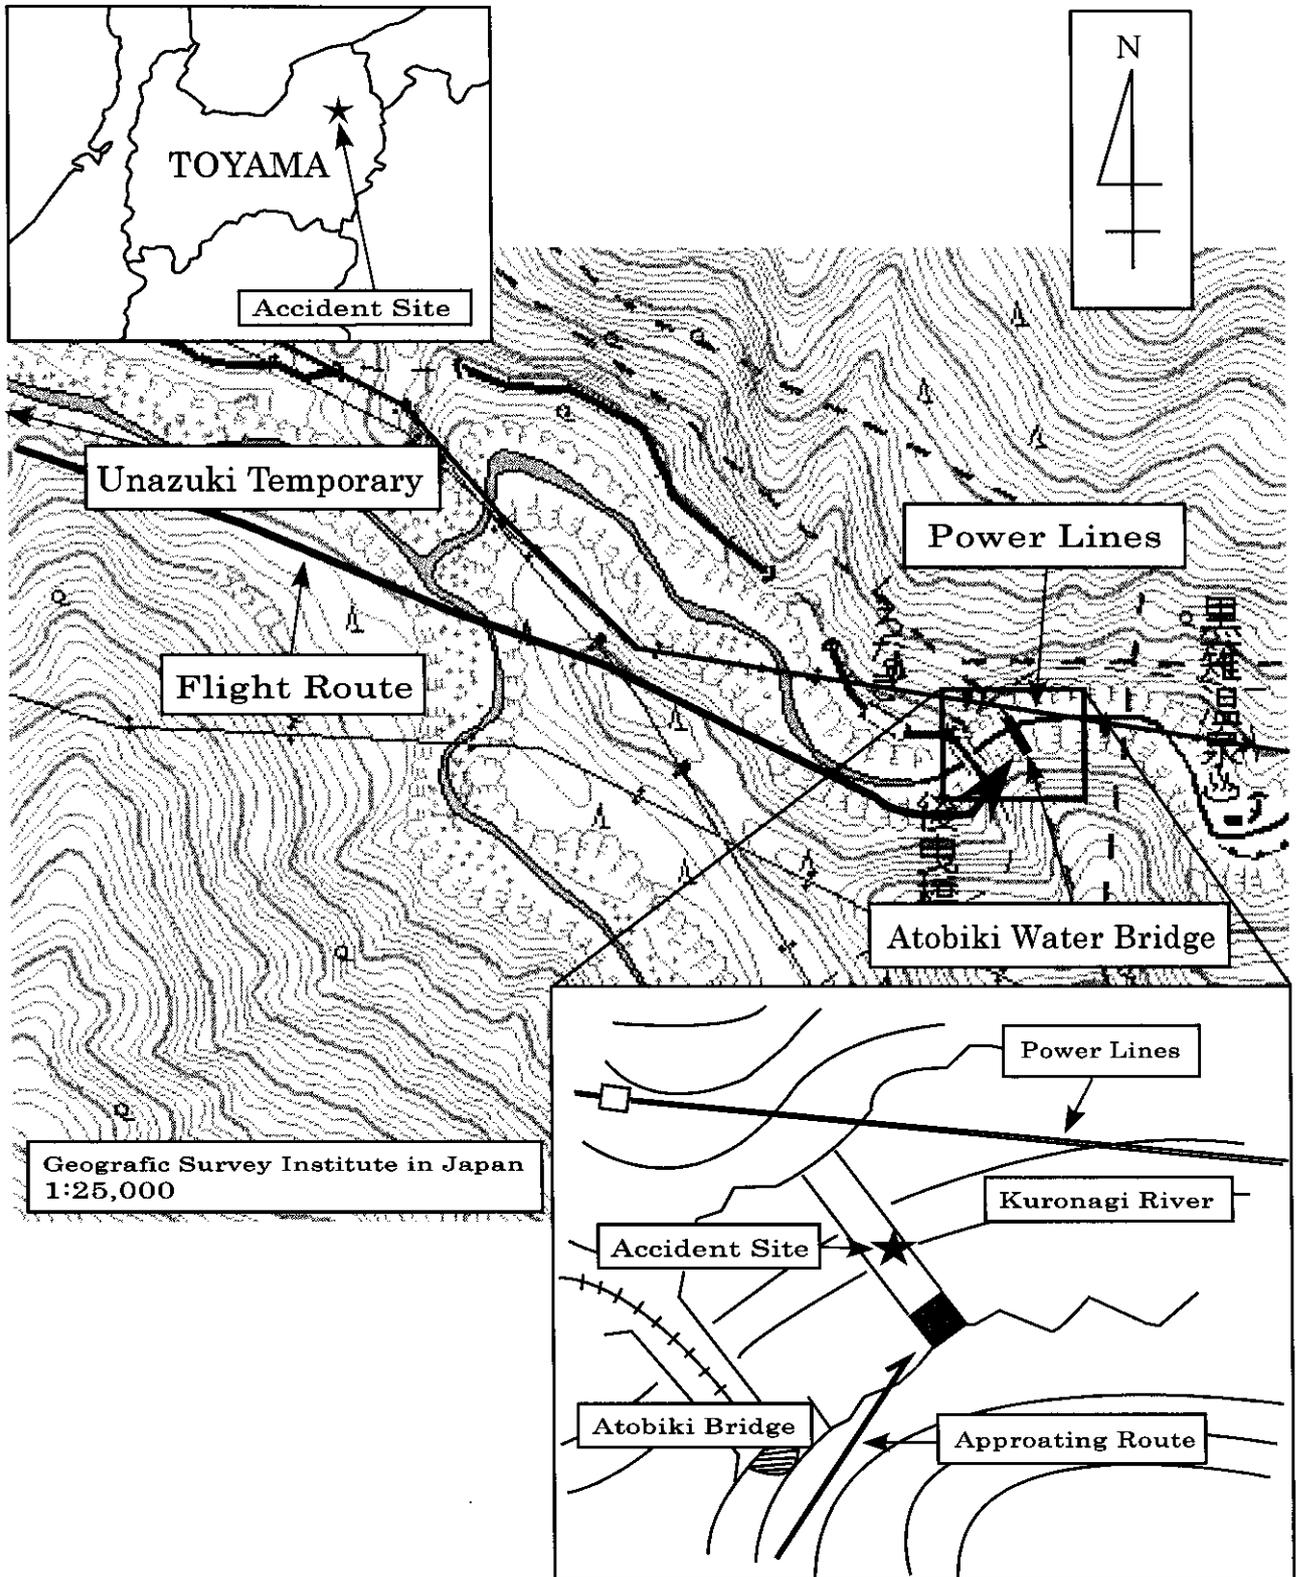
Figure 1 Accident Site

The accident site was the unloading site of Atobiki Water Bridge in Unazuki-machi, Shinkawa County, Toyama Prefecture. The time of the accident occurrence was around 11:05. (See the attached Figures 1 and 2 and Photos 1 and 2.)
