**AIRCRAFT SERIOUS INCIDENT  
INVESTIGATION REPORT**

**NAKANIHON AIR SERVICE CO., LTD.  
JA9743**

**DROPPING OF OBJECTS  
DURING EXTERNAL CARGO SLING OPERATION  
TOUBETSU, TESIKAGA TOWN, KAWAKAMI-GUN  
HOKKAIDO, JAPAN  
AT AROUND 11:58, APRIL 27, 2017**

**NAKANIHON AIR SERVICE CO., LTD.  
AEROSPATIALE AS350B1(ROTORCRAFT), JA9743**

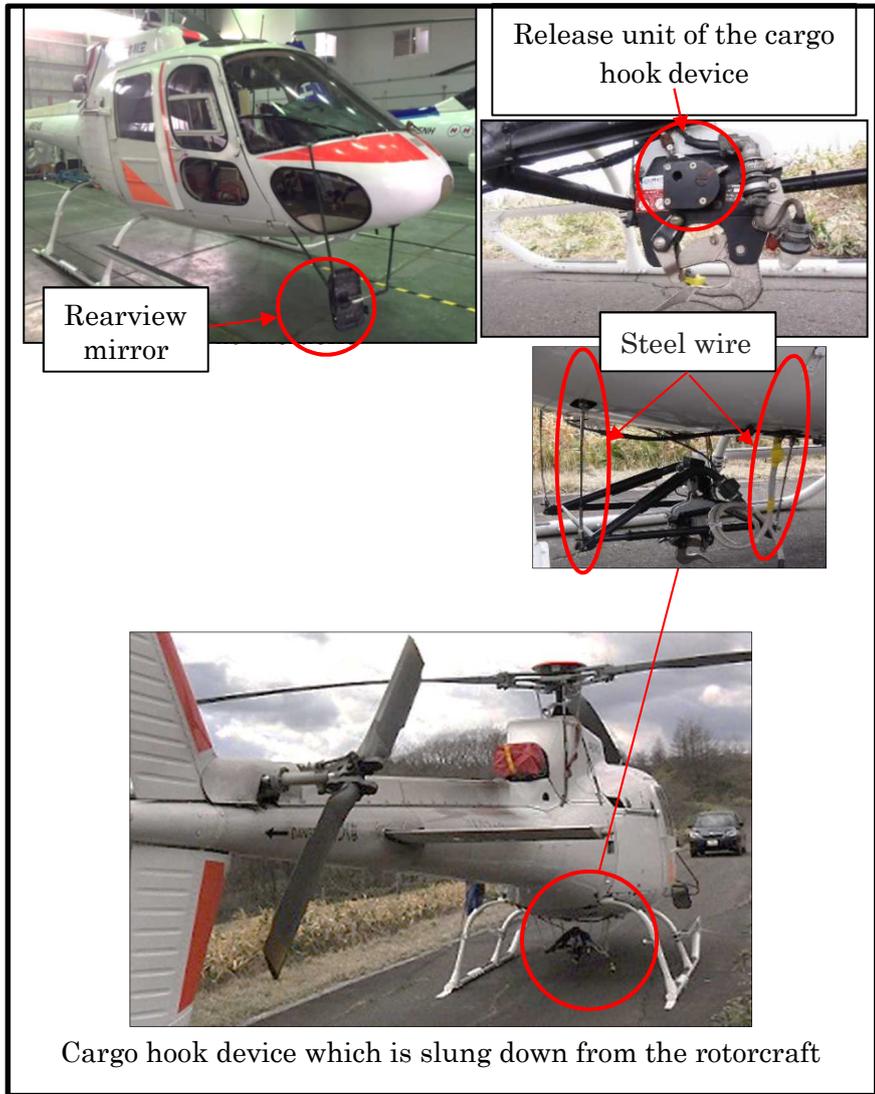
**Photo 1.** The rotorcraft involved in the serious incident

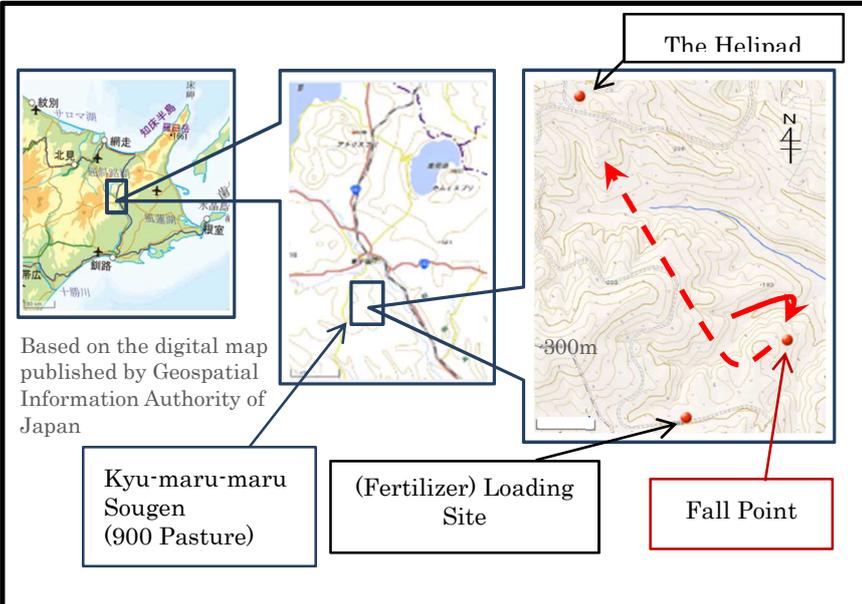
<p style="text-align: center;"><b>Figure 1.</b> Estimated flight route map</p> <p>The serious incident occurred within a grazed pasture at Kyu-maru-maru Sougen (900 Pasture) (N43°25'32", E144°27'44") of a ranch managed by the town at Toubetsu in Teshikaga Town, Kawakami-gun, Hokkaido, Japan, at around 11:58 on April 27, 2017.</p>
<b>2.2 Injuries to persons</b>	None
<b>2.3 Damage to Aircraft</b>	None
<b>2.4 Personnel information</b>	<p>(1) Captain <span style="float: right;">Male, Age 50</span>  Commercial pilot certificate (rotorcraft) <span style="float: right;">February 19, 1990</span>  Specific pilot competence  Expiry of practicable period for flight: <span style="float: right;">December 19, 2018</span>  Type rating for a single turbine engine (land)  <span style="float: right;">February 19, 1990</span>  Class 1 aviation medical certificate  <span style="float: right;">Validity; February 12, 2018</span>  Total flight time <span style="float: right;">6,619 hours 49 minutes</span>  Flight time in the last 30 days <span style="float: right;">49 hours 45 minutes</span>  Total flight time on the type of aircraft <span style="float: right;">1,946 hours 05 minutes</span>  Flight time in the last 30 days <span style="float: right;">49 hours 45 minutes</span></p> <p>(2) Trainee <span style="float: right;">Male, Age 43</span></p>
