AI2012-1

**AIRCRAFT SERIOUS INCIDENT
INVESTIGATION REPORT**

Japan Transport Safety Board

UNITED AIRLINES, INC.
BOEING 777-200, N219UA
AT ABOUT 11,700 FT, ABOUT 46 KM EAST-SOUTHEAST
OF NARITA INTERNATIONAL AIRPORT, JAPAN
AROUND 18:04 JST, JULY 28, 2010

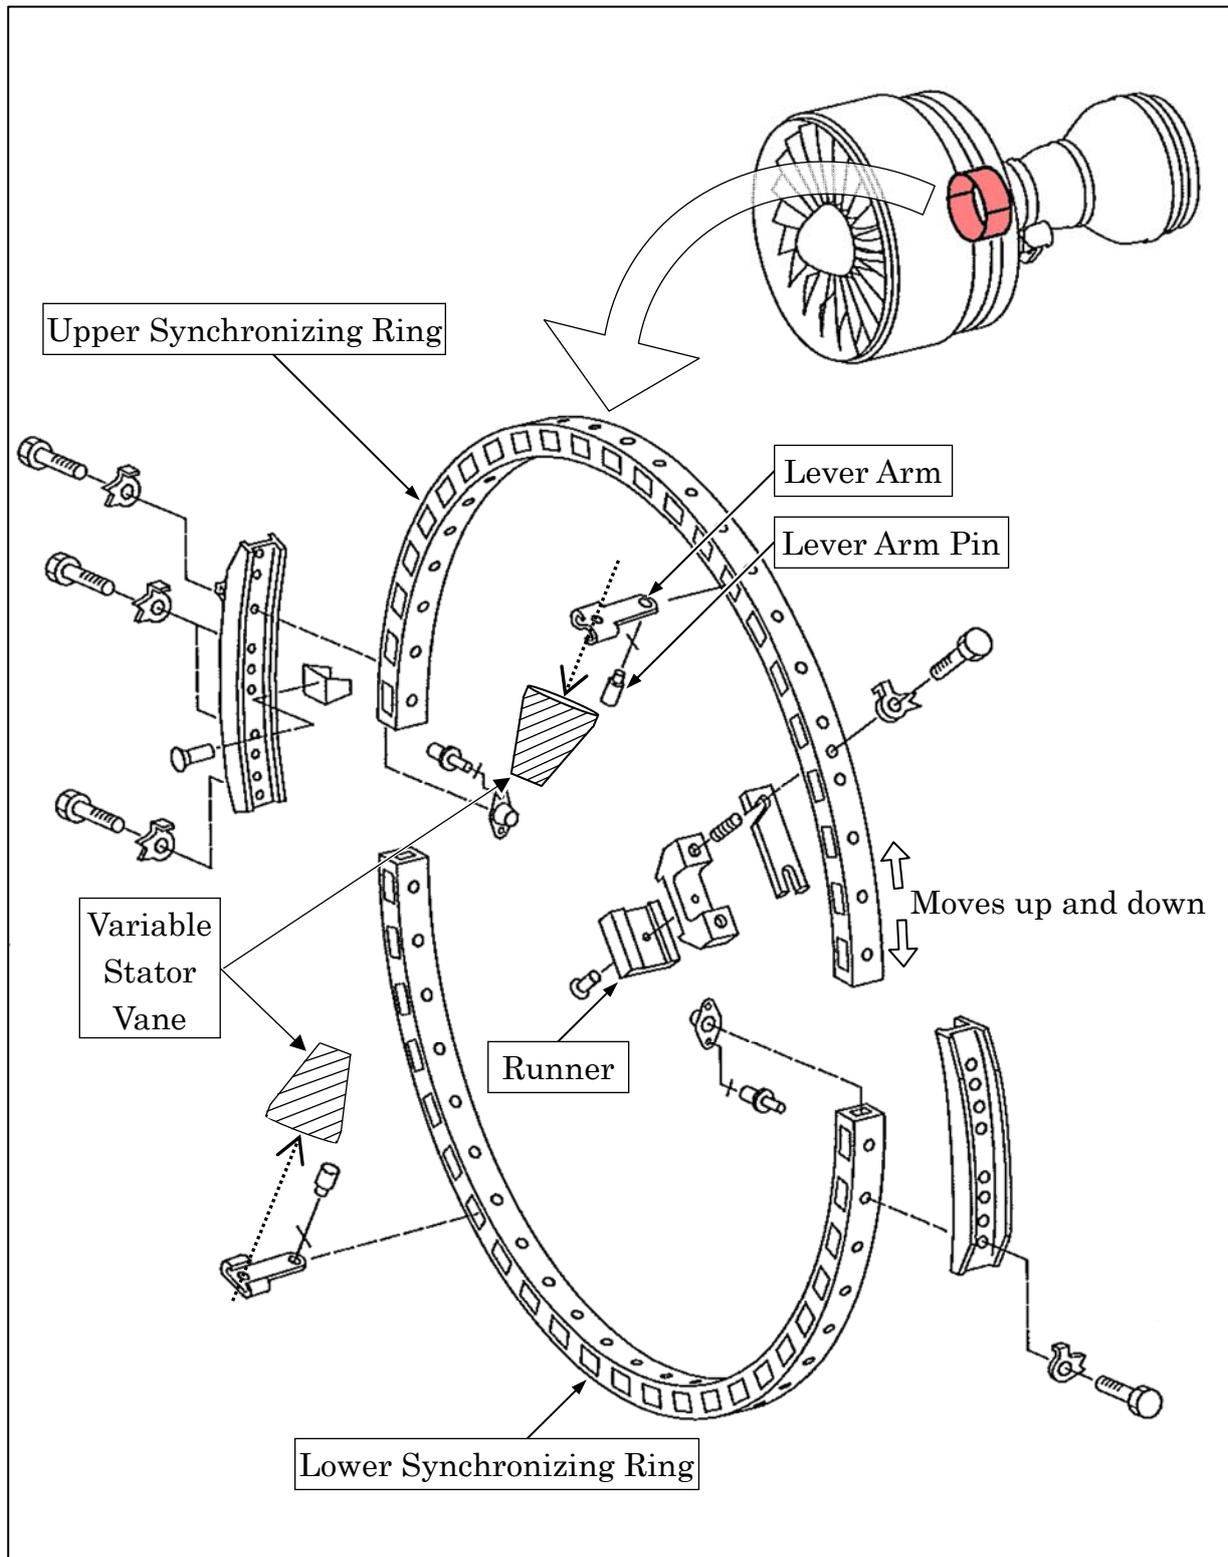
Figure 6 Structure of the Synchronizing Ring

- (4) It is considered highly probable that the succession of breakages described above led to the severe engine damage.
- (5) As to the fractured welds for the #73 Pin, the pivot for the #73 Arm, it is considered possible that the Pin flare and the welds had not been made in an appropriate manner given the following: in several spots of the cracked welds, there were cavities caused by shrinkage near the boundaries with the adjoining metal; in several locations, and examination of the cracked surfaces of the welds revealed marks of solidification cracking, as described in 2.11 (2) ①.

It is considered possible that fracture of the welded points between the pin (Part Number 54H727), which is the pivot for the lever arm, and the synchronizing ring for the inlet guide vanes contributed to the release of the lever arm.

As described in 3.5, it is considered probable that the serious incident occurred as a result of a lever arm coming off from the IGV ring, contributed by the fracture of the welded points on a Pin (Part Number 54H727), the pivot of the Arm. As described in 3.6, it is considered possible that the pin flare and welded points were not performed in an appropriate manner during repair of the Ring. Therefore, any operator of an aircraft or engine must need to seek the system building to ensure repairing according to the procedures specified by the engine manufacturer.
