# AIRCRAFT SERIOUS INCIDENT INVESTIGATION REPORT

NORTHWEST AIRLINES INCOPORATED  
BOEING 747-200B, N645NW  
ENGINE UNCONTAINED EVENT  
KANSAI INTERNATIONAL AIRPORT, JAPAN  
AT ABOUT 10:33 JST, JULY 29, 2004

Aircraft and Railway Accidents Investigation Commission  
Ministry of Land, Infrastructure and Transport

**NORTHWEST AIRLINES FLIGHT 905  
BOEING 747-200B, N645NW  
UNCONTAINED ENGINE FAILURE  
KANSAI INTERNATIONAL AIRPORT, OSAKA  
PREFECTURE, JAPAN  
AT ABOUT 11:33 JST, JULY 29, 2004**

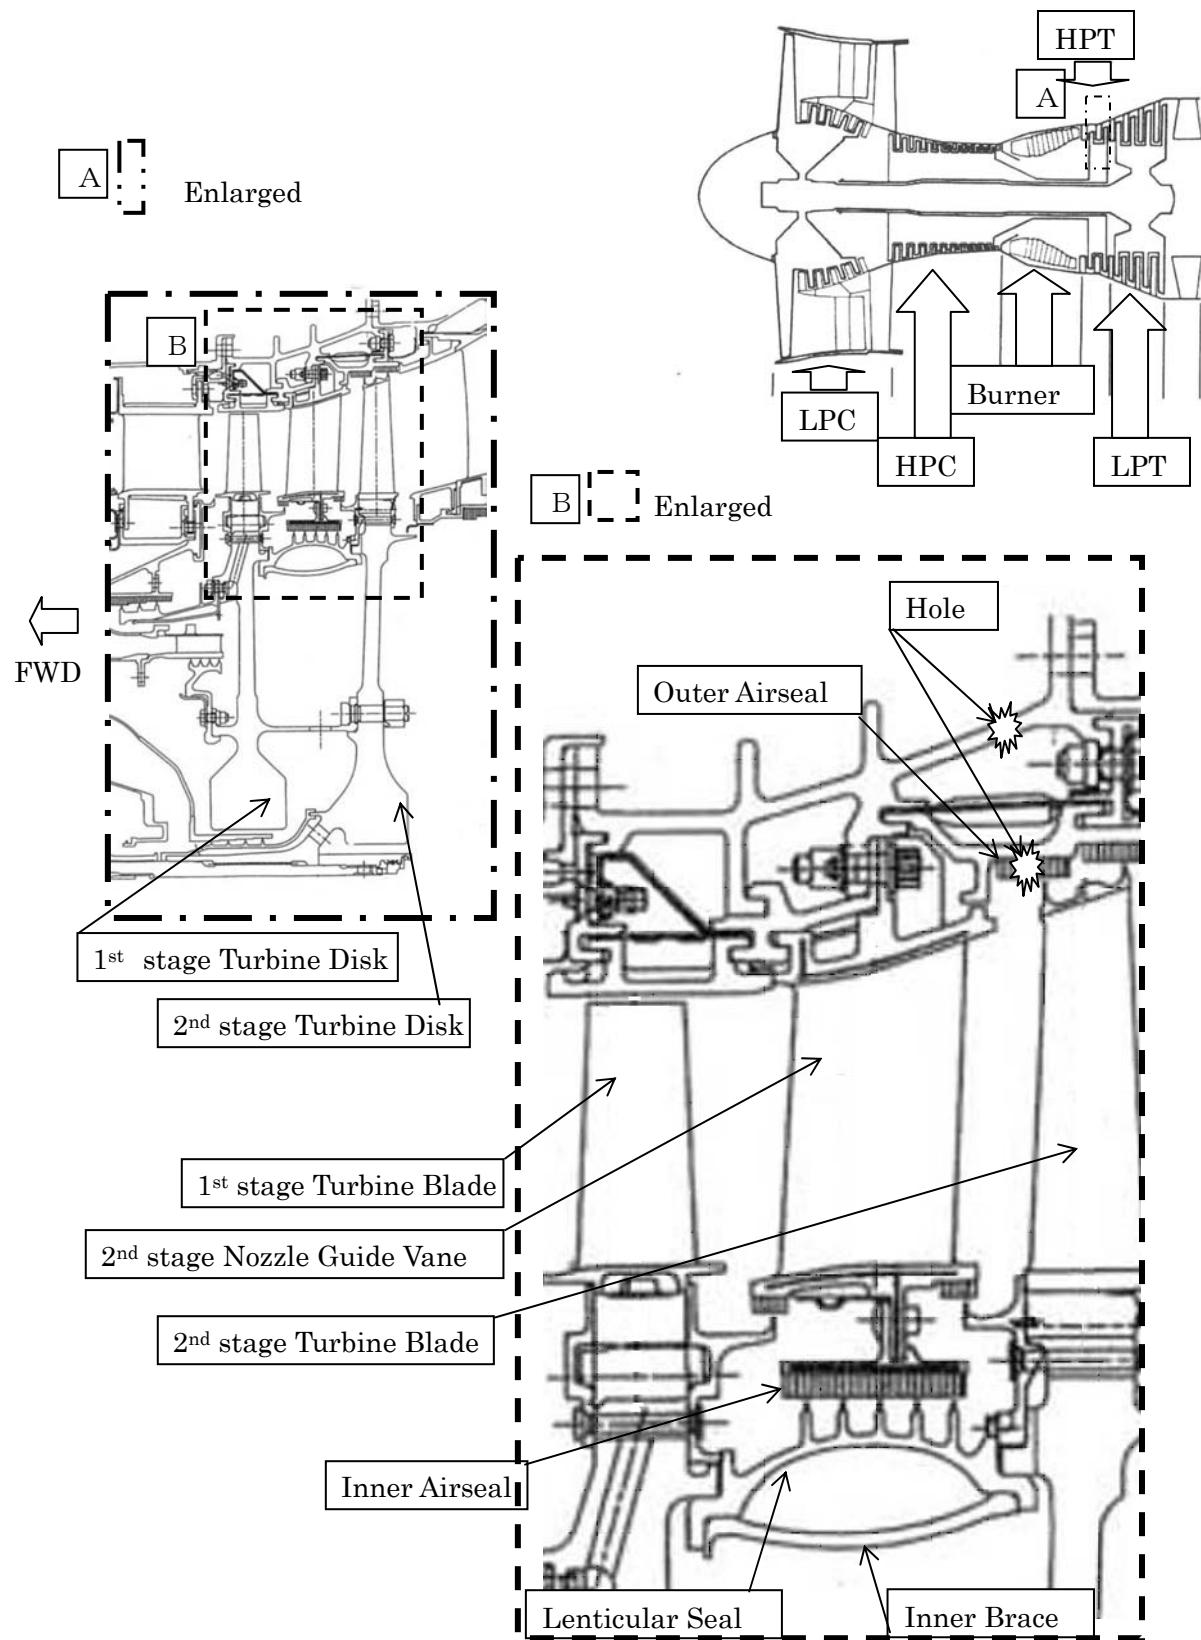
Figure 3 High Pressure Turbine Outline

It is estimated that the cracks in the lenticular seal were the result of high temperature fracture and propagated from the surface to the interior, as described in paragraph 2.9.2.

It is estimated that initiation of the high temperature fatigue was the result of heat stresses due to insufficient cooling combined with the centrifugal force on the lenticular seal, and this caused repeated deformation of the inner brace and the lenticular seal which were attached between the turbine 1<sup>st</sup> and 2<sup>nd</sup> stage turbine disc.

- Measures should be taken to ensure that there is no insufficiency of cooling of the lenticular seal of JT9D-7R4 series engine.
