AA2011-8

**AIRCRAFT ACCIDENT
INVESTIGATION REPORT**

Japan Transport Safety Board

**NORTHWEST AIRLINES INCORPORATED
BOEING 747-400, N676NW (THE UNITED STATES OF AMERICA)
IN THE AIR ABOUT 174 KM SOUTH-SOUTHWEST OF NARITA
INTERNATIONAL AIRPORT
AROUND 11:45 JST, FEBRUARY 20, 2009**

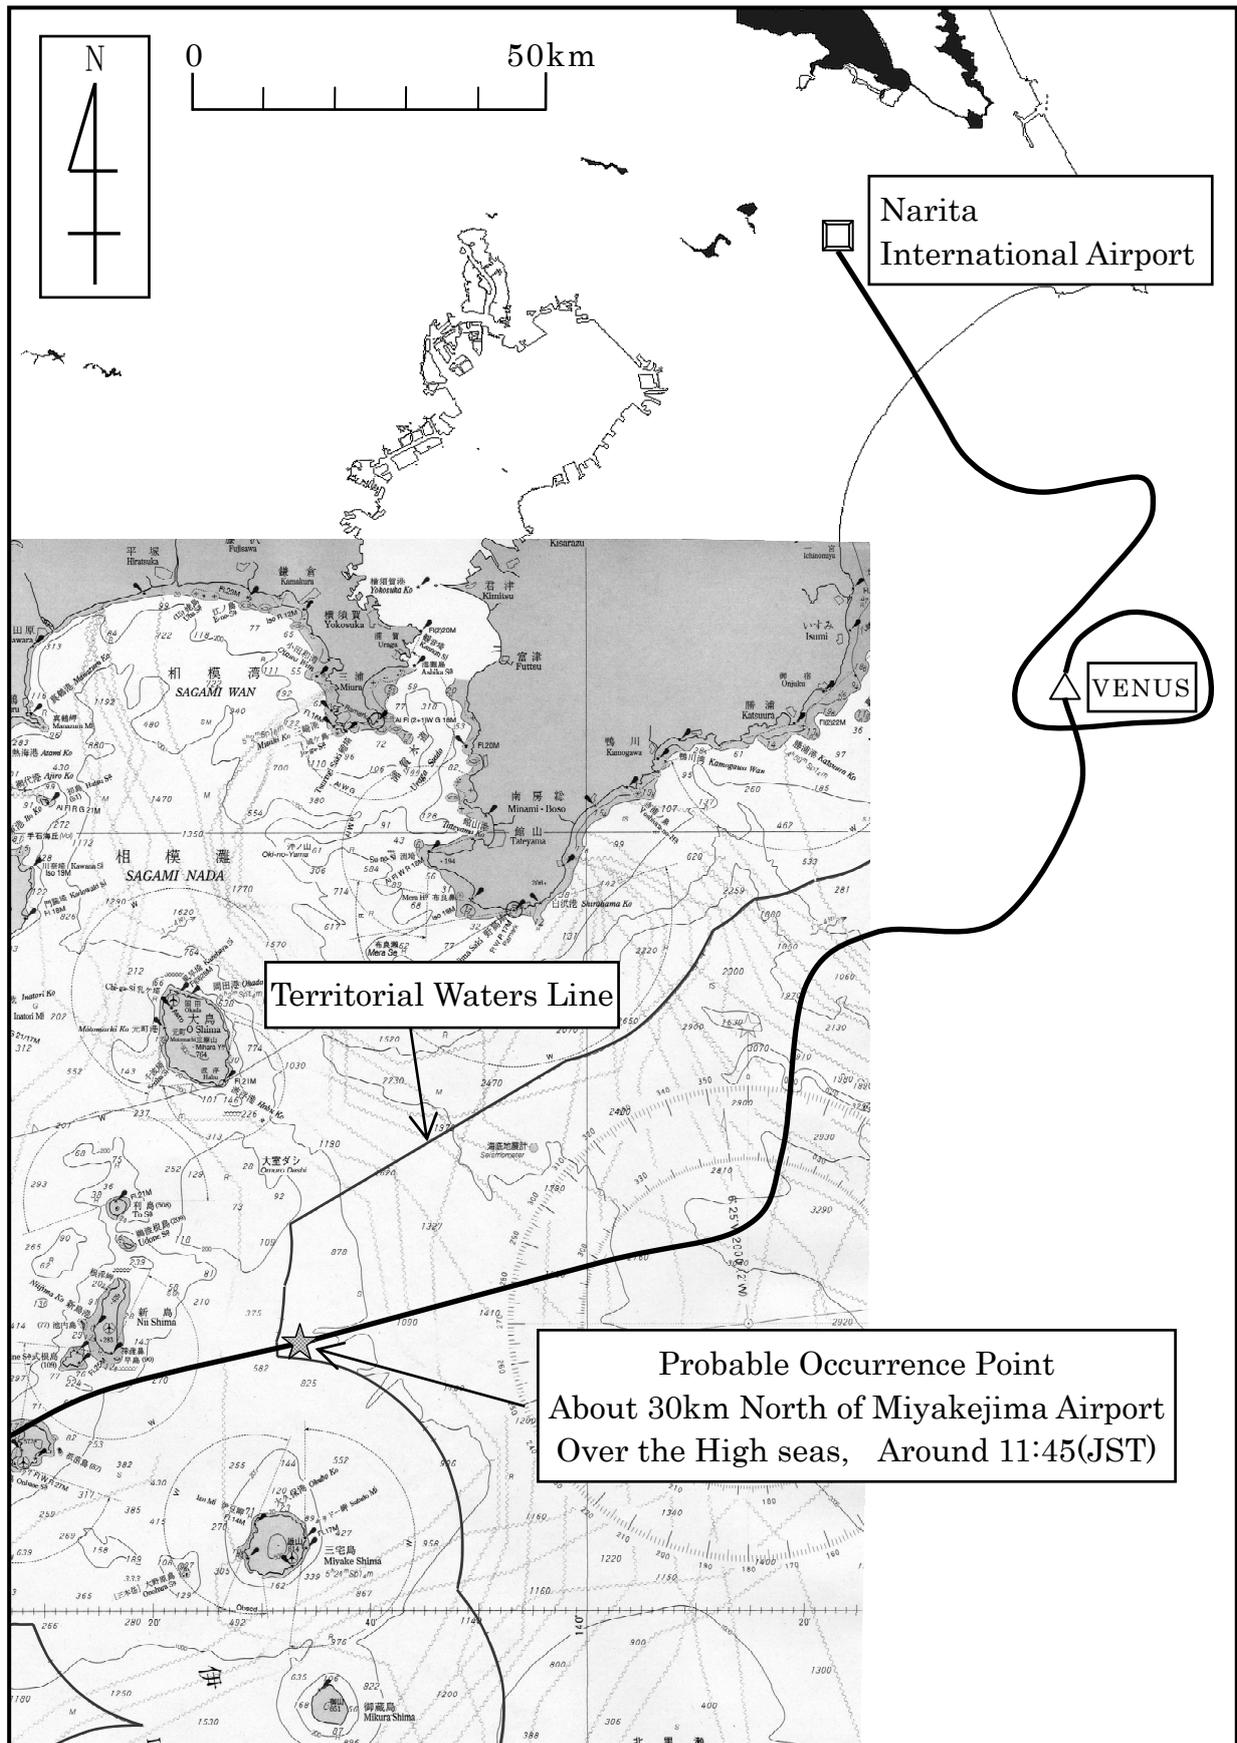
Figure 1 Estimated Flight Route

This accident occurred around 11:45, at an altitude of about 30,300 ft about 174 km south-southwest of Narita Airport (34°20'55" N, 139°33'32" E). (See Figure 1 Estimated Flight Route, Figure 2-1 DFDR Records (1), Figure 2-2 DFDR Records (2), Figure 3 Seat Locations of Injured Persons, Photo 1 The

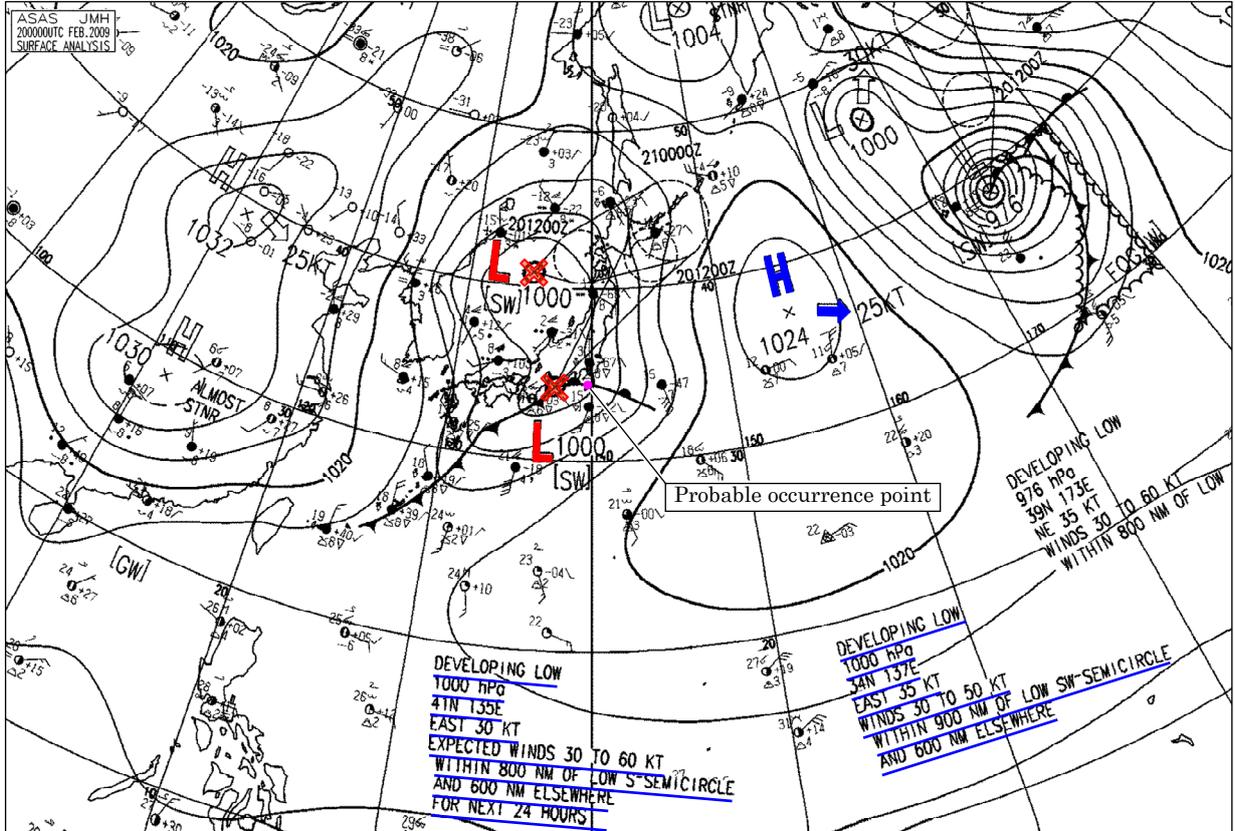
Figure 5 Asia-Pacific Surface Analysis

As described in 2.6.1, because warm and damp winds were blowing from the south into the low pressure near the Tokai region, generating unstable atmospheric condition. As a result, as described in 2.6.2, it is considered highly probable that clumpy convective clouds were developing there. As described in 2.6.3, a vertical wind shear of 6 kt per 1,000 ft was observed amid jet stream near Latitude 35° N at an altitude of 26,000 to 30,000 ft. Therefore, it is considered highly probable that turbulent air was generated in the airspace near the place where the accident occurred.

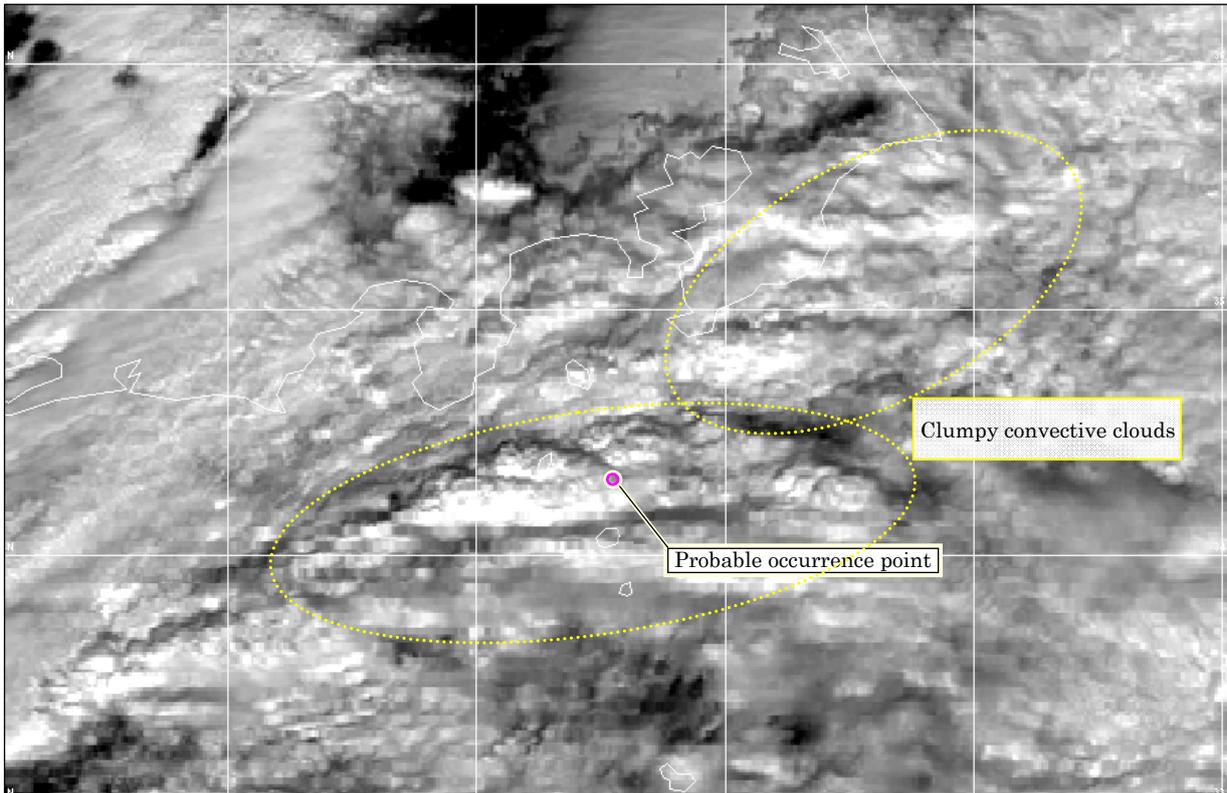
Figure 7 Meteorological Satellite Imagery (Visible)

As described in 2.1.1, the Aircraft requested permission to change its heading when it descended from the cruising altitude of FL370 to FL350. It is considered highly probable that this was aimed to avoid cumulonimbi. The Aircraft was instructed by Tokyo Control to descend to FL180 and change its heading to 080°. According to the statement described in 2.1.2 (1), because clouds were observed in that direction, the Aircraft examined the clouds ahead with its radar, but there was no clear cumulonimbus on the radar screen. Therefore, it is considered highly probable that the Aircraft made a descent through the clouds keeping the direction as instructed.
