**AIRCRAFT SERIOUS INCIDENT  
INVESTIGATION REPORT**

**SILVER AIR CORP.  
N 8 2 9 R A**

## LOSS OF CABIN PRESSURIZATION SILVER AIR CORP. BOMBARDIER BD-700-1A10, N829RA AT FL250 ABOUT 92 KM NORTH-NORTHEAST OF NAHA AIRPORT AT AROUND 18:09 JST, FEBRUARY 20, 2020

July 16, 2021

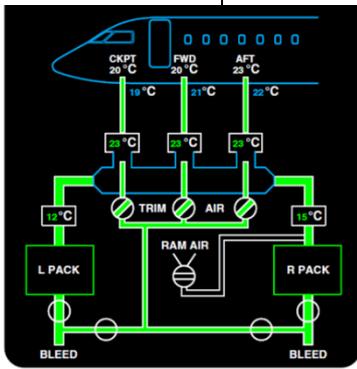
Figure 3: Air conditioning systems (EICAS indication)

be a desired temperature set for each zone (hereinafter referred to as “Trim Air” (See Figure 3). The air delivered to the cabin is used by cabin pressurization systems that keep the interior cabin pressure appropriately using two outflow valves installed in the fore and aft of the Aircraft respectively, which control the air volume discharged to overboard of the aircraft (See Figure 4). The cabin pressurization controller automatically works to maintain a cabin altitude of 7,230 ft at a flight altitude of 51,000 ft. The operation panels for air conditioning and cabin pressurization systems are positioned on the overhead panel (See Figure 5). When the PACK switch is selected off, the switch lights up with a white “OFF” character.
