MA2012-7

**MARINE ACCIDENT
INVESTIGATION REPORT**

Japan Transport Safety Board

Accident Type	Fatality during mooring operation																		
Date and Time	At about 1005 (local time, UTC+9), on January 11, 2011																		
Location	South Berth A, Funabashi Chuo Wharf, Katsunan District, Chiba Port, Chiba Prefecture. Approximately 076° true, 2.0 nautical miles from Chiba-ko Katsunan Ichikawa Lighthouse. (Approximately 35° 40.5' N, 139° 58.4' E)																		
Summary of the Accident	While the cargo ship EN KAI was berthing at South Berth A, Funabashi Chuo Wharf, a tensed mooring rope suddenly bounced and struck the chest of a boatswain working on the forecastle deck. The boatswain was killed. (Photo 1: Whole View)																		
Process and Progress of the Investigation	(1) Set up of the Investigation The Japan Transport Safety Board appointed an investigator-in-charge and another investigator to investigate this accident on January 12, 2011. (2) Collection of Evidence January 12 and 13, 2011: On-site Investigations and Interviews. January 14 and 17, 2011: Interviews. (3) Comments from Parties Relevant to the Cause Comments on the draft report were invited from par

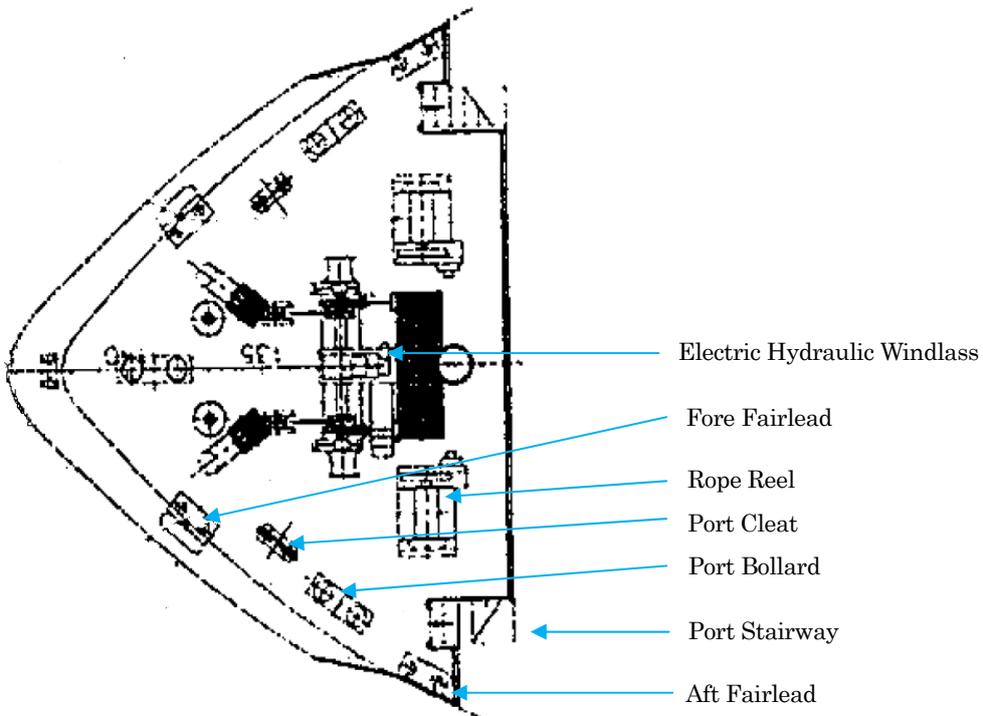
Chart 1 Forecastle Deck Plan

<p>Engine, Output Diesel, 1,618kW Date of launch September, 2006</p>
Conditions at the Forecastle Deck	<p>On the EN KAI (hereinafter referred to as “the ship”), one electric-hydraulic windlass was located near the center of the forecastle deck. Behind the windlass, an electric-hydraulic rope reel (hereinafter referred to as “the rope reel”) is located on each side respectively. Each side was equipped with two fairleads, one bollard and one cleat. (Chart 1: Forecastle Deck Plan)</p>
Crew Information	<p>Gender, Age and Certificate of Competence (1) Master (Nationality: China), male, 54 years old Master certificate (Issued by China) Date of Issue: December 6, 2006 (Valid until December 6, 2011) (2) Chief officer (Nationality: China), male, 57 years old Master Certificate (Issued by China) Date of Issue: November 27, 2007 (Valid until November 27, 2012) (3) Boatswain (Nationality: China), male, 38 years old</p>

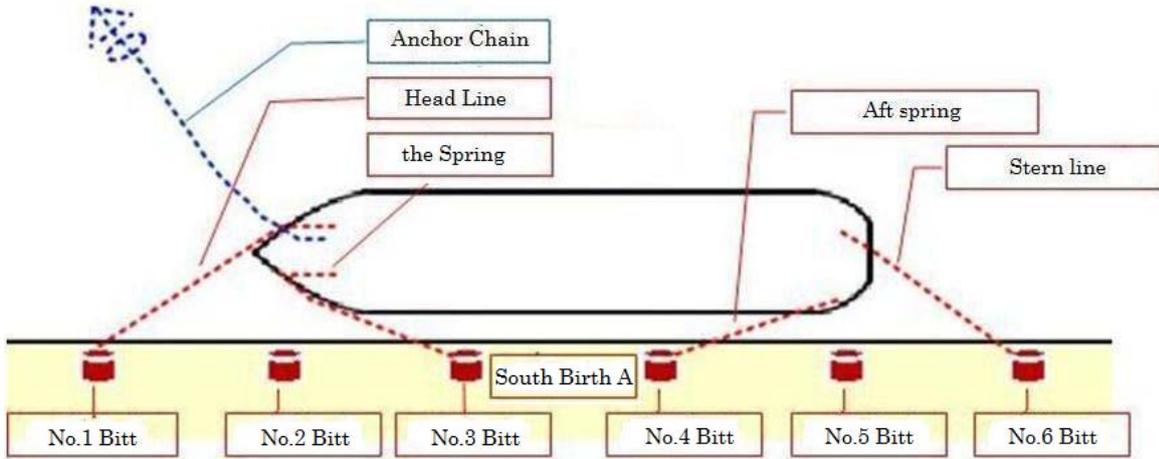
Chart 2 Use Plan of Mooring Line and Anchor

Injuries to Persons	One fatality (Boatswain)
Damage to Vessel	Nil
Events Leading to the Accident Use Plan of Mooring Lines and Anchor	<p>The ship was scheduled to be berthed port side alongside at South Berth A, Funabashi Chuo Wharf (hereinafter referred to as “the Berth A”) where the bitt intervals were 24 meters, casting the starboard anchor and sending two mooring lines from the bow and stern respectively. (Chart 2: Use Plan of Mooring Line and Anchor)</p>
Movement of the ship According to AIS Records at the time of the accident	<p>The ship’s movement until the accident occurred is shown in Chart 3 (Ship Positions Plotted on AIS). (Table1: Records of AIS Information (Excerpt))</p>
Movement of the ship	<p>The ship was manned by a Master and 15 crew members (All nationality:China) and left Shanghai Port, China. She was loaded with 3,271t of steel coils. The ship arrived at the south entrance of Funabashi Fairway, Chiba Port, Japan on January 11, 2011 and anchored there. At approximately 0855, the ship heaved up anchors and proceeded to north for the Berth A through Funabashi Fairway.</p>

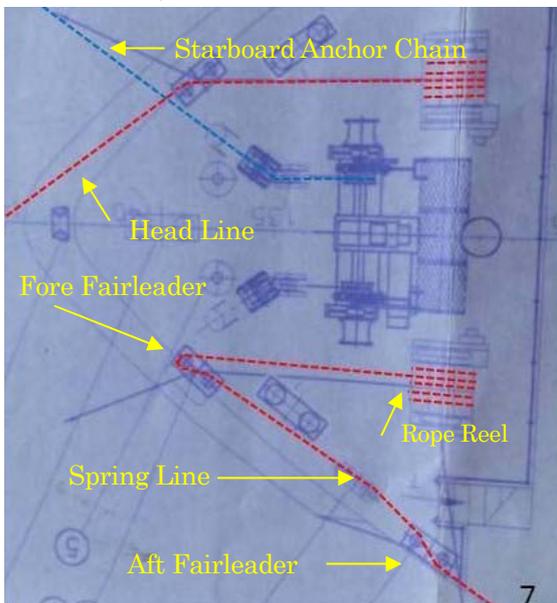
Chart 5 Layout Plan of Head Line and the Spring

Weather and Sea Conditions	<p>Weather : fine, wind direction NW. wind force 5, good visibility</p> <p>Sea conditions : wave height unknown</p>
Analysis	<p>(1) It is probable that the Spring was to be put through the fore fairlead after the Spring was put in snake down coil on the deck to prepare for berthing and the end of the Spring was secured on the bitt.</p> <p>(2) It is probable that while the ship was berthing at the Berth A in Chiba Port, where the Master ordered the engine slow ahead to slightly readjust the berthing position after the Spring was secured on No.3 bitt and then the ship proceeded faster than the reeling-out speed of the Spring, therefore the Spring could not be put through the fore fairlead, as a result, the Spring bounced due to sudden tension and struck the boatswain's chest who stood near the Spring, which resulted in his death from a massive hemothorax.</p> <p>(3) It is possible hat the Spring was caught by something under the rope reel when it became tense as the Spring was not put through the fore fairlead and then the Spring bounced after it was suddenly released from under the rope reel.</p> <p>(4) It is possible that this accident could have been avoided if the Spring had been put through the fore fairlead.</p>
