**MARINE ACCIDENT
INVESTIGATION REPORT**

Vessel type and name: Cargo ship BEAGLE III

Vessel type and name: Container ship PEGASUS PRIME

Accident type: Collision

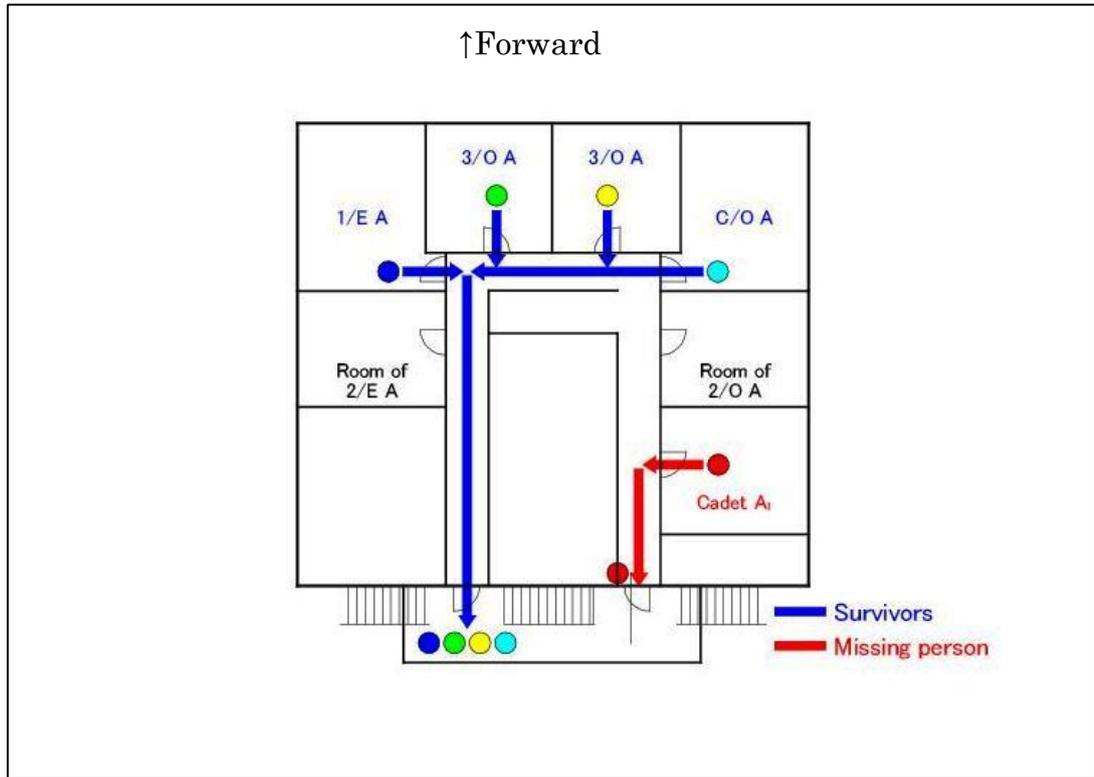
Fig. 2.1-2 Escape situation on A deck

3/O A woke up by the collision and realized that the ship began tilting. 3/O A went out to the passage and found 3/E A who was trying to get out of the cabin and pulled him up to the passage. Together with C/O A and 3/E A, 3/O A went out of the accommodation space through the passage on the port side toward the stern.

C/O A and others found a nautical trainee (hereinafter referred to as Trainee A₁) who could not come out of the passage exit on the starboard side due to the tilting of the ship and tried to rescue him with a rope, but they saw Trainee A₁ drawn in the seawater flowing suddenly to the passage.

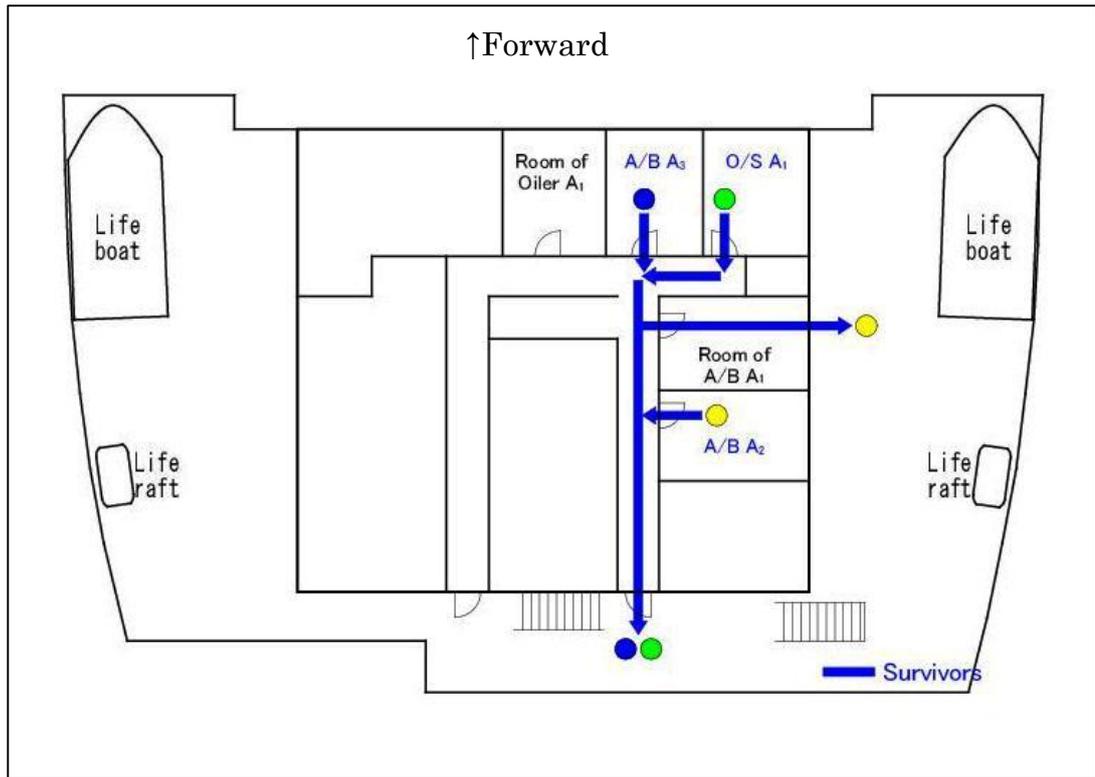
Fig. 2.1-3 Escape situation on boat deck

After the foundering of Ship A, A/B A₃ boarded the inflatable liferaft where 1/E A and others already boarded. A/B A₃, 1/E A, and others on the liferaft were rescued by the patrol boat.

At around 04:10-20, A/B A₂, drifting on a wood piece, was rescued by a passenger ship (hereinafter referred to as Ship C) navigating at the back of Ship A. O/S A₁ swam to Ship C and was rescued.

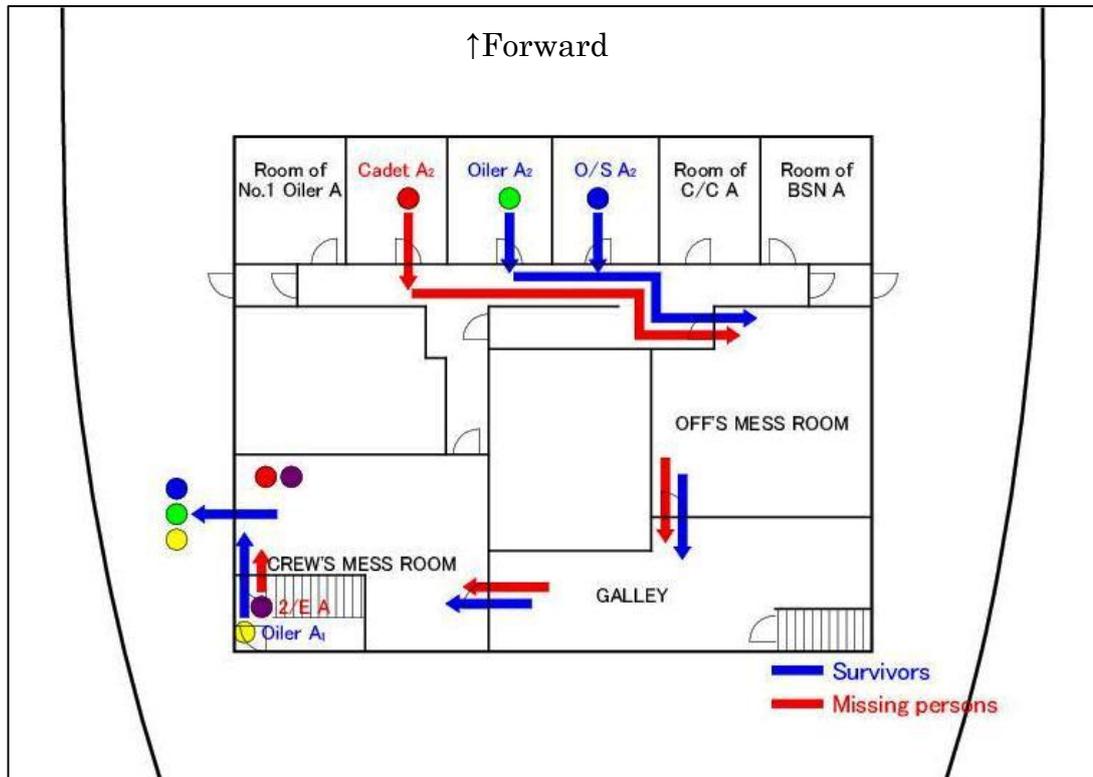
Fig. 2.1-4 Escape situation on upper deck

O/S A₂, together with Oiler A₂, went out of the window of the crew's mess room, swam toward the stern, moved up to the stern deck, and joined other crews. Since Ship A foundered, they moved to the wood piece, on which A/B A₂ already boarded, and were rescued by Ship C.

2/E A and Trainee A₂ could not swim and remained in the crew's mess room.

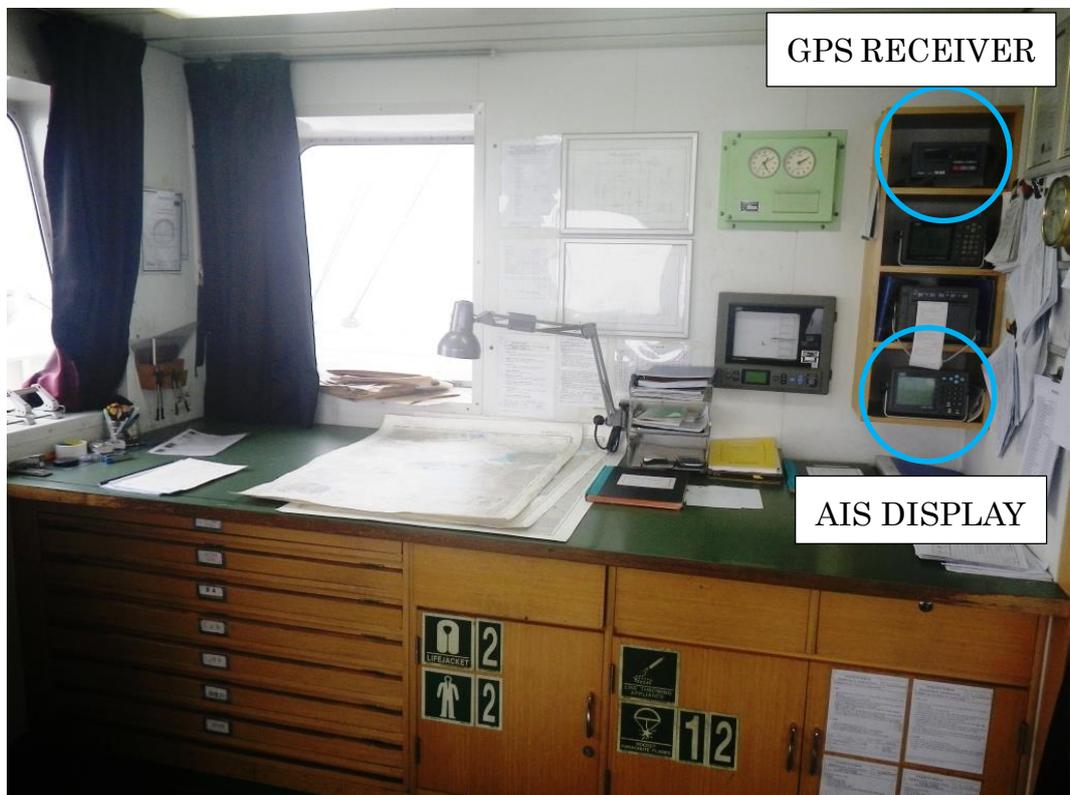
Photo 2.5-3 Chart table situation of Ship B

The AIS display of Ship B shows the position of a ship which transmits AIS information about the bearing and distance. If other ships are searched, various data of these ships are shown. The radar of Ship B did not have a function of overlaying AIS information.

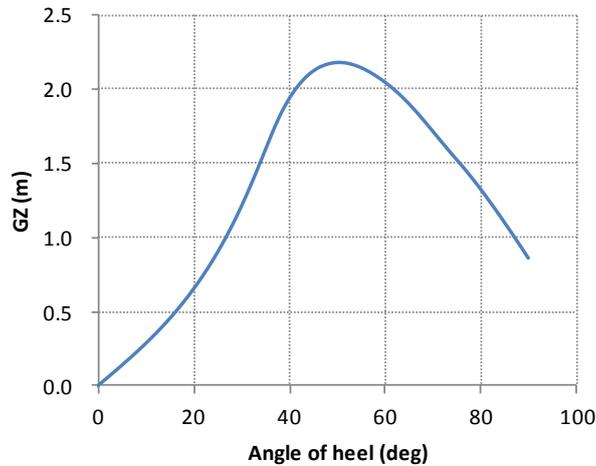
Figure 2-2 GZ curve at the time of departure

Using the above data, the estimated results of center of gravity and the draft at the time of departure are shown in Table 2-4. The GZ curve at that time is shown in Figure 2-2. From these results, it is confirmed that the vessel A had sufficient stability at the time of departure.

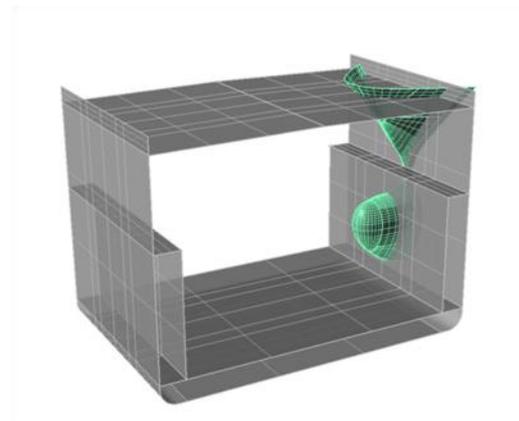
Figure 3-2 Estimate of the collision situation of ship A with ship B
(If ship B penetrated into the vicinity of the bow bulb)

The flooded compartment was estimated from the general arrangement, the midship section and other drawings. Hole is considered to be generated between the frame no. 103 and no. 112 from Figure 3-1. The compartment corresponding to these numbers is "No.1 CARGO HOLD". According to the midship section of vessel A, height of 10m from the bottom is double hull structure whose outside is "W.B.T" and inside is "No.1

CARGO HOLD". Depending on the situation of the collision with vessel B, there is a possibility that the flooded seawater does not reach to the "No.1 CARGO HOLD". For this reason, the collision situation of vessel A and vessel B was examined.

the photograph of vessel B at the time of arrival at the port shows that there were damages on the stem and the hull, and from these, it is estimated that the fore part of vessel B, almost whole part of bulbous bow, penetrated vessel A. Considering the estimated shape of the bow of the vessel B based on the general arrangement and the bow structure drawings, and above situation of the collision, it is estimated that about half of the bow bulb of vessel B penetrated inner plate of the double hull structure. (Figure 3-2)

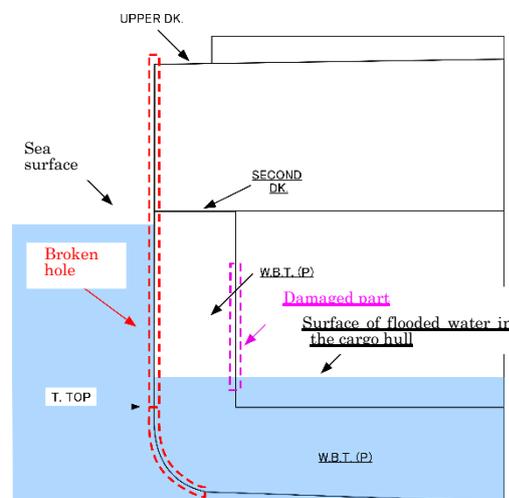
Figure 3-3 Positions of broken hole, sea surface, and surface of the flooded seawater in the cargo hull

Δv stands for the volume of flooded water, Δt stands for infinitesimal time and 5 seconds was used in this calculation. μ stands for the flow coefficient (0.6) at the opening, A stands for the dimension of the opening, and h is determined by the difference in the height of surfaces of the flooded seawater in the cargo hull and sea.

However, since the cargo hull was filled with air at the beginning of the flooding, separate estimation is required for the air part and the underwater part in the cargo hold. (Figure 3-3) In this calculation, total volume of flooded water in the cargo hold was estimated as the mass of volumes of flooded water to each part that were separately calculated using the height of seawater surface in the hull at a time. The time series is calculated at interval of 5 seconds, and the volume of flooded water is assumed to be the same for each 5 seconds.
