MA2017-8

**MARINE ACCIDENT  
INVESTIGATION REPORT**

Vessel type and name: Cargo Ship “HUNAN”

Accident type: Missing crew member

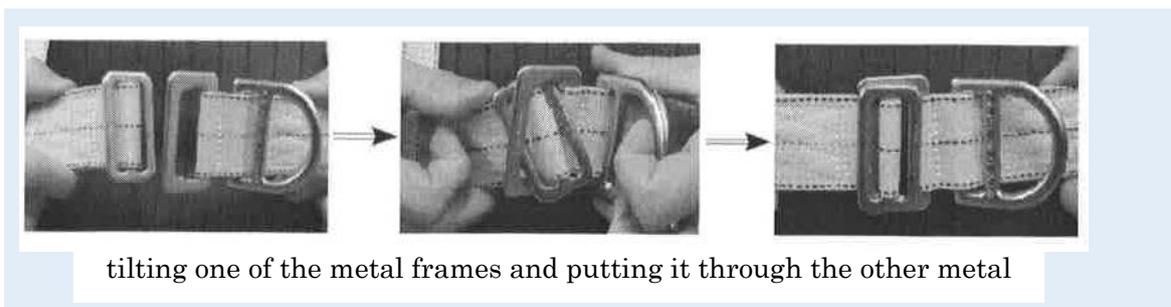
It is a part for connecting both ends of the belt used by tilting one of the metal frames, putting it through the other metal frame and fastening down the belt to thereby prevent the belt from being detached due to the tension on the belt.

Figure 2.9 - 3 How to fix the buckle of the safety belt (provided by a life jacket import agent)

It is probable that the separation of the body of AB B from the safety belt stems from his failure to have two thigh buckles of the safety belt fastened.

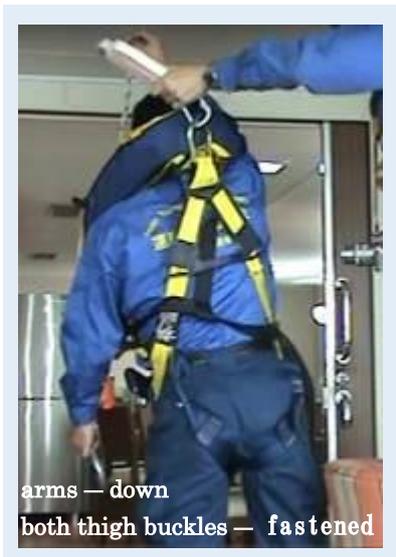
Photo 2.9-1

- (1) When the belt was pulled up overhead in the state of the belt being worn with the buckles of the chest and the both thighs fastened and both arms lowered, the safety belt did not disengage from the body.
