MA2017-9

**MARINE ACCIDENT
INVESTIGATION REPORT**

MARINE ACCIDENT INVESTIGATION REPORT

Vessel type and name: Cargo Ship BBC ASIA

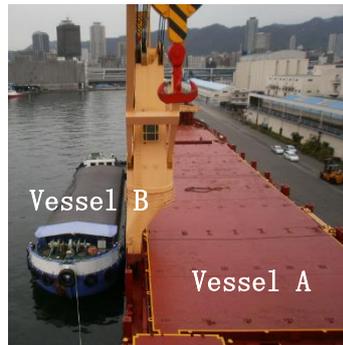
Photo 2.1-2 Circumstances of Vessel B Alongside Vessel A (After the Accident)

At around 8:30, Barge SK1001 (hereinafter referred to as “Vessel B”) loaded with the Bundled Pipes that were scheduled to be loaded onto Vessel A berthed port-side alongside on Vessel A’s port side. (See Photo 2.1-2)

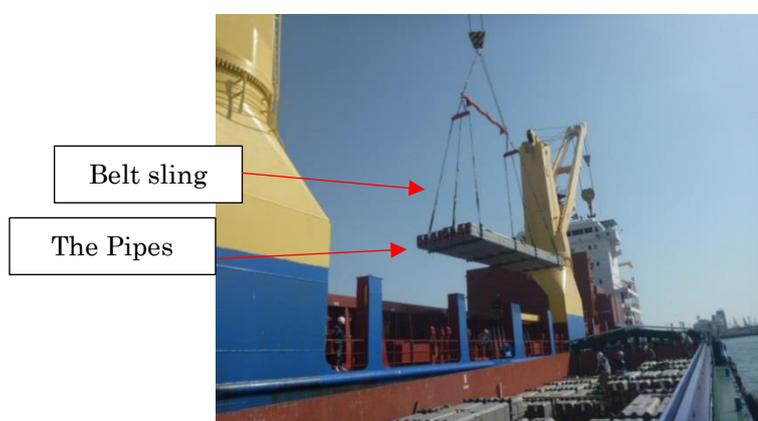
Photo 2.1-3 The Pipes Hoisted from Vessel B
(Courtesy of the Nippon Kaiji Kentei Kyokai)

The Winchman, operating the No. 1 crane in accordance with signs he received by transceiver from the Deckman, moved “four bundles of nine-piece Bundled Pipes that he hoisted from Vessel B” (hereinafter referred to as “the Pipes”) toward the center of the No. 2 cargo hold. (See Photo 2.1-3)

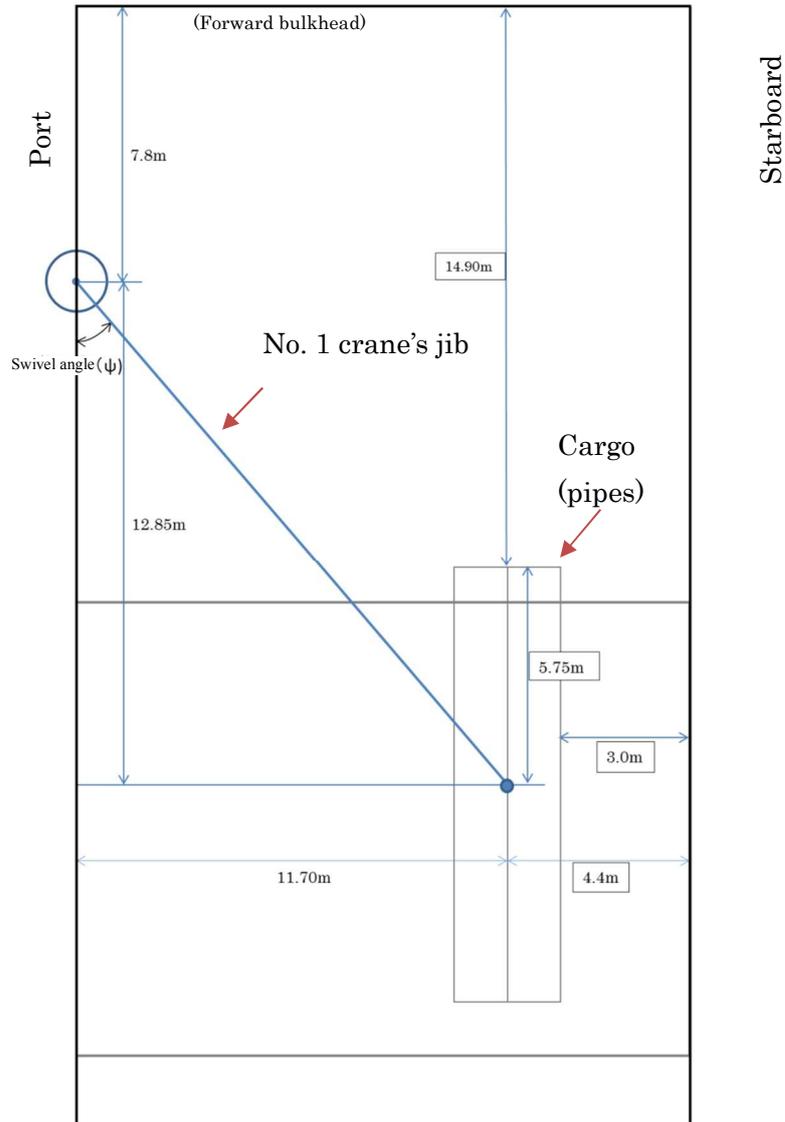
Figure 1: Positional Relationship (1) between the Hoisted Cargo and No. 1 Crane (No. 2 Cargo Hold Plan)

It should be noted that the suspended position of the cargo prior to the accident that is identified in the investigation (hereinafter referred to as the "Established Position") is 2.75 meters from the floor of the No. 2 cargo hold to the bottom surface of the cargo; 4.40 meters from the starboard wall of the cargo hold to the center of the cargo and 3.00 meters to the starboard side of the cargo; and 14.90 meters from the forward bulkhead of the cargo hold to the forward side of the cargo (see Figure 1).

Now we obtain the jib angle of elevation φ and swivel angle ψ (from the aft direction) using values found in materials provided by the Japan Transport Safety Board (hereinafter referred to as the "Materials"). The length of the jib is 37.185 (meters). At the time of the accident, a small hook (weight: 1.03 tons) was being used at the end of the jib. Therefore, the

positional relationship between the hoisted cargo in the No. 2 cargo hold and the No. 1 crane becomes that shown in Figure 1.

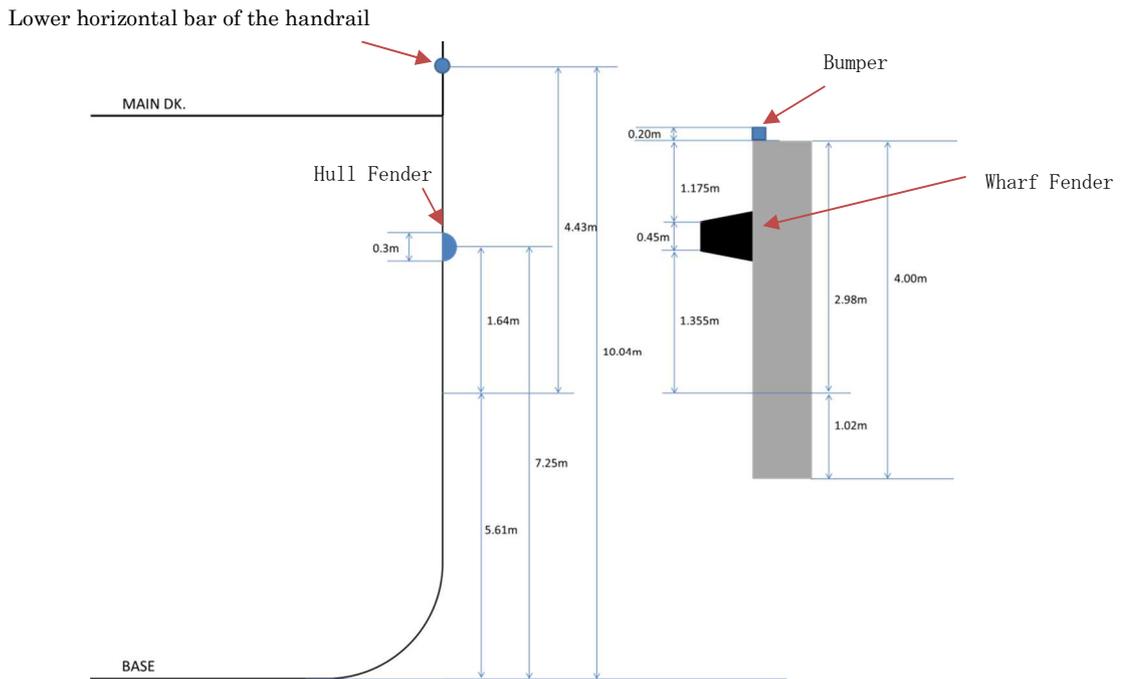
Figure 2 Positional Relationship between the Hull and the Wharf

From the Materials, the positional relationship between the hull and the wharf becomes that shown in Figure 2.

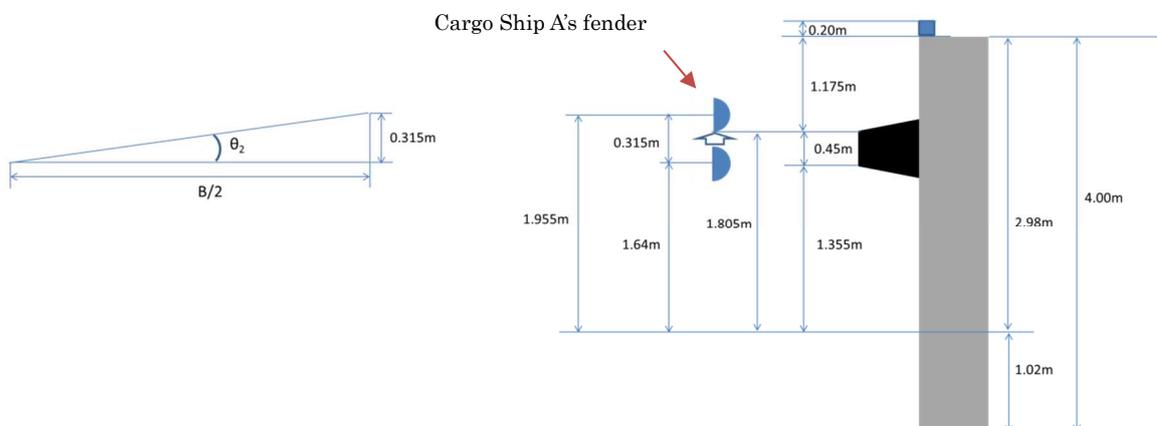
Figure 3 Upward Change in Position of the Hull Fender

As is shown in Figure 3, from the Materials, the rise of the hull's fender (change in position from the state in which the fenders are not caught) is 0.315 (meters). Accordingly, if the beam is expressed as B, θ_2 as a small angle is

$$\tan \theta_2 = 0.315 / (B/2) = 0.0312$$

$$\theta_2 = 1.79(\text{deg})$$

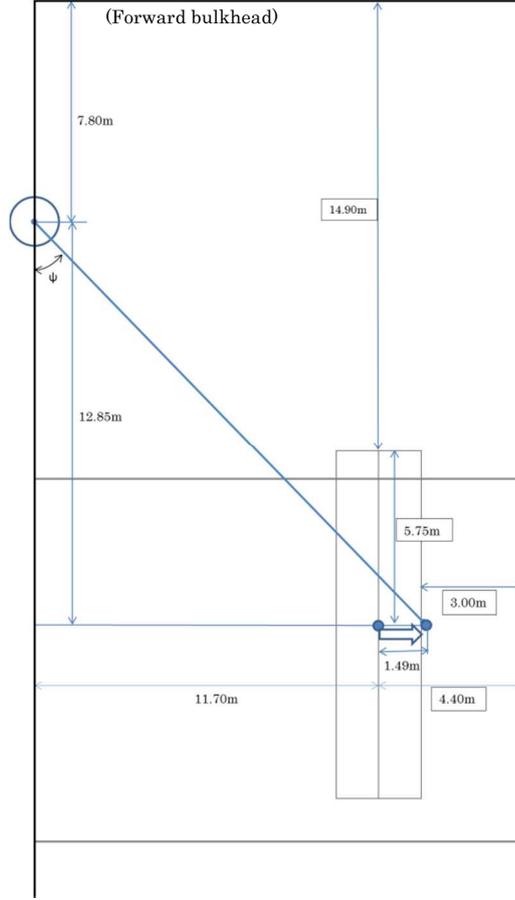
Figure 4: Positional Relationship (2) between the Hoisted Cargo and No. 1 Crane (No. 2 Cargo Hold Plan)

When the hull inclined 1.79 degrees to the port side, the end of the No. 1 crane's jib must move to the starboard side by the 1.79 degrees obtained in (i) so that the hoisted cargo will be at the Established Position (Figure 4, Figure 7). Accordingly, we again obtain the jib's angle of elevation and swivel angle and, further, obtain the inclination angle when the cargo is suspended at the Established Position with the jib at this position.

Consequently, it is necessary to move the jib's end 1.49 meters laterally when looking from above as shown in Figure 4 and, simultaneously, to move it 0.58 meters downward so that it intersects with the 1.79-degree inclination angle line, as shown in Figure 7.

$$\varphi = \cos^{-1}(18.41/l) = 60.32(\text{deg})$$

$$\psi = \cos^{-1}(12.85/18.41) = 45.75(\text{deg})$$

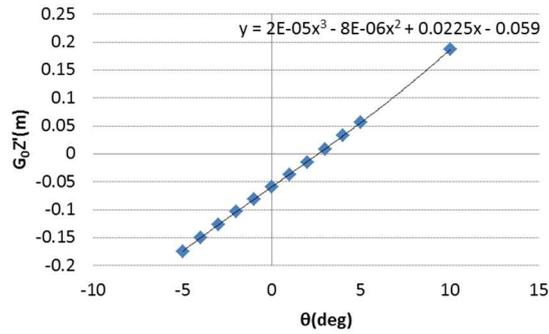
Figure 5 Righting Arm G_0Z' and its Approximation Formula

$G_0 Z'$, which we obtained by correcting the righting arm provided in the stability-related materials with Formula (3), and its approximation formula are shown in Figure 5.

$$\theta_3 = 6.93(\text{deg})$$

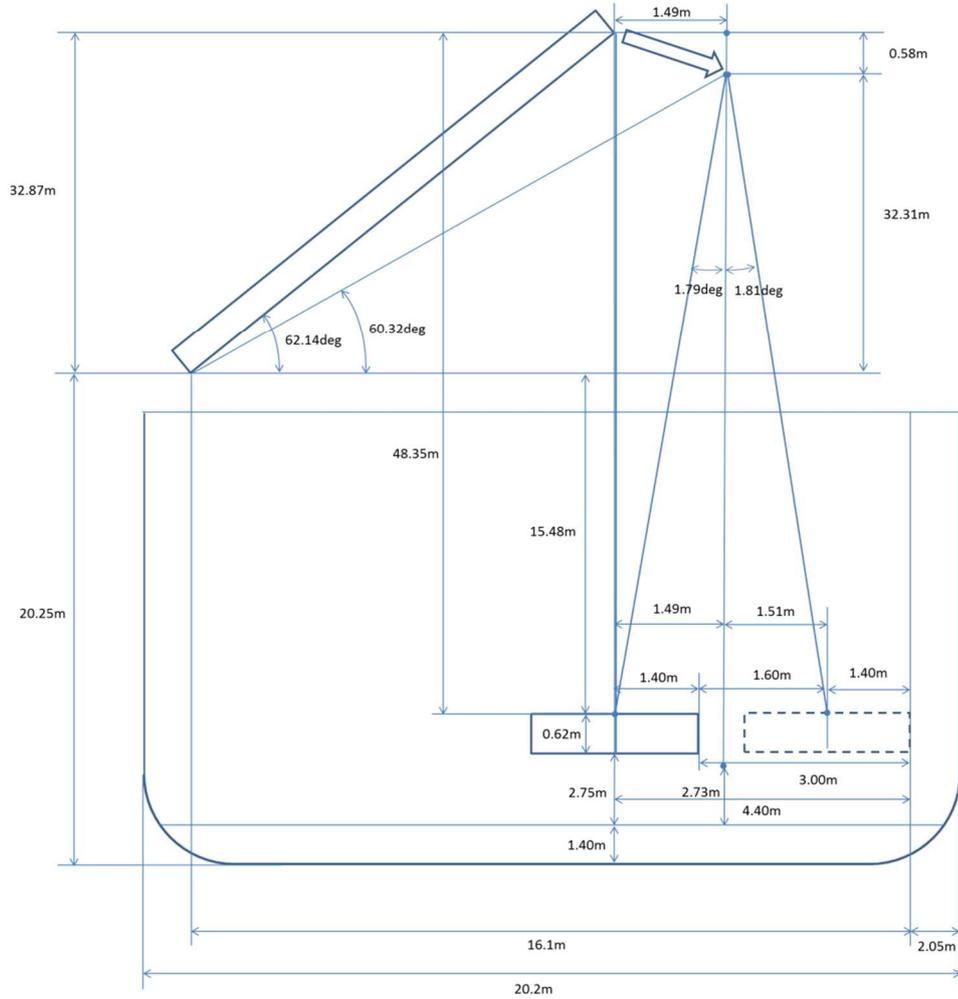
Figure 7 Positional Relationship at the Time of the Hoisted Cargo's Collision

From the Materials, the height from the top surface of the hoisted cargo to the end of the jib becomes 48.35 meters (=32.87+15.48 [meters]) (Figure 7). However, because the jib has a fixed length, the jib's end cannot be moved parallel to the cargo hold's floor within the hull's cross-section. This is because when making the swivel angle larger in order to move the jib in a lateral direction, the end of the jib also moves toward the bow. To correct this, the jib's end must be moved toward the stern by making the angle of elevation smaller.

Because length l_w of the belt sling between the jib's end and the upper surface of the hoisted cargo will change with the jib's motion, reobtaining it based on the Materials (Figure 7) results in

As is shown in Figure 7, because the distance to which the hoisted cargo can travel in the starboard direction is 3.00 meters, the distance the hoisted cargo can move toward the starboard side from a vertical line drawn down from the jib's end to the cargo hold's floor until the hoisted cargo's collision with the starboard wall (s_w) becomes
