**MARINE ACCIDENT
INVESTIGATION REPORT**

Vessel type and name: Container vessel NYK VENUS

Vessel type and name: Container vessel SITC OSAKA

Accident type: Collision

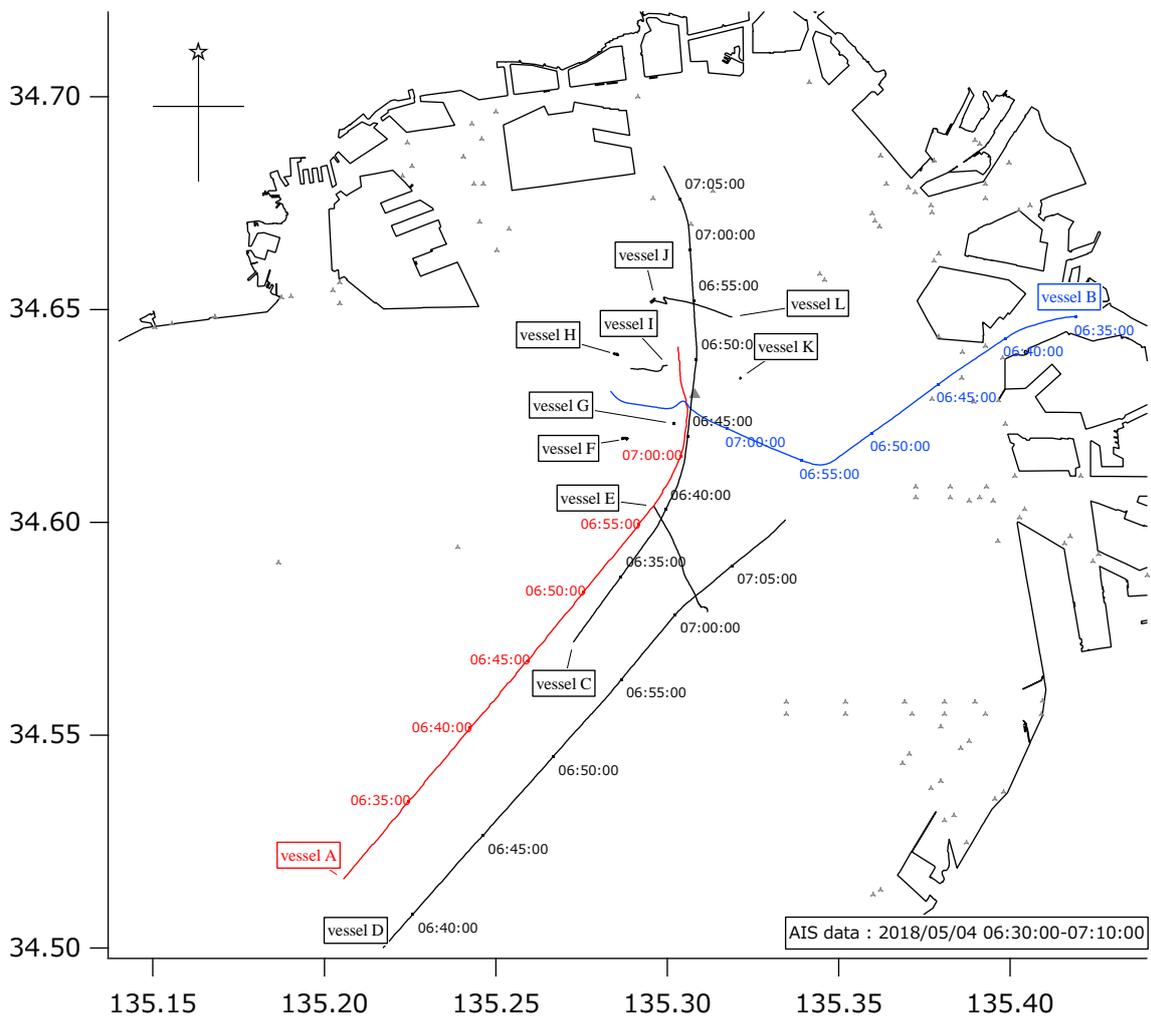
Fig. 2-1 Navigational track chart around the time of the accident

Fig. 2-1 provides a navigational track chart for Vessel A and Vessel B around the time of the accident and the positions of vessels existing in the vicinity. Table 2-1 shows the specifications of the two vessels (Vessel A and Vessel B).

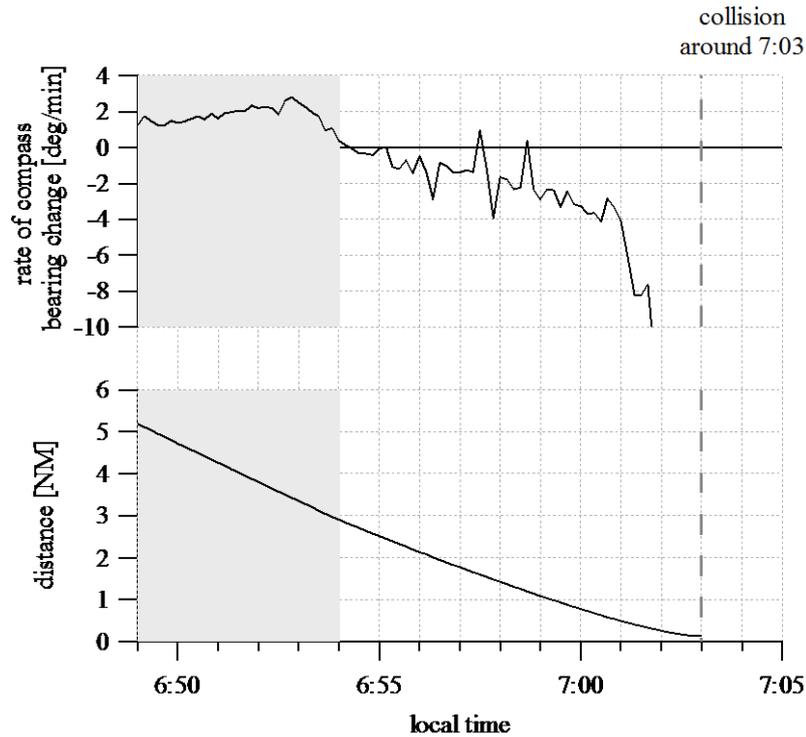
Fig. 2-2 Time-related changes in rate of compass bearing change and relative distance

As is seen in Fig. 2-2, compass bearing changes begin at around 06:54, when Vessel B finished changing course; however, the maximum value of rate of compass bearing change during the time period between 06:54 and around 07:01, when Vessel B conducted steering, was approximately 4 degrees/minute. According to literary sources,^{1) 2)} “human ability to visually detect rate of change is one or two degrees/minute when there is a reference point.” Considering the rate of compass bearing change at the time of the accident, it is possible there were times when changes in compass bearing could not be recognized.

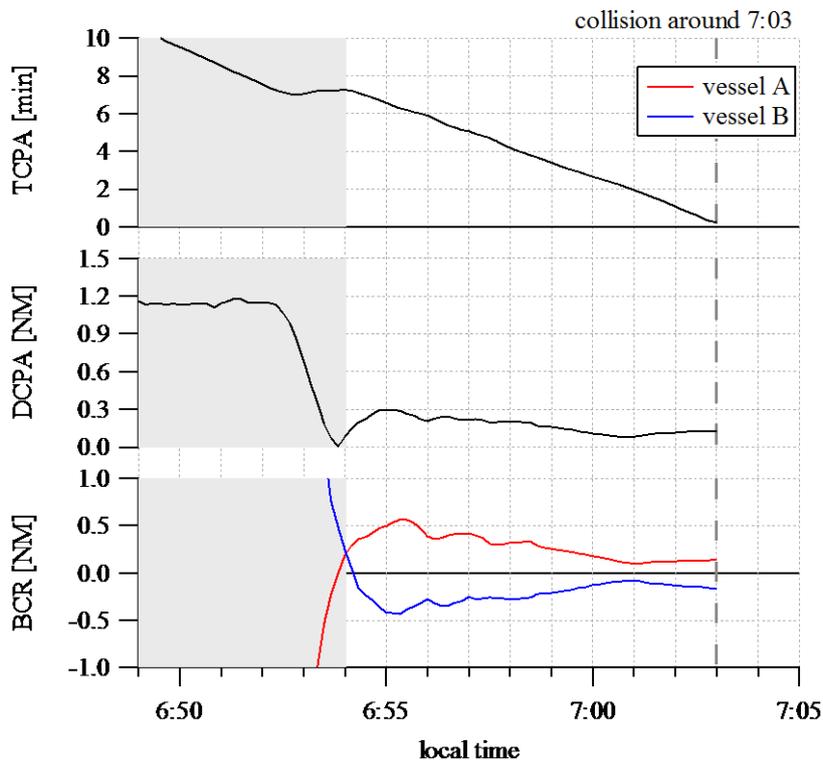
Fig. 2-3 Time-related changes in TCPA and DCPA

As is seen in Fig. 2-3, DCPA was temporarily almost nil at around 06:54, when Vessel B finished changing course, and then remained small afterwards. After 06:54, the highest DCPA value came at around 06:55, when it was approximately 0.3NM.

As is seen in Fig. 2-3, beginning at 06:54, when Vessel B completed her turn, Vessel A's BCR shows positive and it means that Vessel B is passing Vessel A's bow side. Even after 06:55, when it is at its largest, Vessel A's BCR is 0.57NM (approximately 0.44NM from the bow's end), and it gradually grows smaller after 06:55, when Vessel A began making a turn. On the other hand, Vessel B's BCR is on the negative side and it means that Vessel A is passing Vessel B's stern side. After 06:55, after Vessel B completed her turn, Vessel B's BCR is 0.43NM (approximately 0.42NM from the stern's end), and it gradually grows smaller after 06:55.

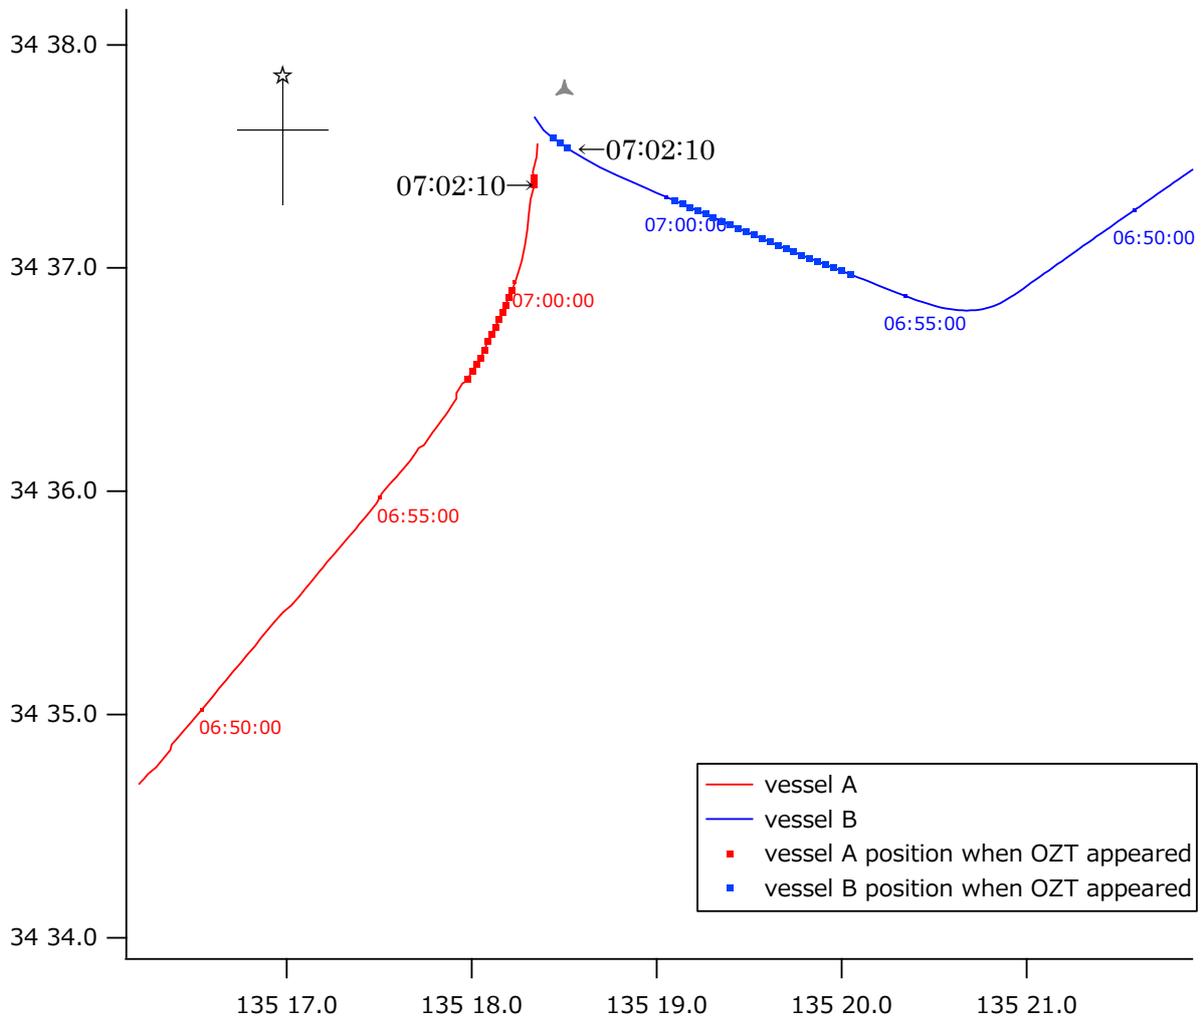
Fig. 2-5 Own ship's position when its course is obstructed by other vessel

Fig. 2-5 shows the positions of the vessels superimposed on their navigational track chart when the course of the own ship has been obstructed by the OZT.

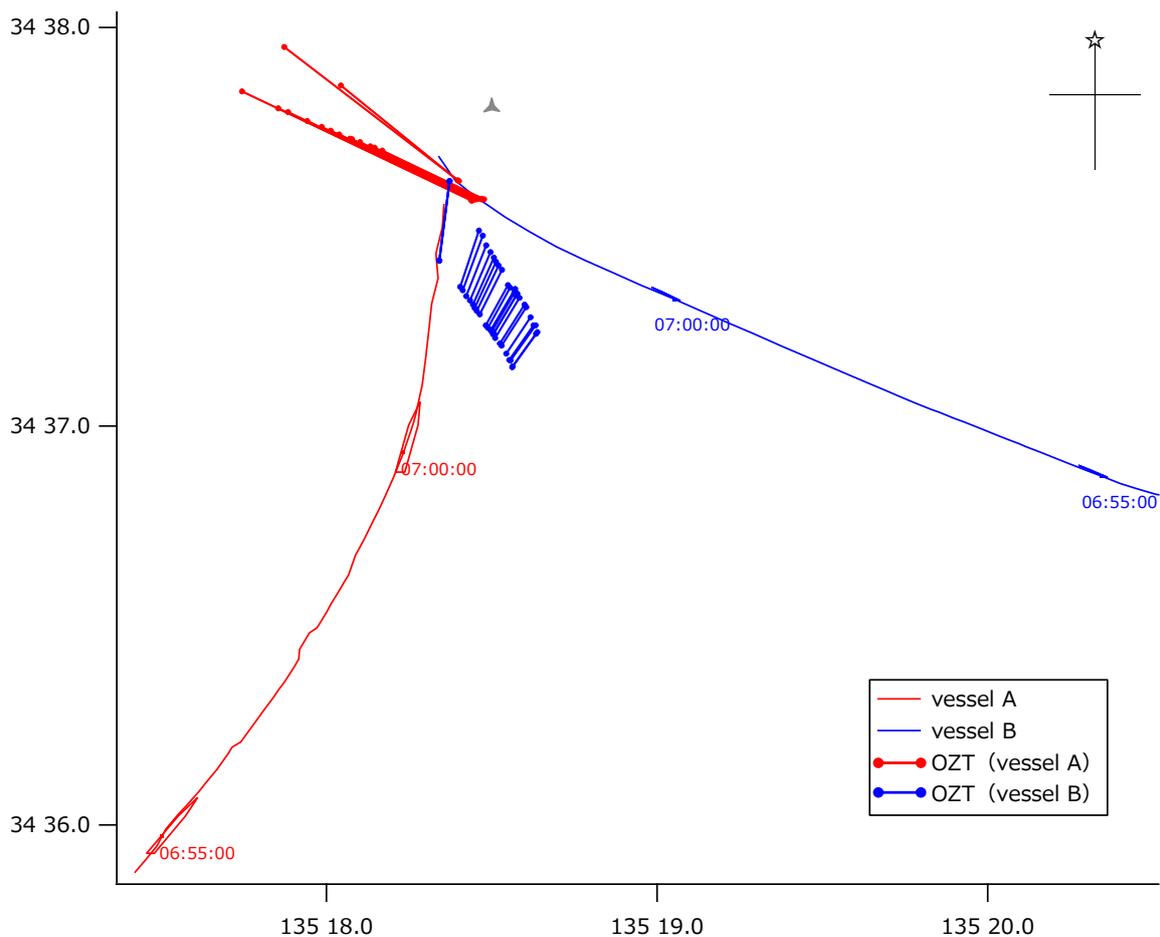
Fig. 2-6 OZT position when encountered by each vessel

Additionally, Fig. 2-6 provides the position of the OZT encountered by both vessels together with a navigational track chart. The OZT encountered by Vessel A occurred on the path that Vessel A intended to take from the time that she first encountered the OZT until just prior to the collision. On the other hand, with the exception of the time just prior to the collision, the OZT encountered by Vessel B occurred at places on the port side that were removed from the path that she intended to take.

Let us observe Vessel B in detail. When she first encountered the OZT, her speed was approximately 13.9 kt and the distance from Vessel B to the OZT was approximately 1.1NM. However, Vessel B was not in a state in which her course was obstructed. The OZT's position of occurrence gradually moved to the northwest until the time when she was temporarily not encountering the OZT. Although it is probable that this was an effect of Vessel A's altering course, Vessel B's course was not obstructed during this time. Vessel B subsequently approached the OZT and, at around 06:59:50, she was gradually approaching the OZT at a distance of 0.6NM and speed of approximately 13.9 kt. At around 07:02:10, when Vessel B again encountered the OZT just prior to the accident, the OZT occurred at a distance of approximately 0.2NM directly ahead of Vessel B (approximately 13.7 kt).

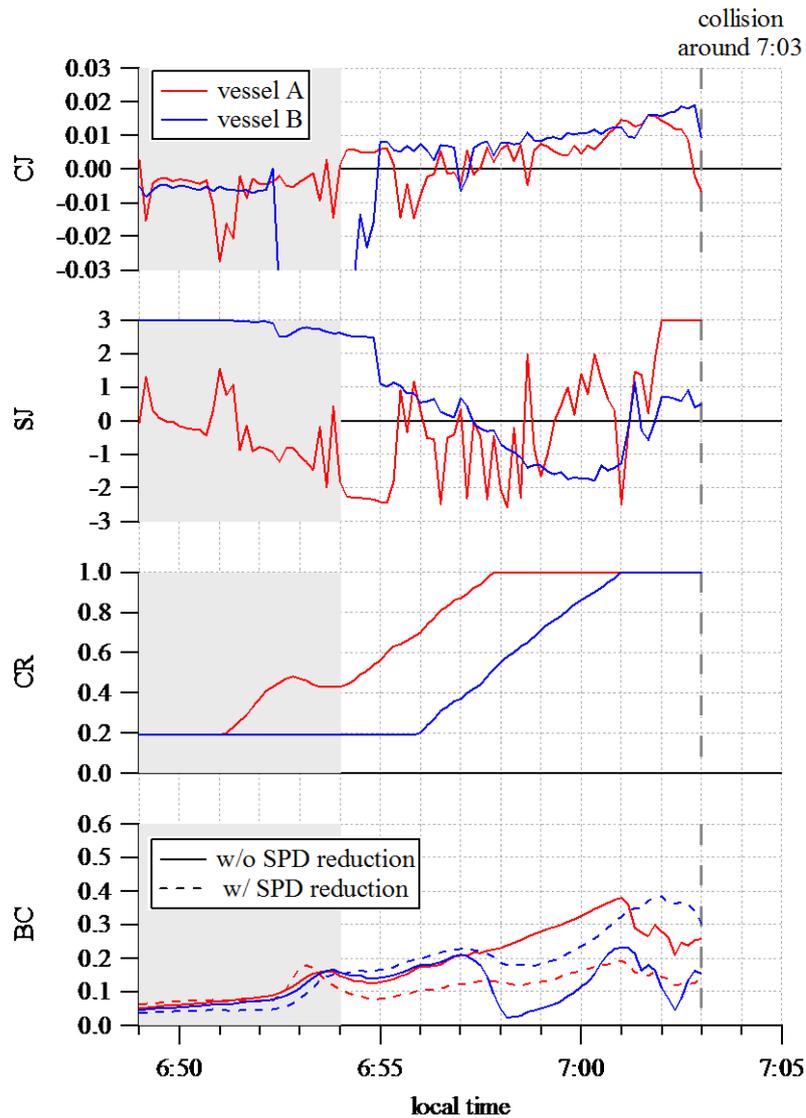
Fig. 2-7 Time-related changes in collision risk level

The solid lines of Fig. 2-7 indicate only course change as the means of giving way and the dashed lines indicate both course change and speed reduction. Regardless of whether the means of giving way is course change only or both course change and speed reduction, Vessel A's BC increases on the whole from around 06:55 and Vessel B's BC increases from 06:55, although it decreases temporarily at around 06:58. Looking at the degree of ship maneuvering by the means of giving way for each vessel, Vessel A's course change only values (solid line) have high BC values, while, conversely, Vessel B's course change and speed reduction values (dashed line) have high BC values. From this, it is probable that, in the circumstances of just these two vessels (Vessel A and Vessel B), ship maneuvering would have been comparatively less difficult if Vessel A had used both course change and speed reduction as her means of giving way and Vessel B had used only course change as her means of giving way.

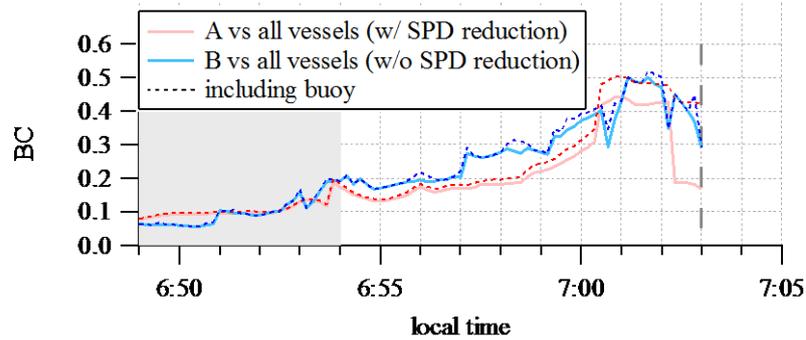
Fig. 2-8 Time-related changes in BC value when vessels in the vicinity are included

Additionally, the solid lines of Fig. 2-8 indicate time-related changes of BC value for all vessels shown in Fig. 2-1 when Vessel A's means of giving way are both course change and speed reduction and Vessel B's means of giving way is course change only. The BC of both Vessel A and Vessel B rise from 06:54 and their maximum values are more than double the two-vessel scenario due to the presence of anchored vessels, etc., meaning that ship maneuvering becomes difficult (Vessel A's BC of 0.19 becomes 0.47, or roughly 2.5 times higher, and Vessel B's BC of 0.23 becomes 0.52, or roughly 2.4 times higher). The level of maneuvering

Furthermore, the Kobe Rokko Island East Waterway's center floating lighted buoy is present in the sea area in which the two vessels were navigating, and it is probable that the buoy had an effect on maneuvering. The dotted lines of Fig. 2-8 show time-related changes of BC values when the light buoy is considered. The maximum value of Vessel A is 0.50 and that for Vessel B is 0.52. BC increases for both vessels when compared to the scenario in which only vessels are considered (solid lines). In particular, Vessel A's BC increases greatly from 07:00, and thus it could be said that the light buoy's presence affects her maneuvering.

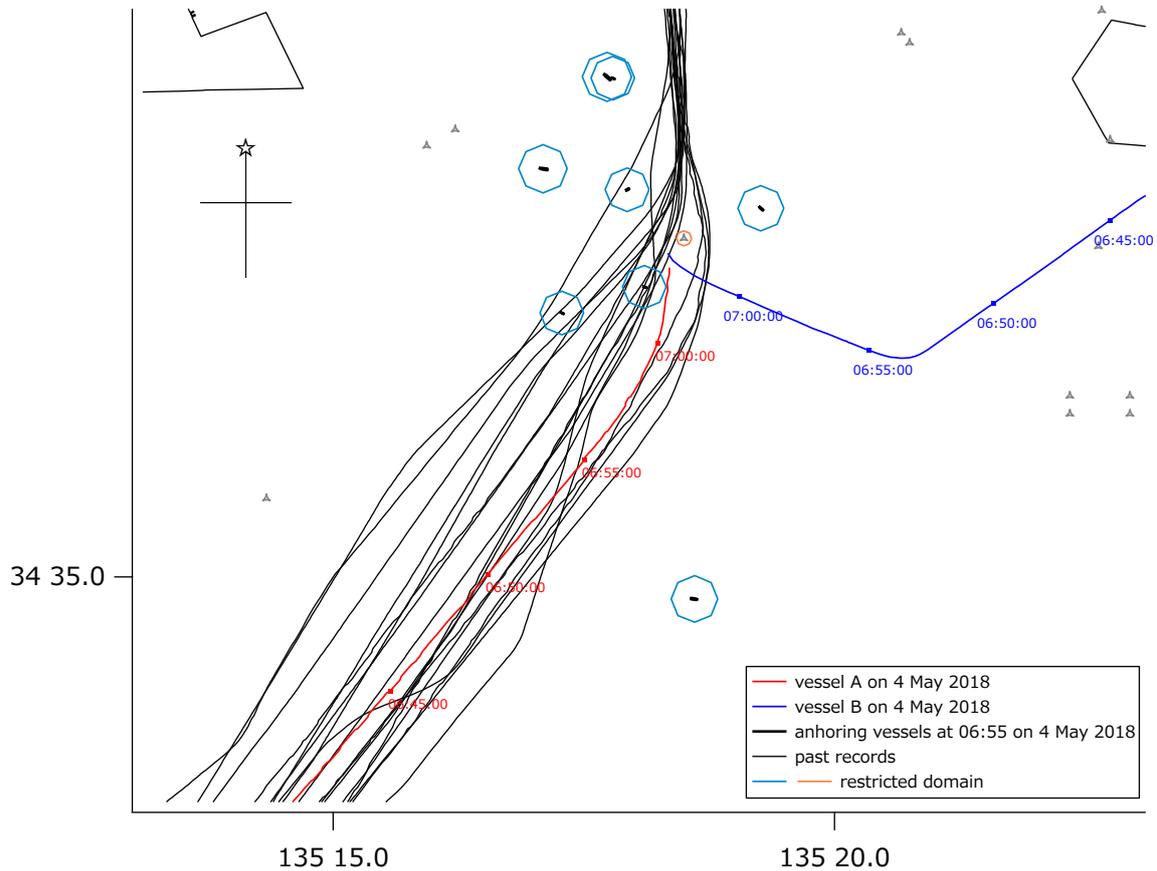
Fig. 3-2 Each vessel's navigation track and positional relationship of anchored vessels at around 06:55

In considering Vessel A's method of entering port at the time of the accident, because the sea area on the port side of Kobe Rokko Island East Waterway's center floating lighted buoy

was occupied by numerous anchored vessels, it is somewhat likely that Vessel A took an approach that involved proceeding north at an angle near the waterway's course from a position to the south of the light buoy. On the other hand, it is probable that Vessel B navigated between anchored vessels, which was the shortest path, in order to enter port on the Kobe Chuo Passage.

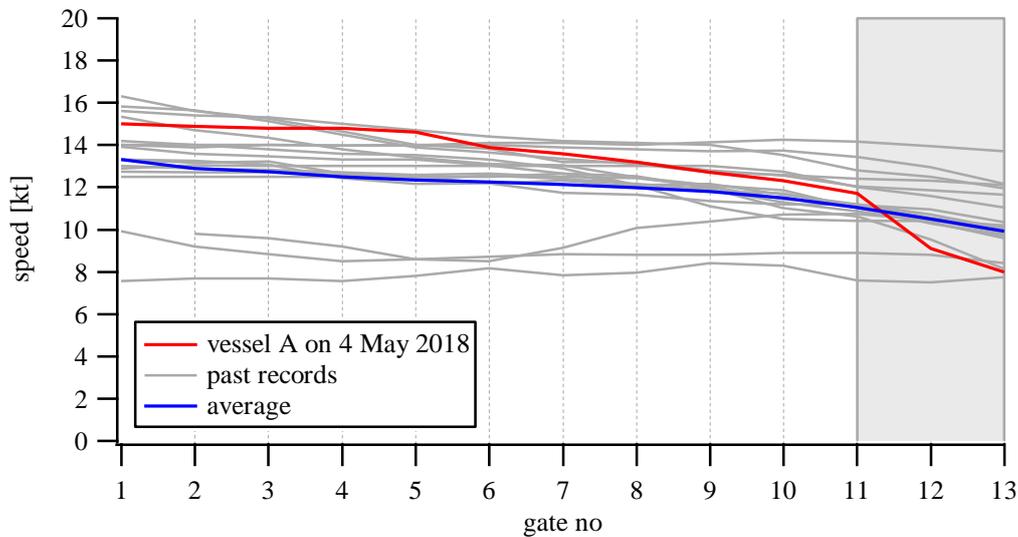
Fig. 3-4 Speed when passing gates

It is probable that the speed at which Vessel A was navigating at the time of the accident was a standard speed compared to the speeds of vessels when entering port in the past, albeit slightly faster than the average. The diagonal line section between No. 11 and No. 13 is when Vessel A is passing gates after the collision points.

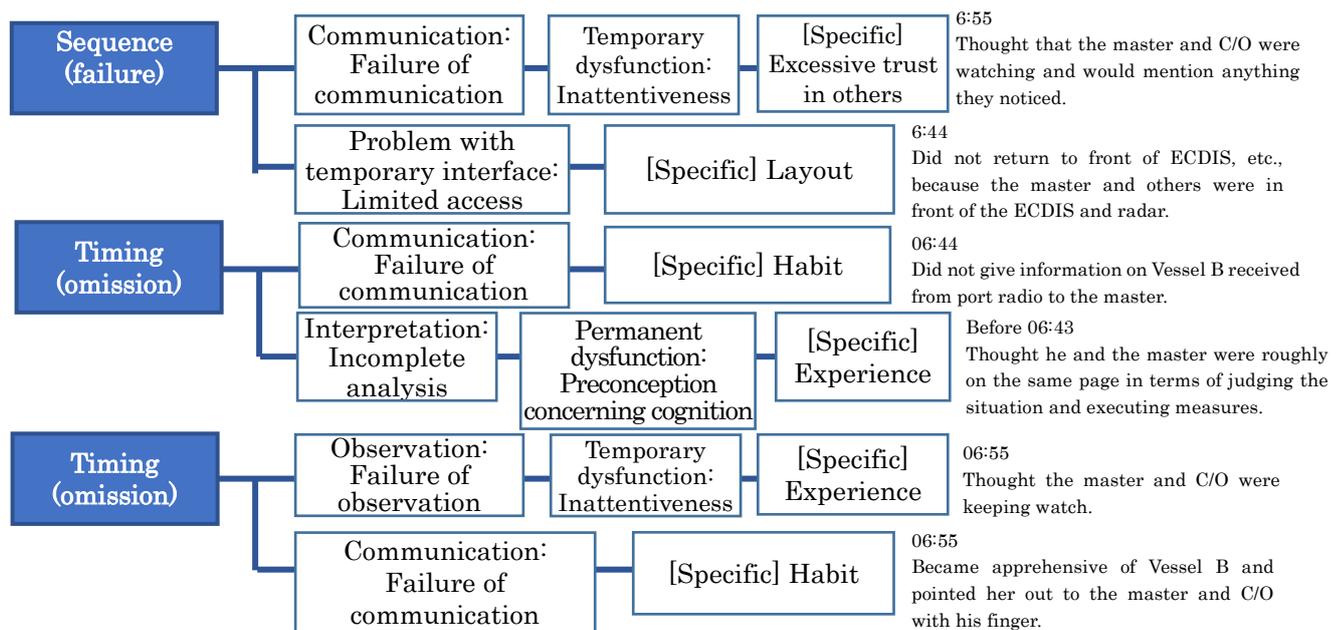
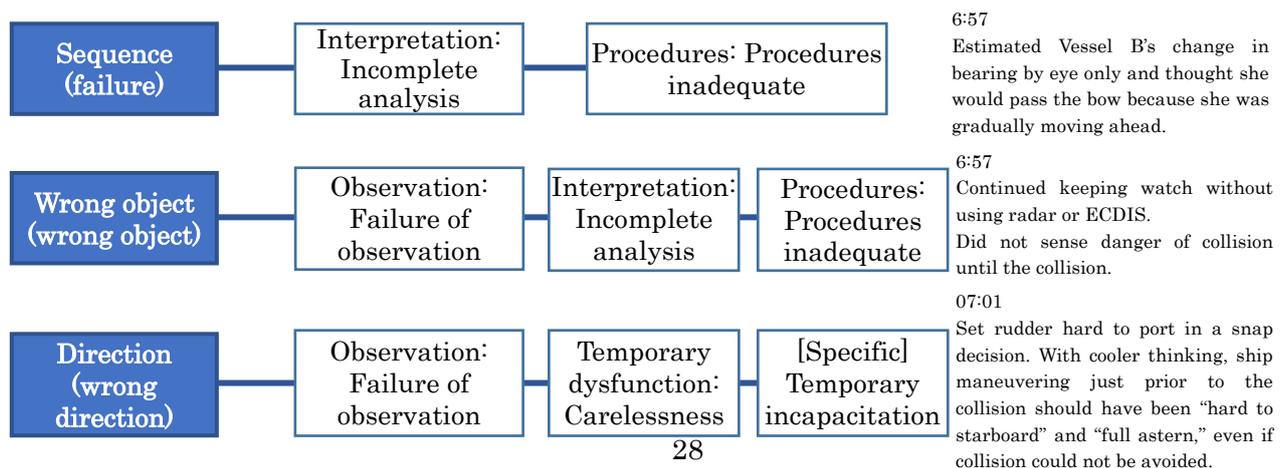
Fig. 5-3(a) Result of background factor analysis on the Pilot of Vessel A

5-3(a)(b) show the results of background factor analysis. The pilot thought that the master

or others would mention any questions they had concerning ship handling, and that the lack of questions was because they were keeping watch with thinking that was in agreement with his own. Because the pilot did not give the master the information on Vessel B that the pilot received from the port radio, the master judged that Vessel B would take a course away from Vessel A. He was therefore engaged in a discussion on port entry with the chief officer without keeping lookout and was not paying attention to the pilot's ship maneuvering. However, the pilot did not notice this because communication was inadequate. Additionally, after communicating with Kobe Port Radio, the pilot was keeping watch without using the radar or ECDIS and did not notice that Vessel A was approaching Vessel B in a manner that would lead to a collision. Additionally, although he was slightly apprehensive because Vessel B's change in bearing was gradual, he did not communicate with Vessel B by VHF. Subsequently, he visually observed the other vessel's bearing change and saw her moving forward against the background and therefore thought Vessel B would pass the bow of Vessel A. He was not aware of the danger of collision until just prior to the collision, and ordered the speed reduced in preparation for entering port.

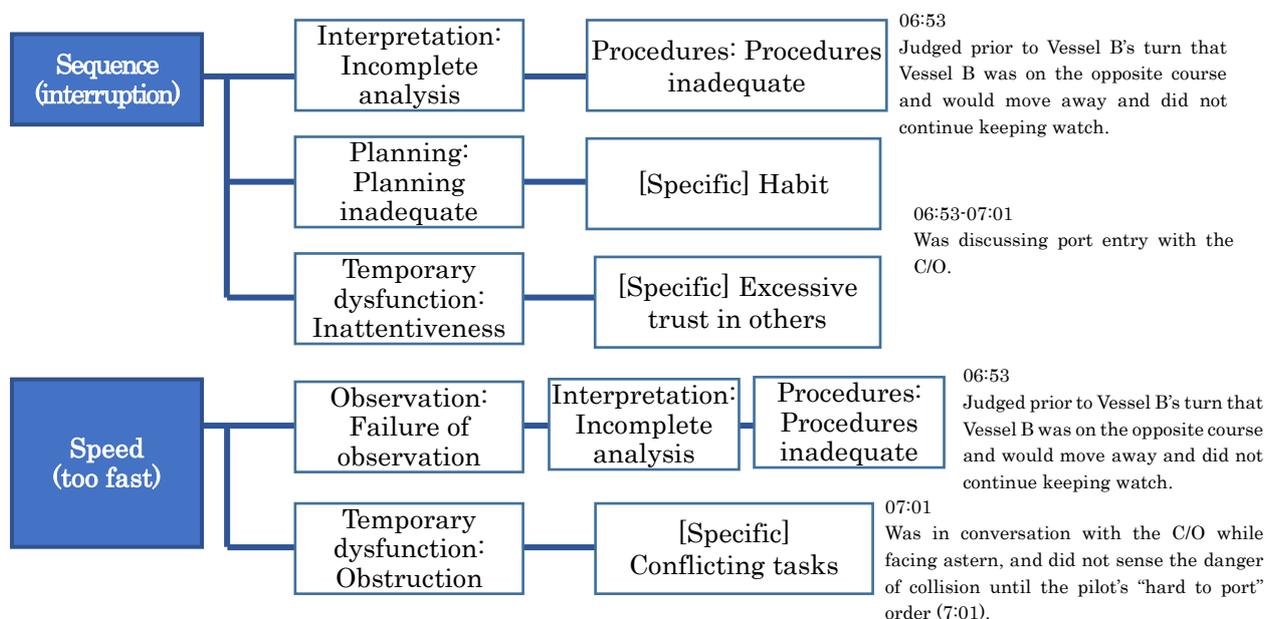
Fig. 5-4 Result of background factor analysis on the Master of Vessel A

Fig. 5-4 shows the result of background factor analysis. Vessel A's master had to simultaneously keep watch and discuss matters prior to entering port. Vessel B began a starboard turn toward the central passage from around 06:52. However, Vessel A's master had judged that Vessel B was on the opposite course before she changed course and was discussing the port entry with the chief officer while facing astern. Consequently, he did not notice that Vessel A was navigating in a manner that posed the danger of a collision with Vessel B until immediately before the collision.

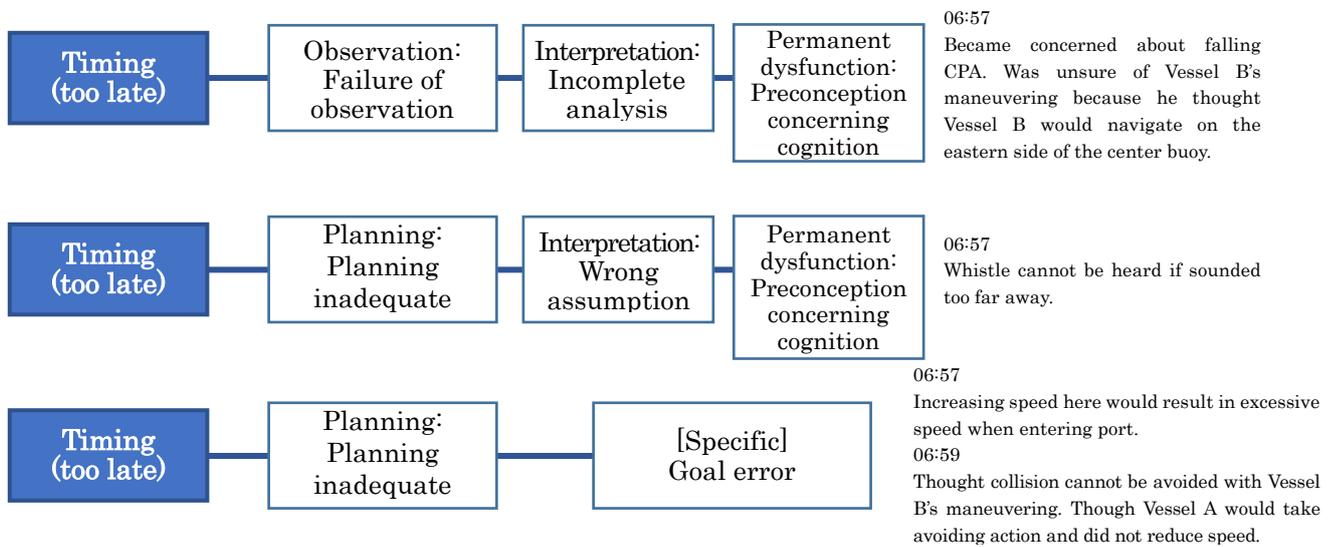
Fig. 5-5 Result of background factor analysis on the Master of Vessel B

Fig. 5-5 shows the result of background factor analysis. Based on the radar’s predicted course, Vessel B’s master thought that Vessel A would pass the eastern side of the central buoy. However, at around 07:00, it appeared that Vessel A was beginning a port turn and he questioned Vessel A’s maneuvering. He sensed the danger of collision, as he could not make a large starboard turn due to the presence of anchored vessels; however, he did not confirm Vessel A’s intentions by VHF or sound an alarm using the whistle or other means until immediately prior to the collision. Additionally, he needed to communicate with Vessel A at 06:57, when he became anxious about the falling CPA. Since whistle signals are used for vessels that are within visible range, he was required to alert Vessel A using the whistle if he could not understand Vessel A’s maneuvering intentions after observing her.
