RA2017-8-II

Railway Accident Investigation Report

Train Derailment Accident
between Kumamoto station and Kumamoto General Train Depot
of the Kyushu Shinkansen of the Kyushu Railway Company

Japan Transport Safety Board

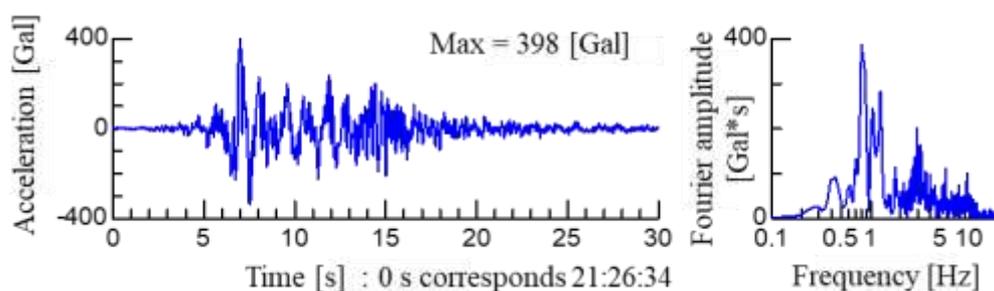
Figure 10. Estimated waveform of seismic ground motion of ground surface in orthogonal direction to track at the estimating point

the ground surface at around the accident site was estimated as shown in Figure 10. The estimated seismic ground motion of the ground surface had the maximum acceleration of 398 Gal, and many oscillatory frequency components in around 0.8 Hz and around 1.3 Hz.

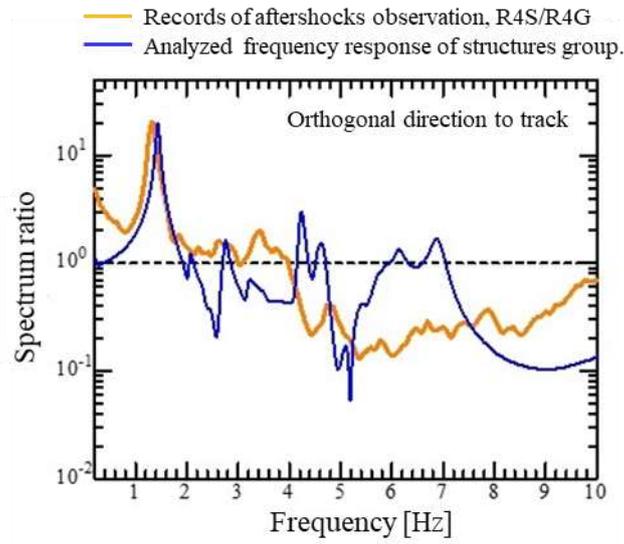
Figure 11. Comparison of records of the aftershock observation and analyzed results of frequency response

The comparison of the spectrum ratio obtained from the frequency response analysis and the spectrum ratio obtained from the records of the aftershocks observation, for the vibration at top of the R4 viaduct of the No.2 Tasaki BL against the ground surface, were shown in Figure 11.

As the result of comparison, validity of the supposed structures group model was confirmed as the analyzed results and the observed results were almost agreed with each other, for the peak values and the frequencies of the spectrum ratio corresponding the first mode vibration in orthogonal direction to the track.

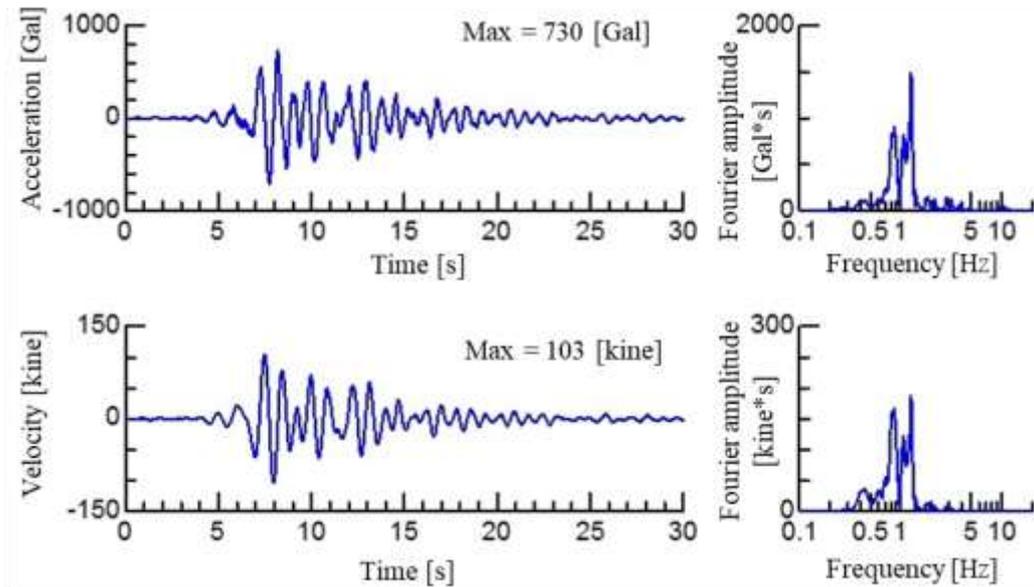
Figure 13. Sample of response waveforms of the structures group, at end edge direct to terminal in R4, in the direction orthogonal to track.

The accident occurred in the place where the guard angles were not installed, and the reasons why the guard angles were not installed there, were as described in 2.6.2. It is somewhat likely that the seismic ground motion vibrating in about 1 Hz was amplified in the surface ground in around the accident site by the effects of the surface layer ground as described in Figure 22 in 3.2.4. It is somewhat likely that the acceleration of the seismic ground motion at the top of the structure, having the peak in around the natural frequency 1.3 Hz, might be amplified to over 1.8 times in maximum of the seismic ground motion at the ground surface, according to the results of the simulation described in Figure 13 in 2.10.2.2[4].

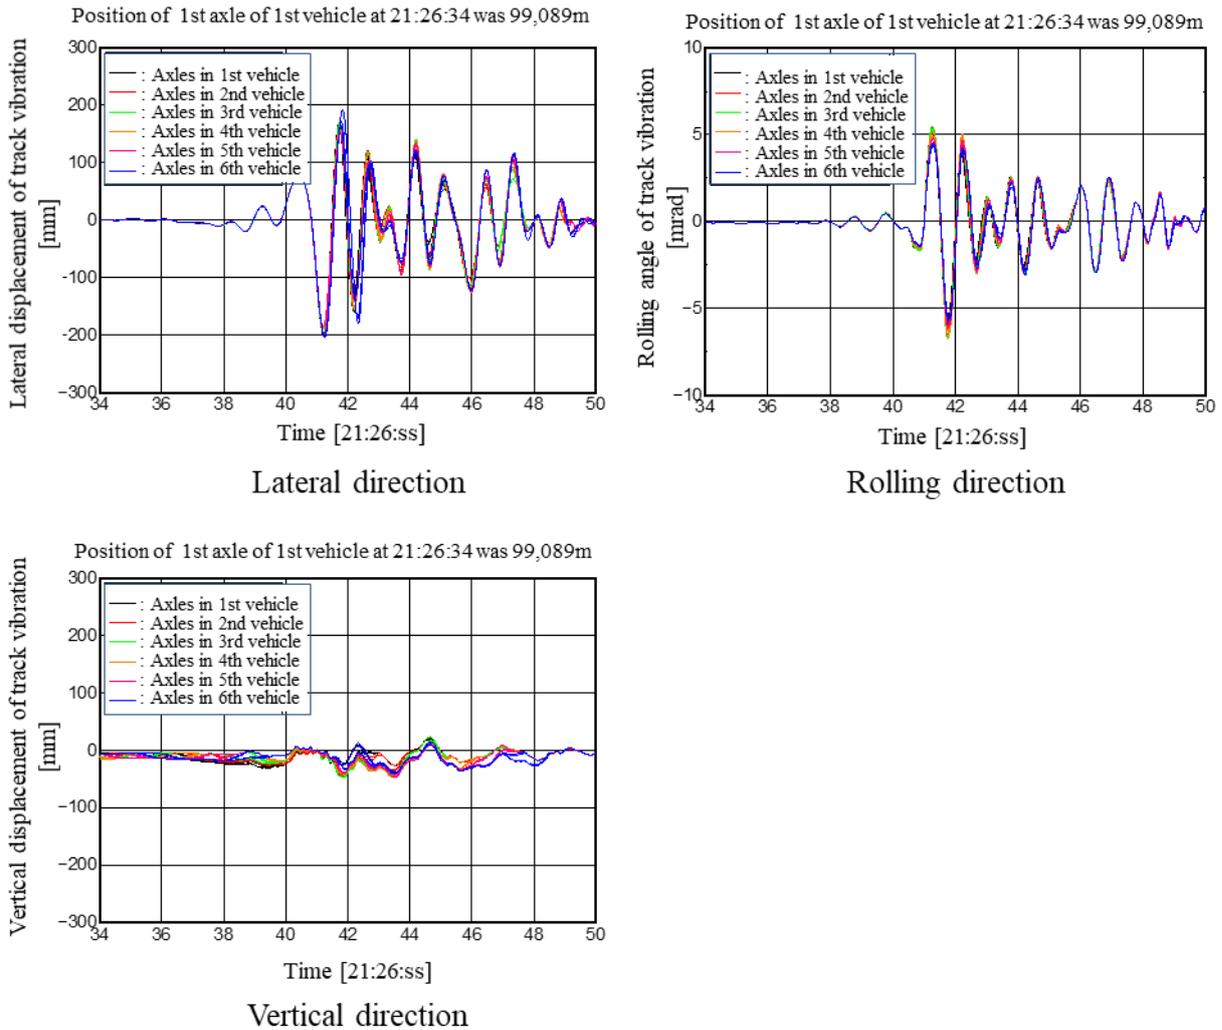
Figure 18. Input vibration of the track surface at just beneath the axles

As for the input vibration of the track surface just beneath the individual axles, the time history wave forms of the lateral, rolling and vertical components of the vibration were shown in Figure 18, and the Fourier amplitudes of the lateral and rolling components of the vibration were shown in Figure 19. The Fourier amplitude of the track surface vibration had the peaks in around 0.8 Hz and around the natural frequency of the structure 1.3 Hz. The largest peaks were in around 0.8 Hz for the lateral direction, and in around 1.3 Hz for the rolling direction, as shown in Figure 19.

The emergency brake of the accident train operated after confirmed the receipt of the emergency stop signal "02E" at 21:26.43, as indicated in Table 2 in 2.1.2.1, but the accident train received from the violent lateral vibration of the track surface considered as caused by the S-wave of the concerned earthquake at about 21:26:41 to 21:26:42 as shown in Figure 18, before the velocity was decreased.

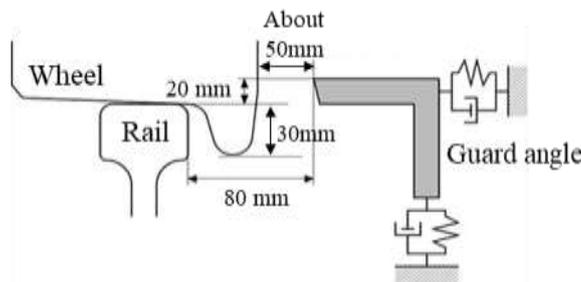
Figure 21. Guard angle model

The vehicle behavior was analyzed for the case if the guard angles were equipped in around the accident site, as shown in Figure 21. The analyzed results showed that the maximum values of the relative lateral displacement between wheel and rail in the 1st, 2nd, 3rd and 6th vehicles, which had derailed in the section where the guard angle were not equipped, exceeded 50 mm and did not derail because the wheels came into contact with the guard angle, as shown in Table 18. The maximum values of the height of the raised wheels exceeded the flange height 30 mm in all vehicles.

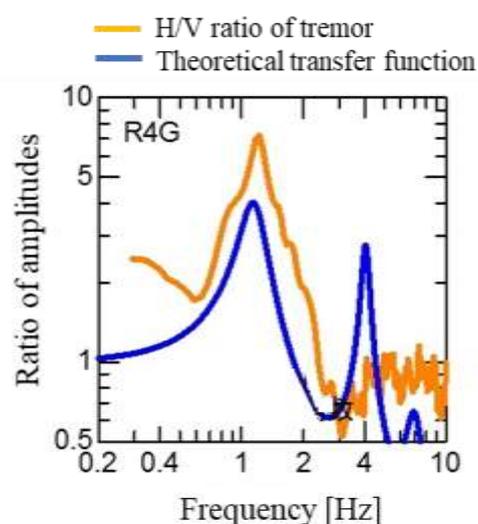
Fig 22. Comparison of theoretical transfer function and H/V spectrum ratio of the tremor, observed at R4G

The surface layer ground in around the accident site was modeled as shown in Attached figure 12 as described in 2.10.2.2[1]. The estimated results of the transfer function from the Dg1 layer, *i.e.*, the bedrock of seismic design, in the ground around R4 viaduct of the No.2 Tasaki BL, using the multiple reflection theory^{*38}, was shown as the blue line in Figure 22. Here, it was assumed that the signal was input from downward in vertical direction. The H/V spectrum ratio obtained from observation of the microtremor was shown by the orange line in Figure 22. It is probable that the possibility of amplification of the

vibration component of around 1 Hz in the ground surface in around the viaduct R4 of the No.2 Tasaki BL was high, because there were dominant peaks in around 1 Hz in both characteristics. Therefore, it is somewhat likely that the large lateral vibration as shown in Figure 10 in 2.10.2.1, were acted to just beneath the structures in around the accident site.

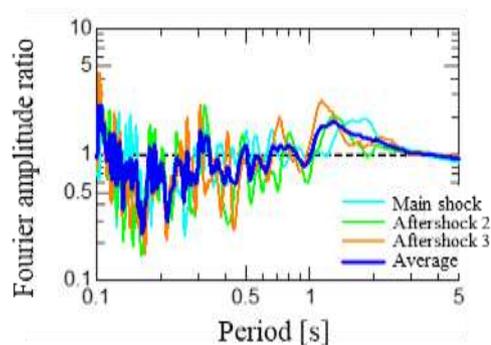
Figure 23. Transfer function between two points on the ground surface, JMA Kumamoto Nishi-Ku Kasuga was used as the reference point.

In addition, it is probable that the seismic ground motion was amplified by the effects of the surface ground at the estimating point, because the average Fourier amplitude ratio in the period of 1.0 to 1.5 seconds, *i.e.*, frequency was 0.8 Hz, exceeded 1.0 significantly.

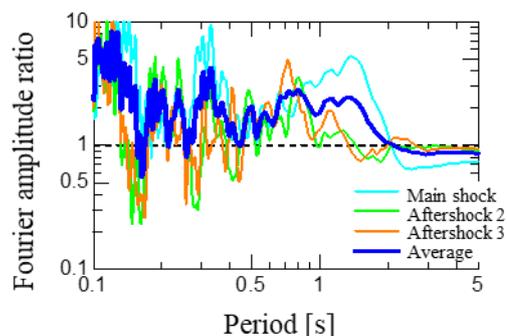
Figure 24. Transfer function between two points on the bedrock. JMA Kumamoto Nishi-Ku Kasuga was set as the reference point.

The transfer function on the bedrock between the reference point and the estimated point was shown in Figure 24. The transfer function on the bedrock was expected as smaller than the transfer function on the ground surface indicated in Figure 23, but it was larger in wide frequency band. It is somewhat likely that the transfer function could not be estimated stably because the Fourier amplitude ratios of the main shock and two aftershocks varied largely, and the amplitude ratios of each earthquake differed significantly with each other.

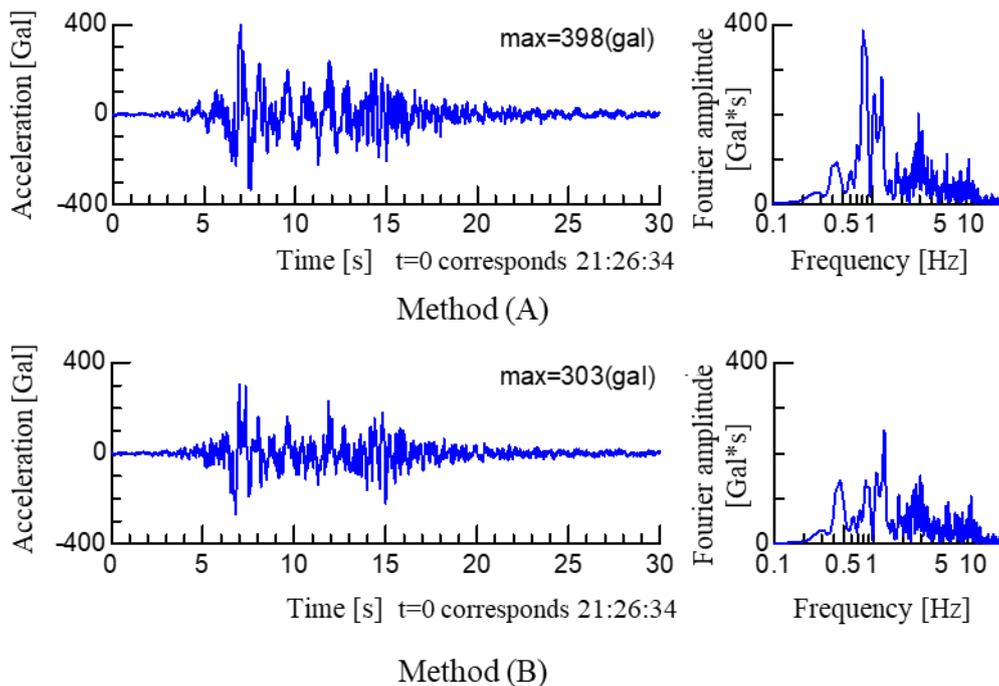
Figure 25. Estimated seismic ground motion on the ground surface in the estimating point

It was highly probable that the estimated waveforms of seismic ground motion obtained from the above discussions, contained a lots of frequency components in around 0.8 Hz and

around 1.3 Hz, as shown in the upper figure of Figure 25.

Next the seismic ground motion on the ground surface at the reference point was estimated by the response analysis of the ground using the obtained seismic ground motion at the bedrock and the ground conditions at the estimating point. The physical properties of the ground and the nonlinear characteristics were determined by the same conditions as in the calculation of restoring. The estimated waveforms of the seismic ground motion obtained as the results of the calculation

was shown in the lower figure in Figure 25.

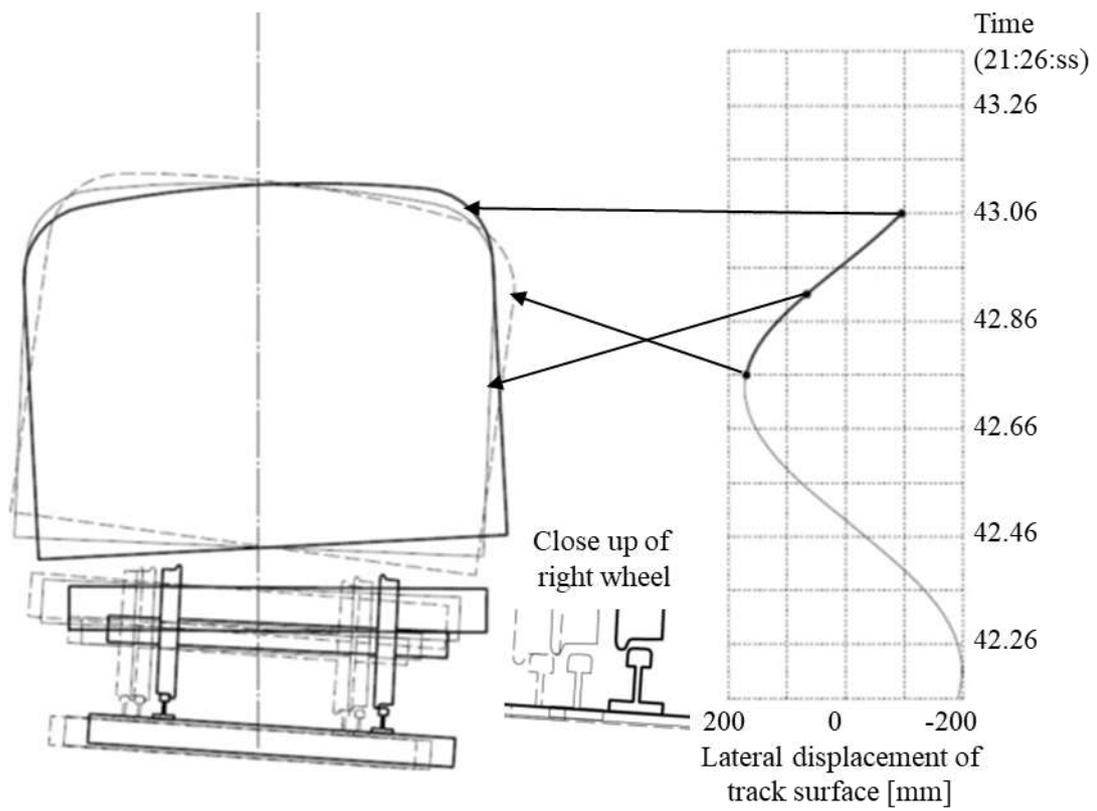
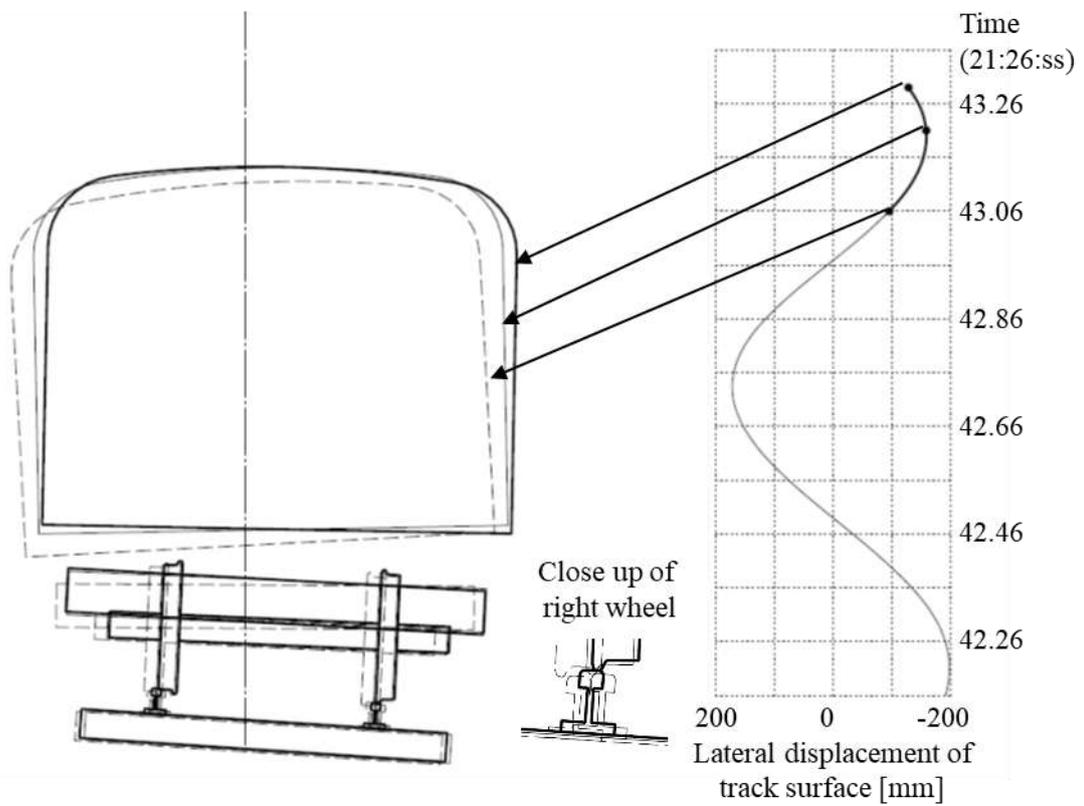
Attached figure 17. Transition of posture of the 1st vehicle just before the derailment

[Refer to Attached figures 17 and 18]

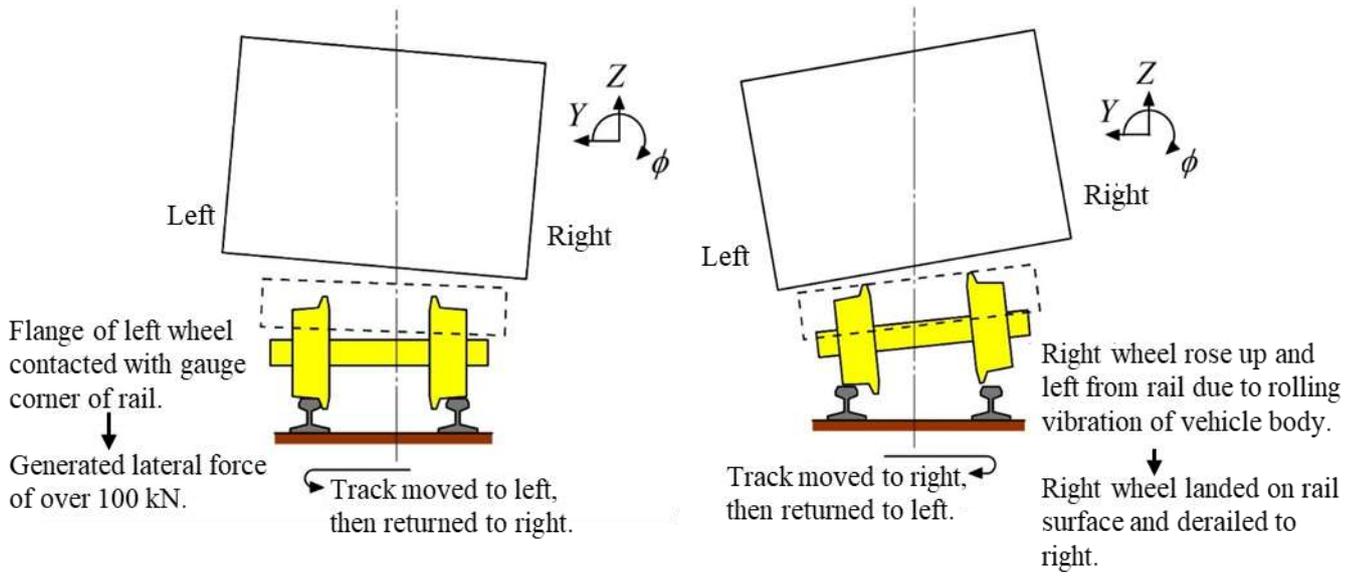
Attached figure 21. Behavior of the vehicle when derailed to right

[Ref. Attached Figure 21]

It is probable that the vehicles derailed to left and right of the train direction because of the difference in the vehicle behaviors in each vehicle due to some differences of vibration of the track surface acted on each vehicle, as the positions of each vehicle running on the viaduct in a certain moment were existed on the different structures, as shown in Figure 20. Here, there were occasions having a possibility of derailment twice in the interval of about 0.5 second, *i.e.*, vehicles derailed to right in the first occasion and vehicles derailed to left in the second occasion.
