**AIRCRAFT ACCIDENT
INVESTIGATION REPORT**

**NON-PROFIT ORGANIZATION NIRASAKI-CITY
AVIATION ASSOCIATION
J A 2 4 4 6**

FUSELAGE DAMAGE IN LANDING
NON-PROFIT ORGANIZATION NIRASAKI-CITY
AVIATION ASSOCIATION
SCHEIBE SF34B (GLIDER, TWO-SEATER), JA2446
NIRASAKI GLIDING FIELD, TATSUOKA-MACHI, NIRASAKI CITY,
YAMANASHI PREFECTURE, JAPAN
AT AROUND 11:02 JST, APRIL 26, 2015

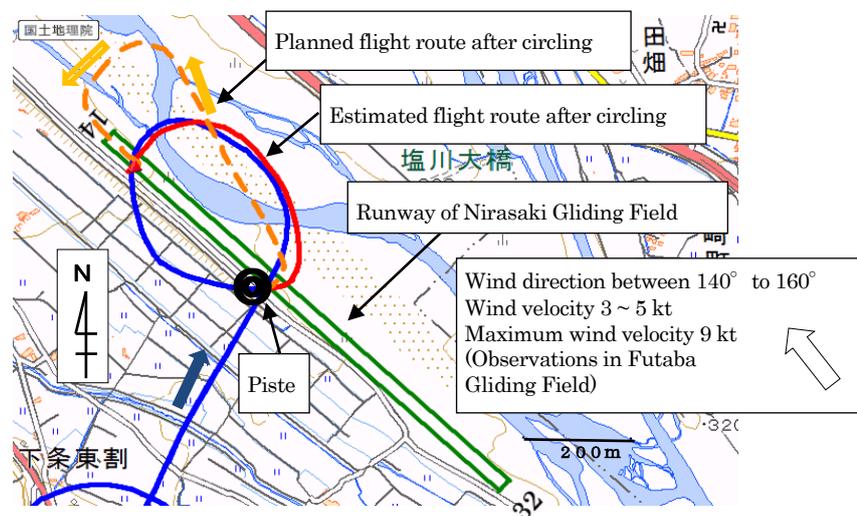
Estimated Flight Route Map (According to records of cellular phone with built-in GPS owned by the trainee)

Although the Glider continued to turn to the left, it could not directly face the Runway and the left main wing tip was brought in contact with the ground in front of the Runway. Afterward, the Glider touched down to the ground with the nose up, once bounced on the Runway, slightly veered the nose to the right, crossed the Runway while skidding sideways, and stopped in the edge of the Runway with the nose directed to the west.
