## SAFETY ALERT 072

# Minding Weight, Maintaining Balance

Improper or Unperformed Calculations Can be Fatal

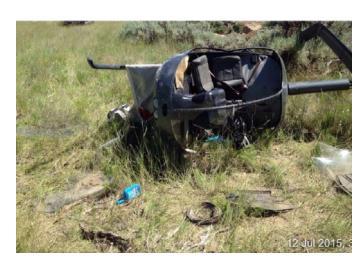
A Robinson R22 Beta II helicopter sustained substantial damage when it collided with rising terrain 10 miles west of its departure point (see figure 1). The private pilot sustained a serious injury, and the passenger sustained a minor injury. The pilot reported that, as he was flying the helicopter up a canyon and climbing in rising mountainous terrain, he no-

Figure 1. Photograph of substantial damage to Robinson R22 Beta II helicopter

er, the helicopter impacted rising terrain. The investigation determined that the helicopter was operating about 30 lbs above its maximum gross weight and that the calculated density altitude was about 9,600 ft. The pilot did not know that the helicopter's gross weight was greater than its maximum due to inadequate preflight planning. His subsequent decision to attempt to climb over rising terrain in high-density altitude conditions with a tailwind resulted in the helicopter's inability to maintain a positive climb rate and subsequent impact with terrain. (GAA15LA131)

- **Know** your aircraft's limitations and the factors that can affect its performance.
- **Conduct** weight and balance calculations in accordance with the applicable aircraft flight manuals (AFM) to ensure that your aircraft is loaded within its weight and CG limits. The limitations section of each AFM or Pilot's Operating Handbook contains details about the maximum weight and CG limits for takeoff and landing.

- **Determine** the CG even if your aircraft is under its maximum gross weight. Even if an aircraft is within its allowable gross weight, it may be loaded outside of its CG limits.

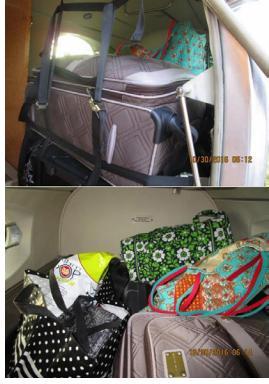
A Beech 100 ran off the departure end of the runway during takeoff, substantially damaging the airplane (see figure 2). The airline transport pilot, copilot, and eight passengers were not injured. During the takeoff roll, the airplane did not accelerate as quickly as the pilot expected. When the airplane reached the last third of the runway, the pilot pulled back on the control yoke to lift the airplane off the runway, but the stall warning horn sounded. He lowered the nose, but the airplane subsequently departed the runway and impacted terrain and obstacles. The pilot reported that he knew that the total weight of the eight passengers, their bags, and the fuel caused the airplane to be overweight, but he did not complete a weight and balance form or determine the expected takeoff performance before the flight (figure 3 shows the unweighed luggage on board the airplane). After the accident, the pilot determined that the airplane was 623 lbs over its maximum gross weight. The pilot's decision to depart knowing that the airplane was over its maximum gross takeoff weight was unsafe. Coupling that decision with the pilot's failure to determine the expected takeoff performance resulted in the airplane not accelerating as expected and its subsequent runway excursion. (CEN17LA029)

Figure 3 (at right). Photographs showing unweighed baggage on Beech 100

- **Do not "guesstimate"** passenger and cargo weights. The margins of error are small, and even slightly underestimating these weights could kill or seriously injure you, a friend or colleague, or a family member.
